In Small Things Forgotten:

EXAMINING THE KIZILBURUN COLUMN WRECK FASTENERS

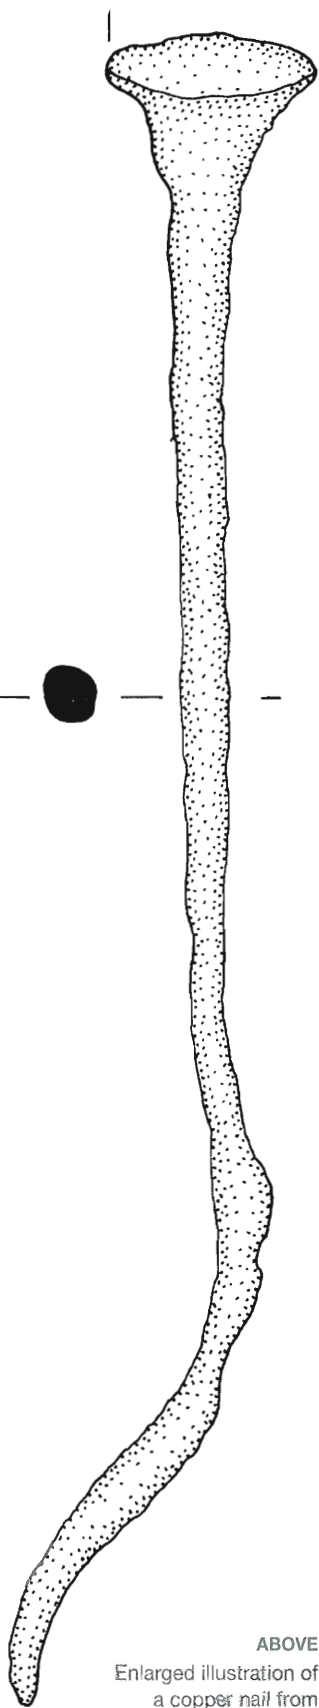
ABOVE
Enlarged illustration of
a copper nail from
the Kizilburun site.
Mustafa Korkmaz

All fasteners were tested with a rare earth magnet and found to be of non-ferrous material, which prompted the desire to know if they were made of copper or bronze. Few ancient vessels have been found to have been constructed with bronze fasteners, although translations of ancient texts suggest bronze was the material of choice. This is another on-going question in ancient ship construction, as so few wrecks have had fastener metals identified with little more than visual examination that often proves to be problematic or incorrect. To this end, I requested the use of INA's pXRF (portable X-ray fluorescence) analyzer that gives an elemental breakdown of metals. Luckily, visiting scholar Yuval Goren of Tel Aviv University was in Bodrum to conduct petrographic analysis of cooking pots from the Tektaş Burnu shipwreck and was kind enough to instruct Deborah Carlson, fellow NAP student Ryan Lee and myself in the use and applicability of the pXRF. After a few days of analyzing what seemed like

every available bit of modern metal available in order to test known materials, I turned my attention to the ancient nails and found that they are made of a very pure copper, not intentionally alloyed with another element (such as tin to form bronze). This information amends our still small database of ancient nail studies.

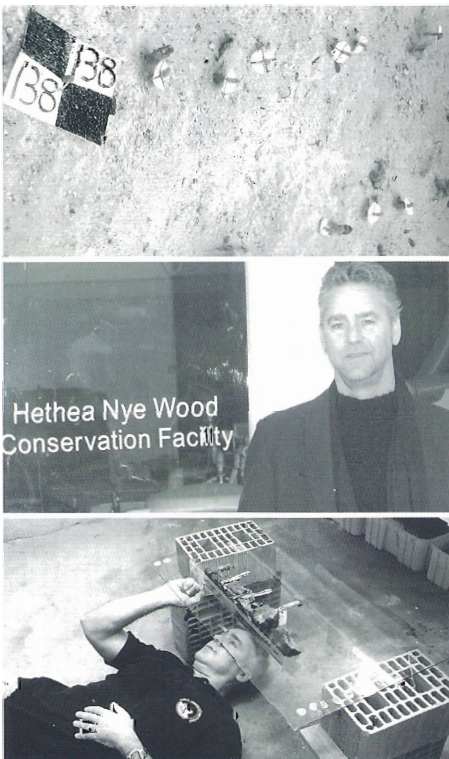
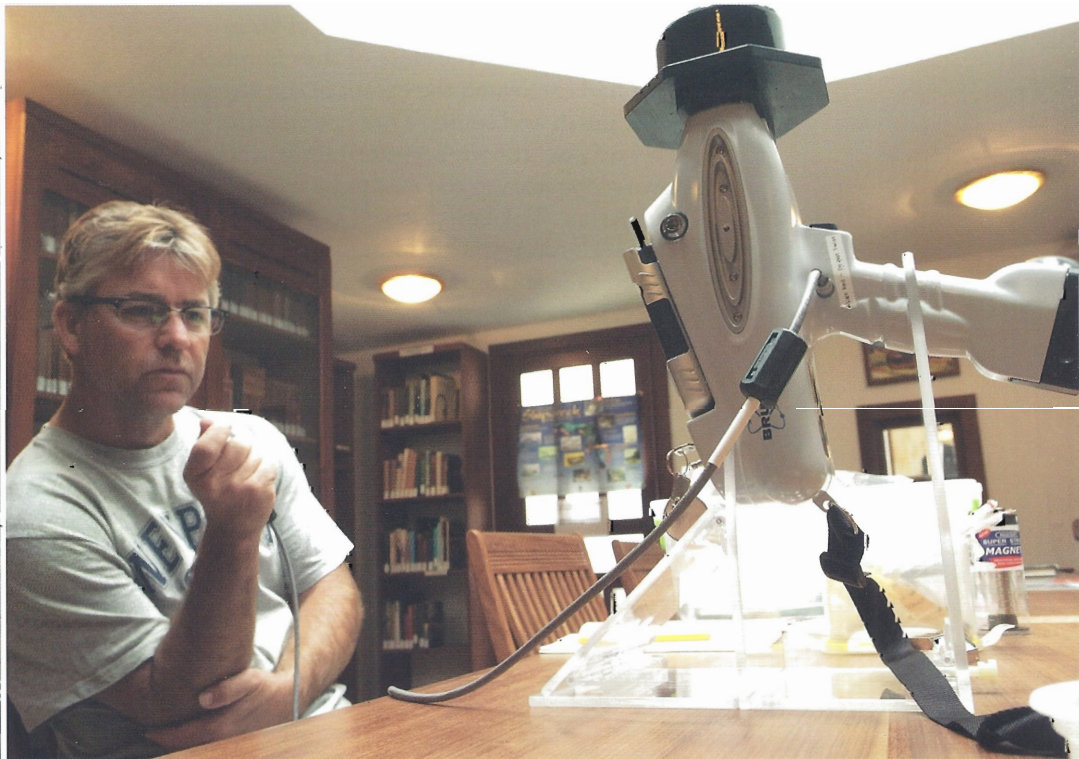
BELOW (CCW from upper left)

Rows of in situ fasteners.
PHOTO Catherine Sincich

John using a portable X-Ray Fluorescence (pXRF) unit. This state-of-the-art technology uses an x-ray beam to identify the specific elements present within archaeological material and provides archaeologists and conservators with valuable chemical information that can be used to better conserve and interpret submerged cultural heritage.
PHOTO Ryan C. Lee

away from the planking, which made determining the frame spacing problematic. Using the positions of in situ nail heads, I was able to determine the frame spacing of 25 cm. This figure was later corroborated by two impressions from adjacent frames found on a small section of reconstructed hull planking. Frame spacing is one of the major diagnostic attributes of ship construction. In addition to frame spacing, laboratory analysis of the fasteners also offered information about planking thickness and framing dimensions.
