**THE HULL REMAINS OF THE LATE HELLENISTIC
SHIPWRECK AT KIZILBURUN, TURKEY**

A Thesis

Submitted to the Office of Graduate Studies of
Texas A&M University
in partial fulfillment of the requirements for the degree of

MASTER OF ARTS

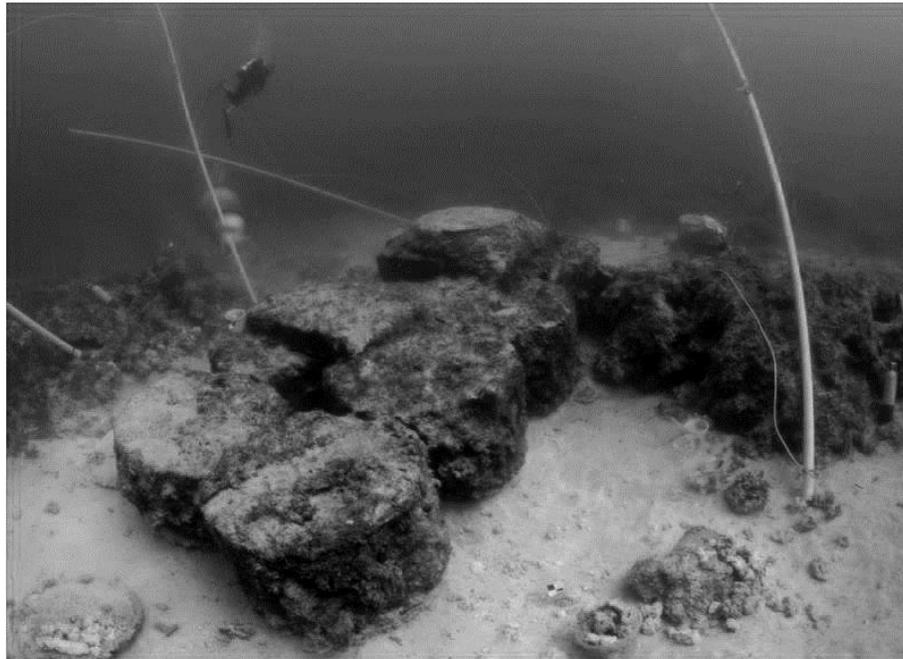
Figure 1.2. Early 2005 site photograph looking upslope. Photograph by Don Frey.

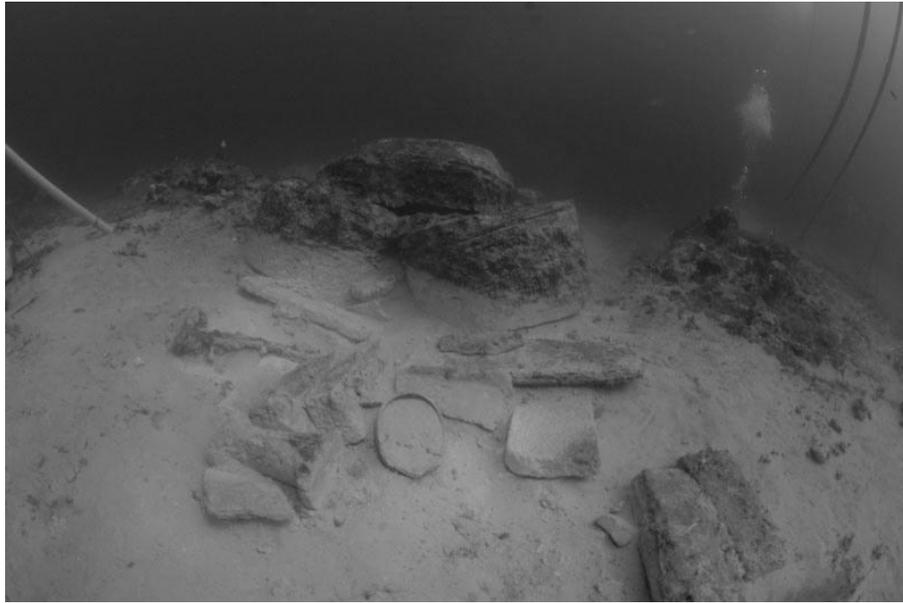
Figure 1.3. Column drums at seafloor level, looking downslope. Note the capital on top of drums 1 and 2. Photograph by Don Frey.

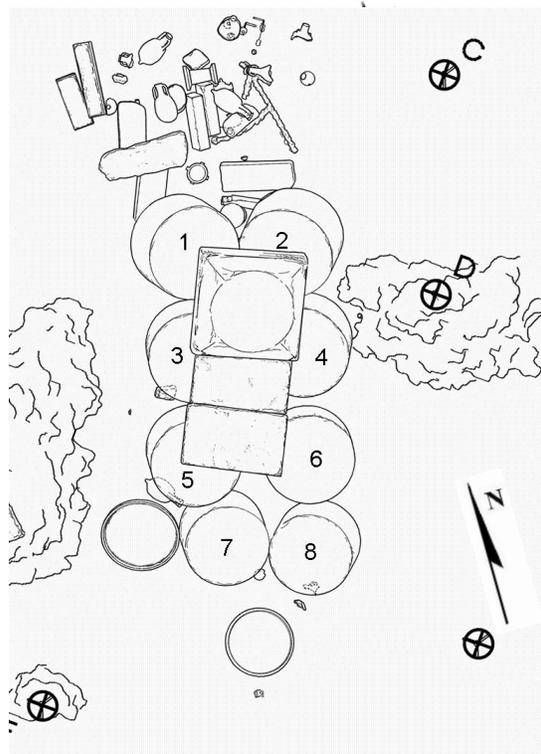
Figure 1.5. Site plan showing drum numbering system. Image by Sheila Matthews.

During the final weeks of the 2006 excavation season, four of the eight column drums (nos. 5, 6, 7, 8) (Figure 1.5) were rigged with large-capacity lifting balloons and removed off the wreck site, allowing for excavation of an area approximately 9 m² beneath the drums. The delicate procedure of repositioning the drums off site was accomplished with little disturbance of the fragile wooden hull remains that lay directly beneath the drums, although not without incident (discussed below). The area beneath drum 5 (designated area U5) proved the most lucrative in terms of wood remains. Numerous fragments of longitudinal planking were recovered along with four distinct frame fragments. These frame fragments have proven to be the most diagnostic and well-preserved timbers from the vessel.

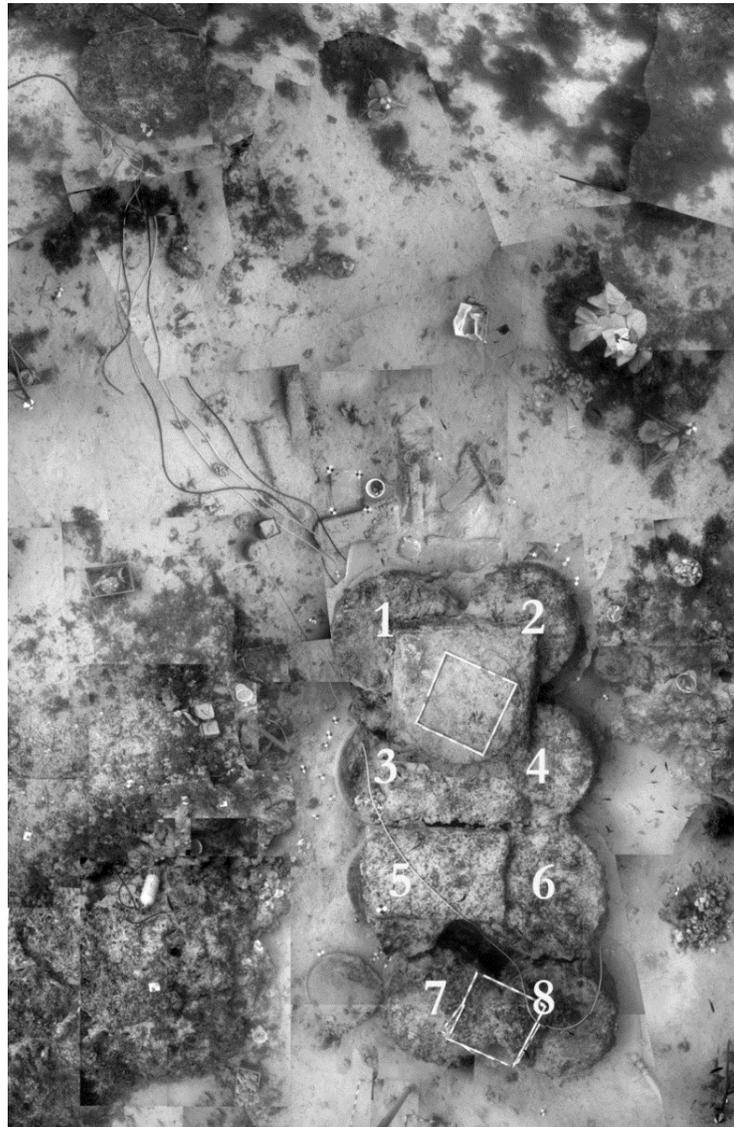
Figure 2.1. Column drum positioning as found and their assigned numbering. Photomosaic by Sheila Matthews.

After the ship sank, it came to rest on a moderately sloping, coarse-sandy seafloor at a depth of 42-45 m, grounded between outcrops of rocks (Figure 2.1).⁴³ Although site formation processes have not been formally addressed, evidence suggests the hull was not immediately buried in the seafloor sediments. Rather, the hull likely came to rest on the seabed and slowly became structurally weak by the effects of seawater saturation, bacterial

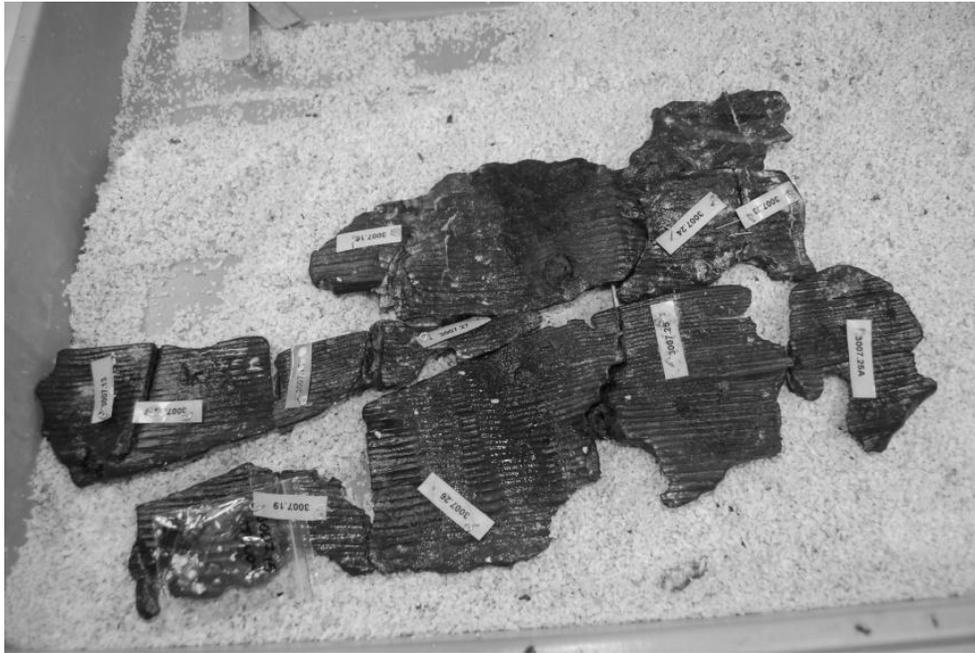
Figure 2.4. Planking section 3007 being reassembled. Photograph by the author.

Some timbers, often made up of many fragments, could be temporarily reassembled and recorded as a unit (Figure 2.4). Therefore, in addition to recording each individual fragment, a second catalog sheet was created solely for laboratory use (Figure 2.3) to record each distinct timber.

A long, shallow plastic container filled with tiny marble chips was used to support and align the timber fragments so that they could be recorded as a unit (Figure 2.4). These marble chips were chosen as they were easily form fitted under and around the fragments and offered more support than sand, which was also experimentally used. Further, the marble chips were more easily rinsed off the wood. This was a minor, albeit essential, adaptation that allowed accurate drawings and measurements to be produced. It further allowed for features such as nail spacing and mortise spacing to be measured or estimated more accurately. An illustrated catalog of reconstructed timbers follows in Appendix A.

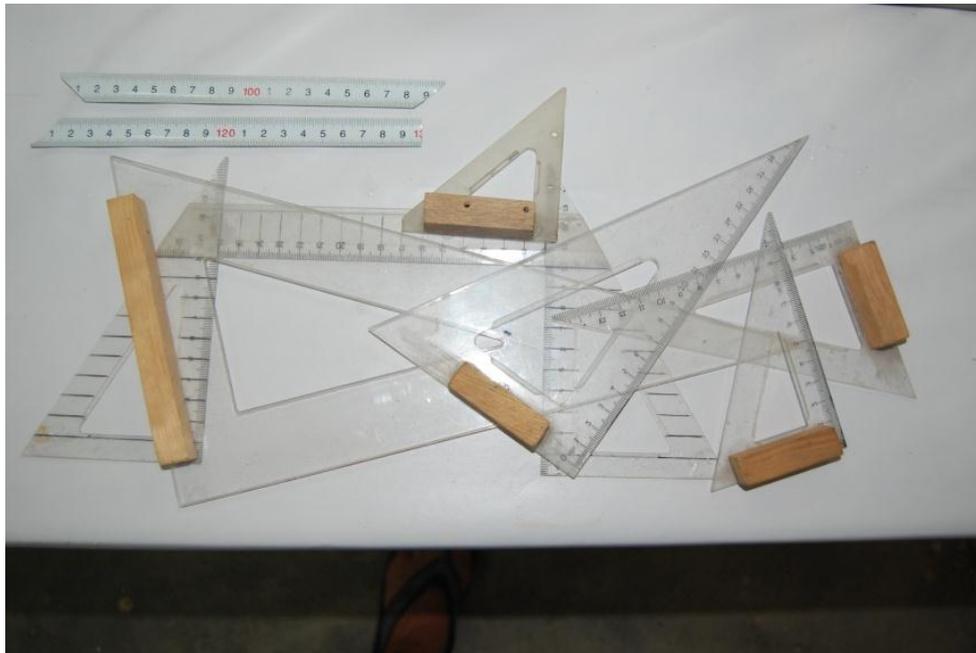
Figure 2.5. Tools adapted for recording timbers. Photograph by the author.

Steffy's method was adopted to record the wooden remains of the Kızılburun timbers and fragments. Proper alignment of the marker over the wood was maintained through the use of variously sized right-angle triangles with a small block of wood fastened to the lower edge for vertical and horizontal stability (Figure 2.5). By using the vertical edge of the triangle I was able to create a line of sight between the eye, the acetate, and the edge of the fragment, the goal being to keep the point of the marker directly over the edge of the timber being drawn in order to reduce the margin of error.⁵⁷

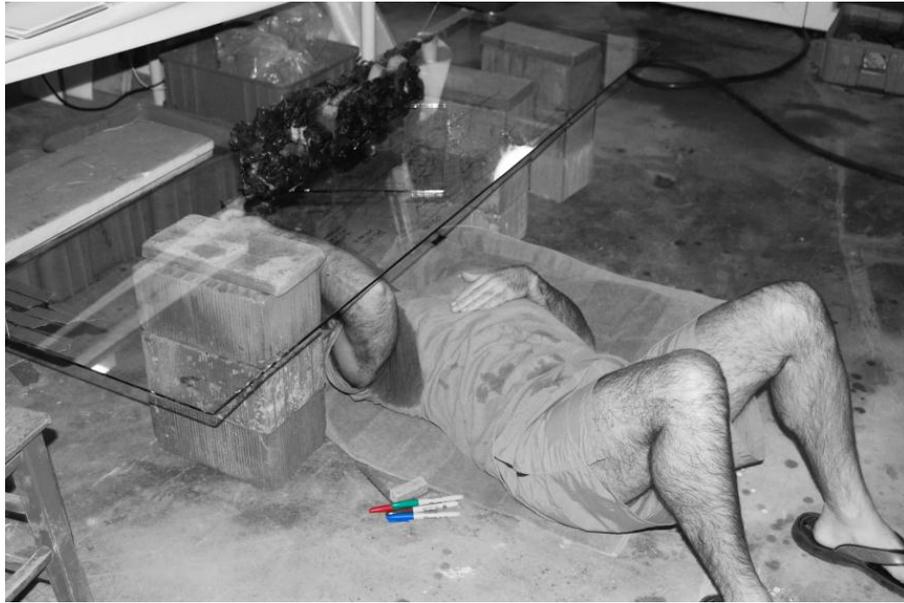
Figure 2.6. Recording the keel fragments. Photograph by Kimberly Rash.

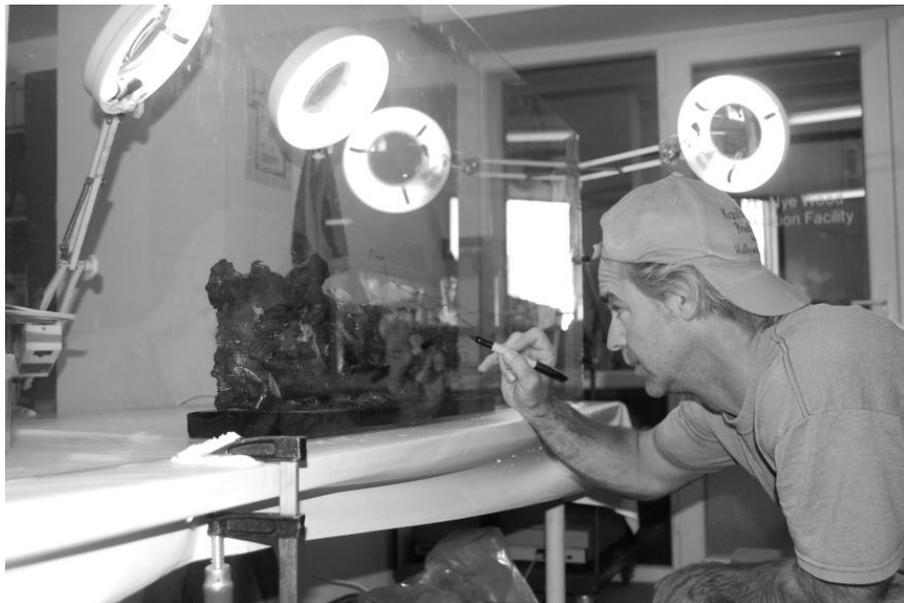
Figure 2.7. Recording keel fragments using plate glass and 90° brackets. Photograph by Kimberly Rash.

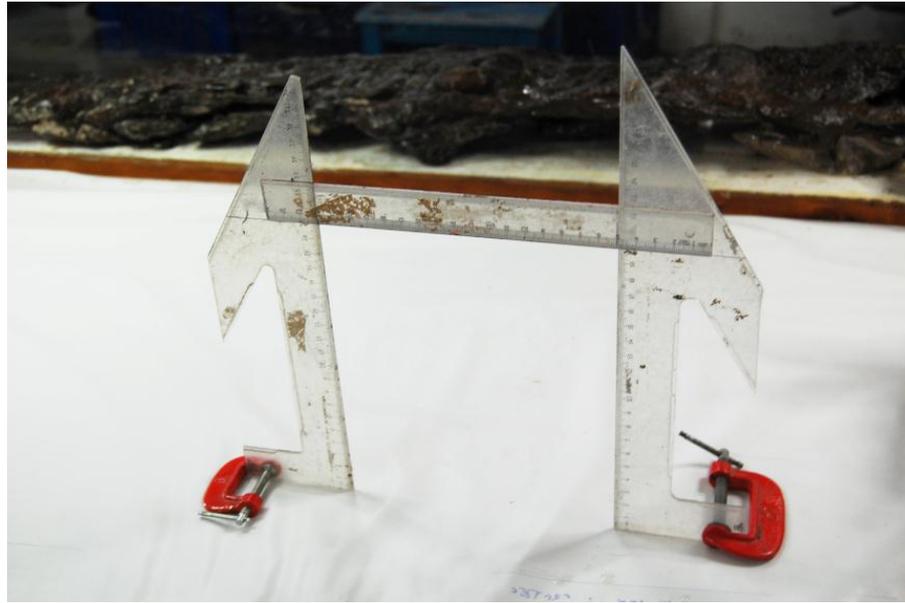
Figure 2.8. Tool for measuring timber profiles. Photograph by the author.

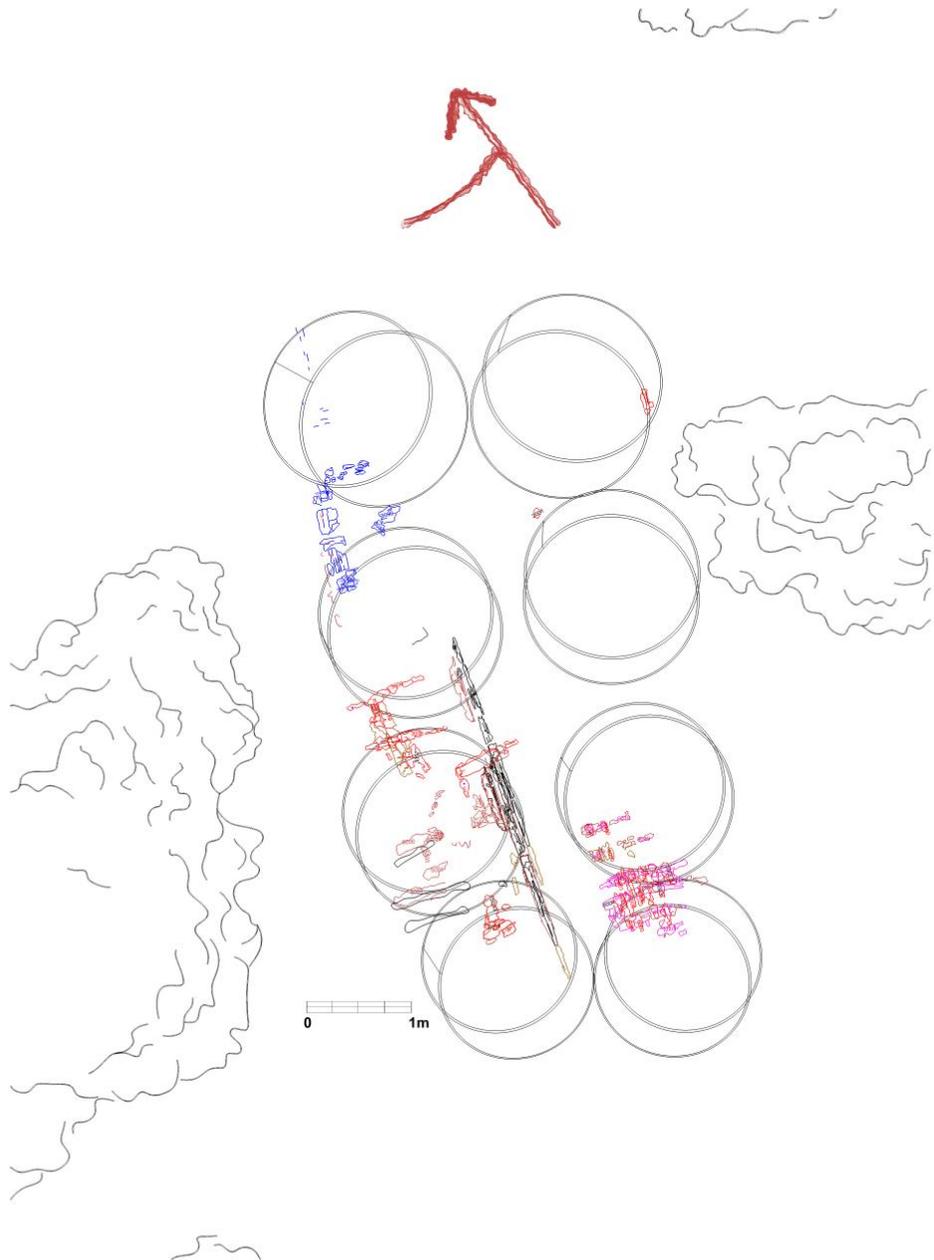
Figure 3.1. Timber fragments and iron anchor from Kızılburun with column drums superimposed. Site plan by Sheila Matthews and the author.

Almost all of the wood that survives was located under or between the eight column drums, concentrated in four areas (U1, U3, U5, and U6) with a few sporadic fragments coming from areas U7 and U8 (Figures 3.1 and 3.2) (Table 3.1). There was little continuity of individual timbers, even among those that were presumably adjoined (e.g. a floor timber that crossed the keel may have had fragments on both sides of the keel, yet had no physical connection). In instances where elements such as framing or planking were contiguous, they were still broken such that individual pieces are seldom more than 20 cm in length. The most substantial timber excavated was the keel, retrieved in three relatively large sections, with at least 30 additional smaller fragments. Often, recording the timber fragments was only feasible in two dimensions and not always in the same two dimensions, further complicating the interpretation of a constructional puzzle with most of the pieces missing.

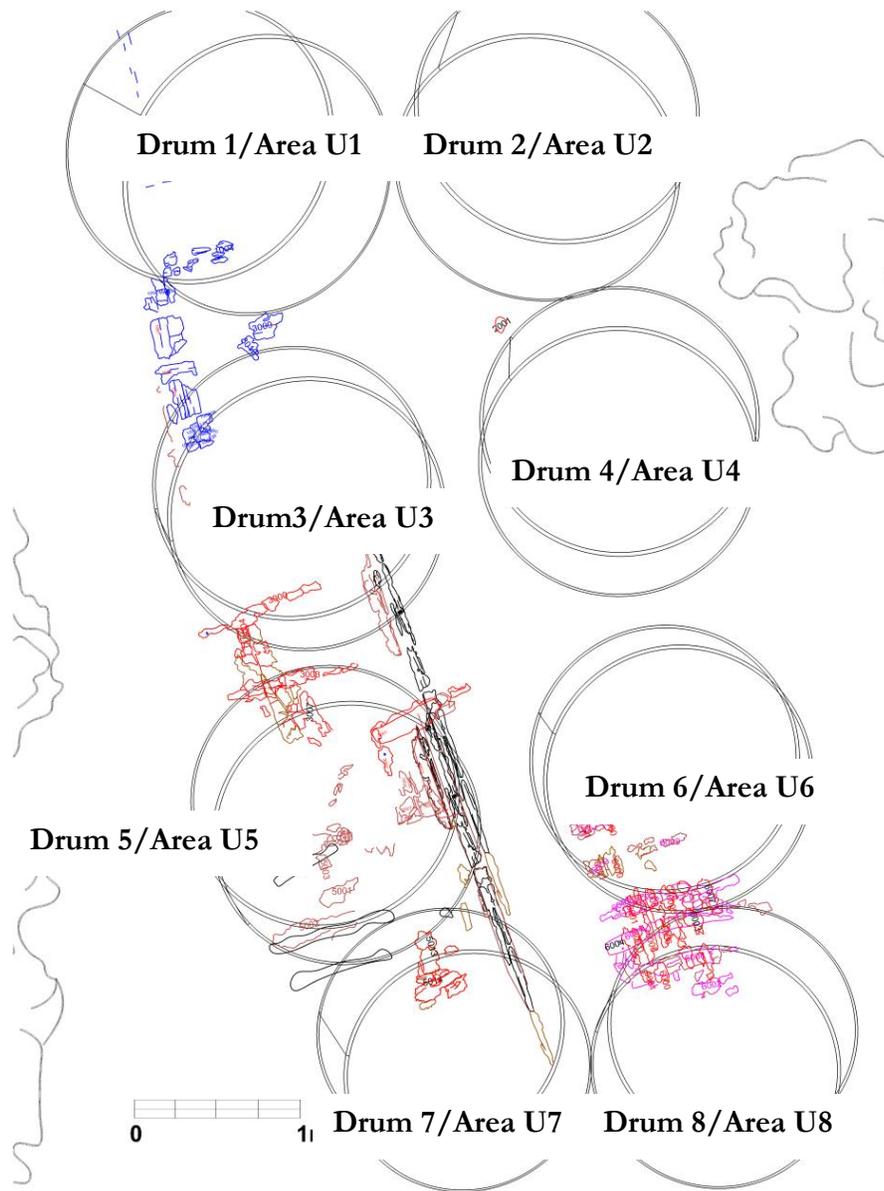
Figure 3.2. Detail of Figure 3.1. showing main concentrations of wood remains with column drums included for reference. Areas under the drums were named according to the corresponding drum after it was re-positioned off-site. Image by Sheila Matthews and the author.

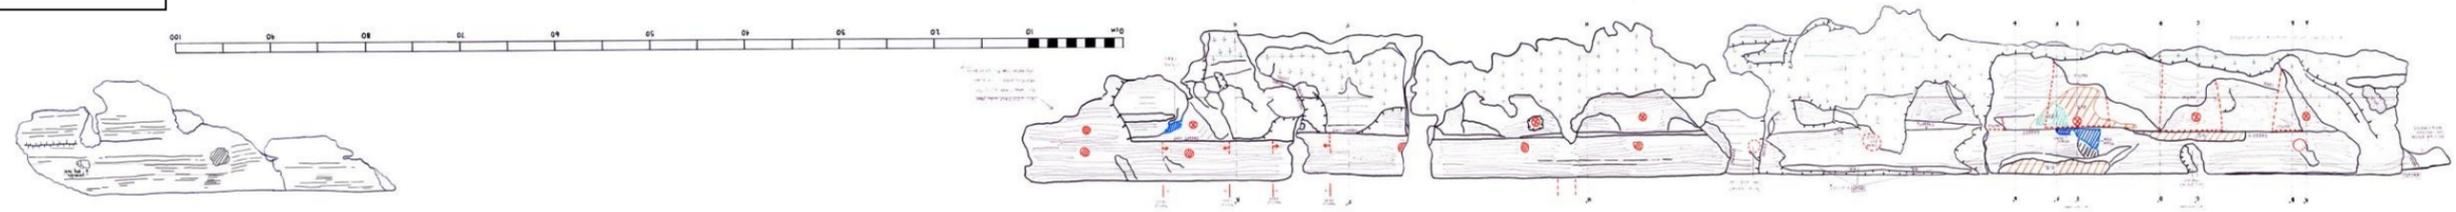
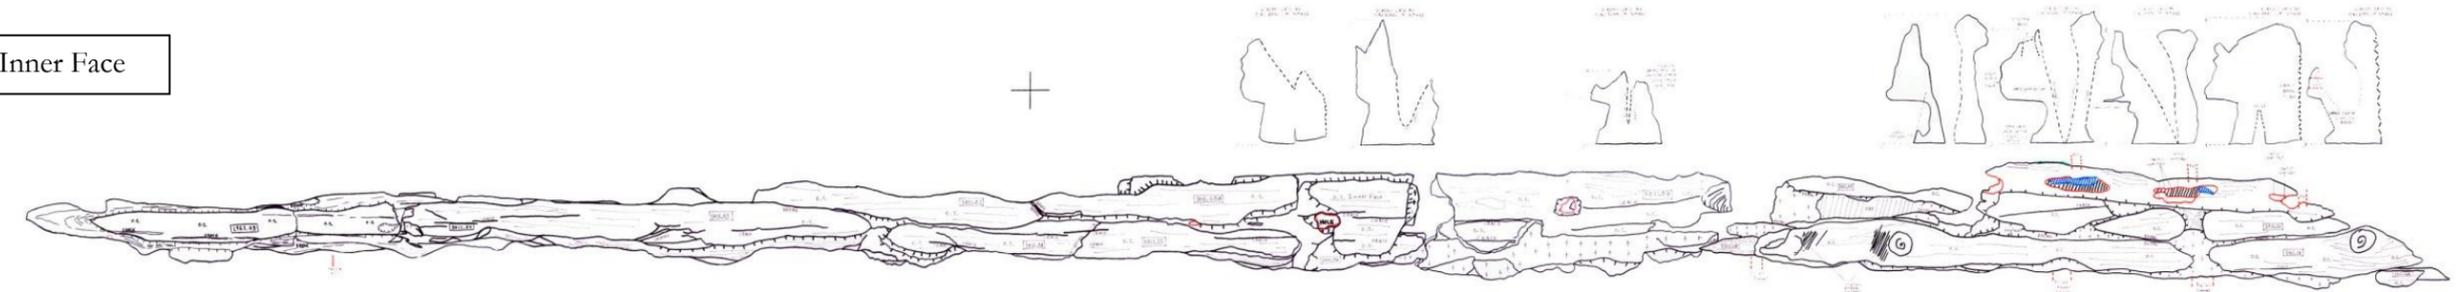
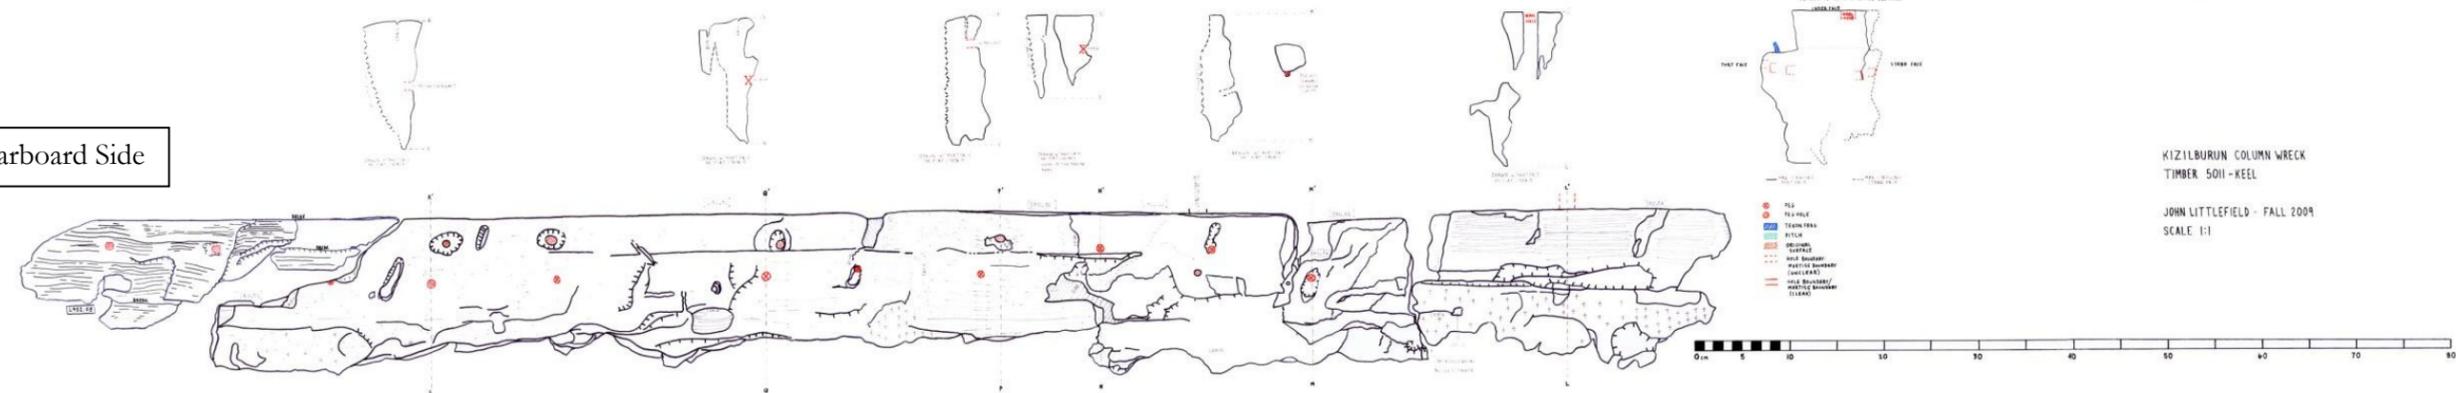
Figure 3.3. Extant keel section. Drawing by the author.

Port Side

Inner Face

Starboard Side

KIZILBURUN COLUMN WRECK
TIMBER 5011-KEEL
JOHN LITTLEFIELD - FALL 2009
SCALE 1:1

A longitudinal timber discovered in 2006 was initially thought to be a stringer due to its small transverse dimensions. In 2009 this timber was positively identified in situ as the keel owing to the presence of a rabbet. Only a portion of the overall keel survives; less than 3 m in three fragmentary, but contiguous sections along with numerous small disarticulated fragments (Figure 3.3).⁶⁴ Although this surviving keel section is relatively small when the potential overall length of the ship is considered, it is the single most substantial surviving timber. There is no evidence of a scarf in the extant keel and no remains of the stem or sternpost. It is also unclear if the keel was rockered, but no rockering is present in the extant timber. Evidence, in the form of three partial nails, suggests the use of a false keel or shoe attached to the bottom of the keel, although the actual timber does not survive.⁶⁵ The nail fragments literally disintegrated upon lifting the timber from the seafloor and reassembly of the fasteners was impossible. Consequently, it is not possible to comment on the thickness of the false keel beyond that it was at least 1-3 centimeters thick, presuming its existence.

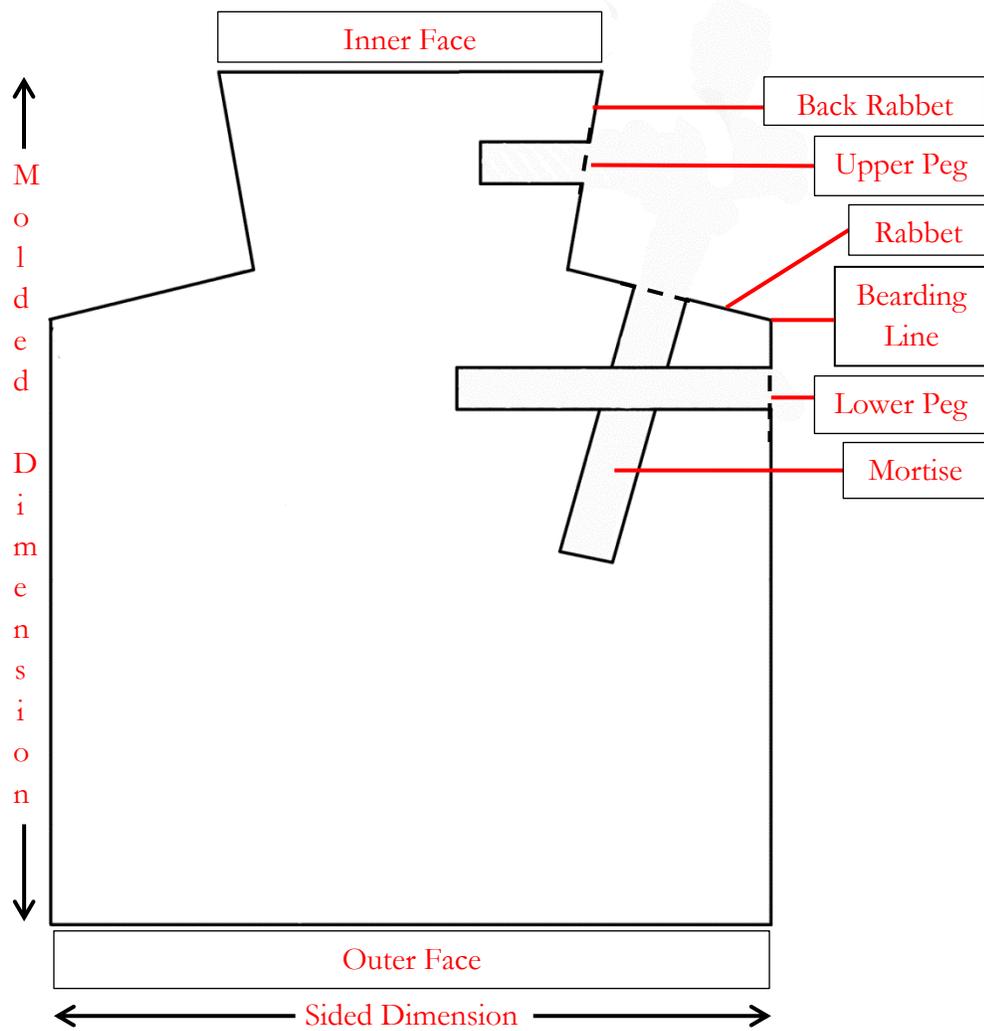
Figure 3.4. Keel features, in profile view. Image by the author.

From the aforementioned keel fragment the first cross section was taken and found to be lacking sufficient preservation to produce an accurate profile. Due to its incomplete and degraded nature, particularly below the bearding lines, a series of 21 cross sections were taken from various stations along the length of the timber and a composite profile was created (Figure 3.4). This was aided by a score mark (Figure 3.5) that was observed in the port-side rabbet of a keel fragment (5011.09) approximately 17 cm in length and protected by a small fragment of the garboard that was still in place. In order to ascertain the accuracy of the dimensions, this score mark was utilized as a point of reference to produce composite measurements where direct measurement was not possible and subsequently transposed to other sections for measurement as possible.

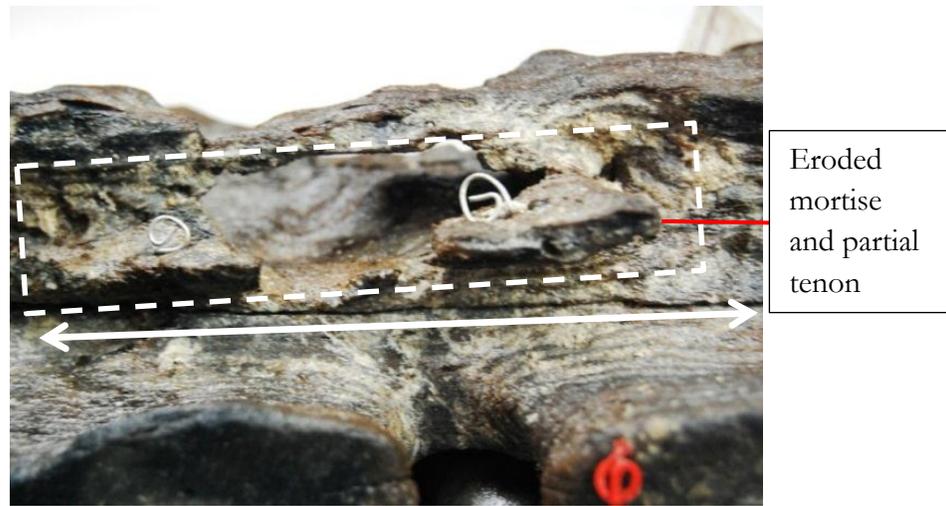
Eroded
mortise
and partial
tenon

Figure 3.5. Score mark in rabbet of keel. Photograph by the author.

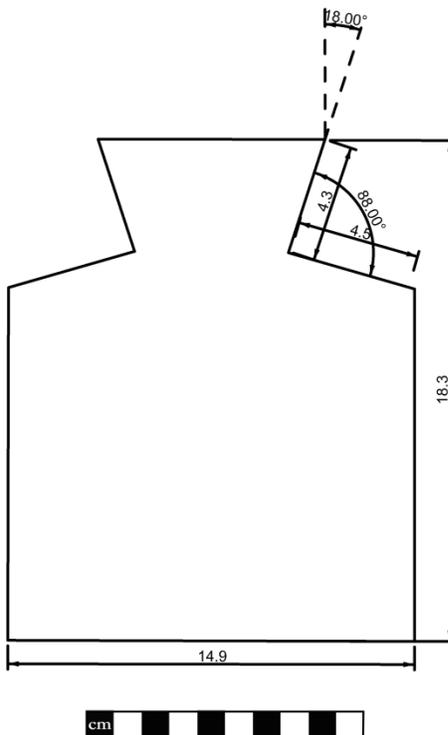
Figure 3.6. Keel profile. Image by the author.

Using the measured angles of the rabbets and back rabbets, the surviving dimensions of the flat inner face and the incised rabbet line as references, along with the maximum extant dimensions, I was able to extrapolate the minimum original sided dimension of the keel as 14.9 cm at the bearding line (the widest point of the keel) using a combination of hand-drawings and *Rhinoceros* 4.0 software. It was not possible to determine anything more than the maximum surviving molded dimension of 18.3 cm due to the lack of any existing original surface of the outer face (Figure 3.6).

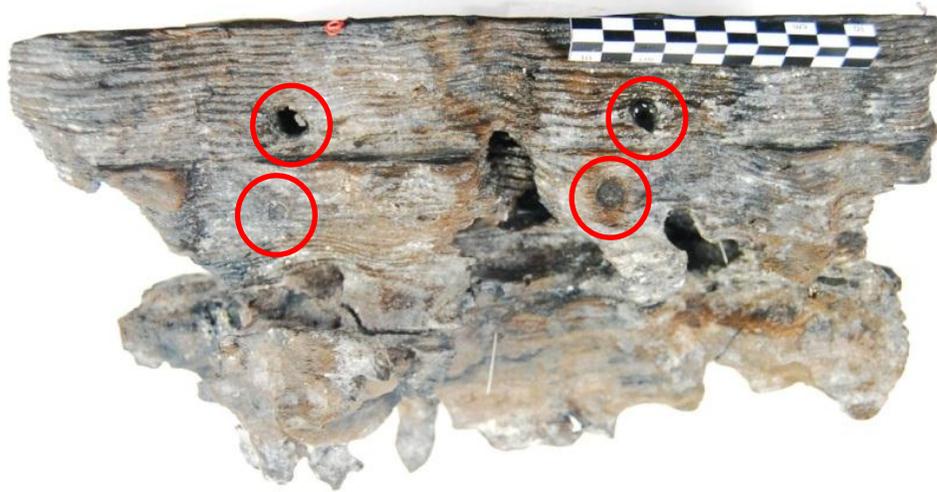
Figure 3.8. Staggered peg holes in the keel. Photograph by the author.

In all cases where pegs or peg holes were discernible in the keel, the upper pegs were driven into the back rabbets parallel to the inner face of the keel. The lower pegs were likewise driven into the keel's molded faces at an angle parallel to its inner face. An unusual and possibly unique feature is observed in the placement of the tenon pegs; they are consistently

staggered along the vertical central axis of each tenon when viewed from the molded faces. This occurs in over 90% of mortise stations that have discernible pegs or peg holes, and always in the same orientation regardless of which side of the keel is viewed. The upper peg is always placed to the right of the central axis (Figure 3.8). This feature may have been employed to prevent possible splitting of the tenon, but may simply be the habit of a particular shipwright with no functional purpose. Staggered placement of tenon pegs is seen in at least one other ship, the fifth century C.E. Dramont E wreck, yet there the pegs are staggered randomly.⁶⁷

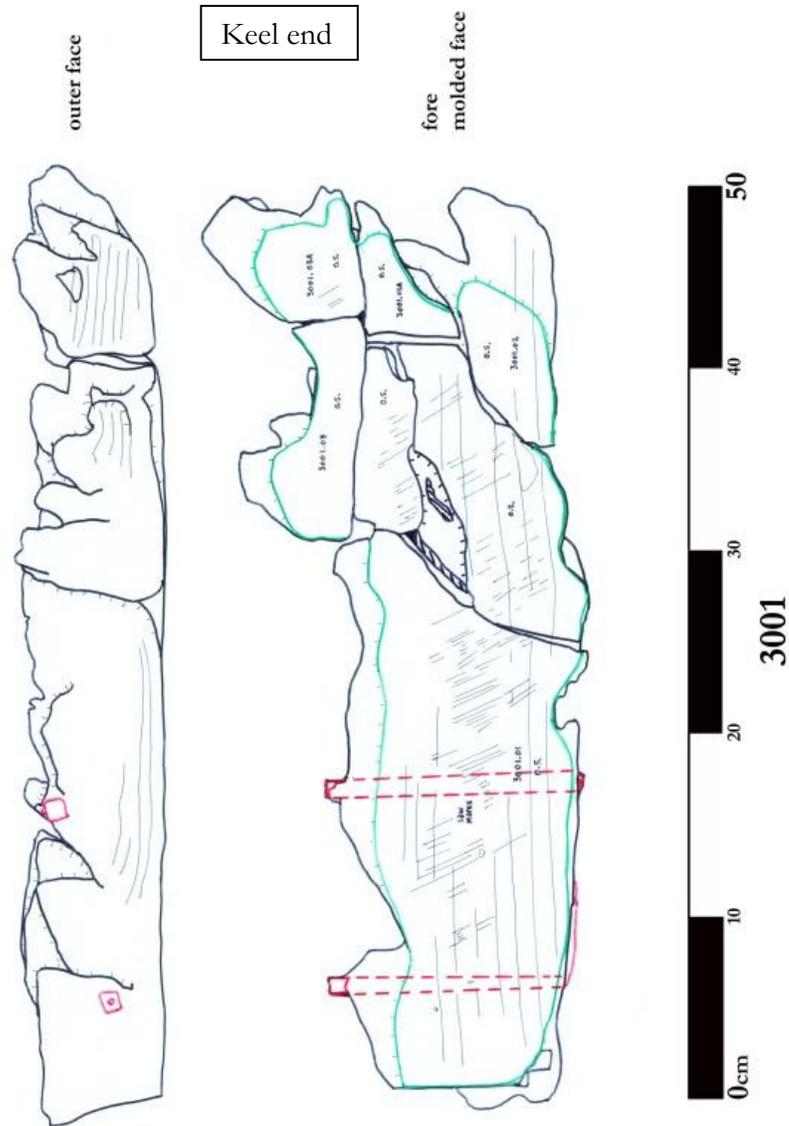
Figure 3.9. Frame 3001 showing sculpted shape. All frame drawings were made as the timber was found with the forward molded face up. Often not all pieces could be placed correctly for drawing and had to be omitted from some views. Drawing by the author.

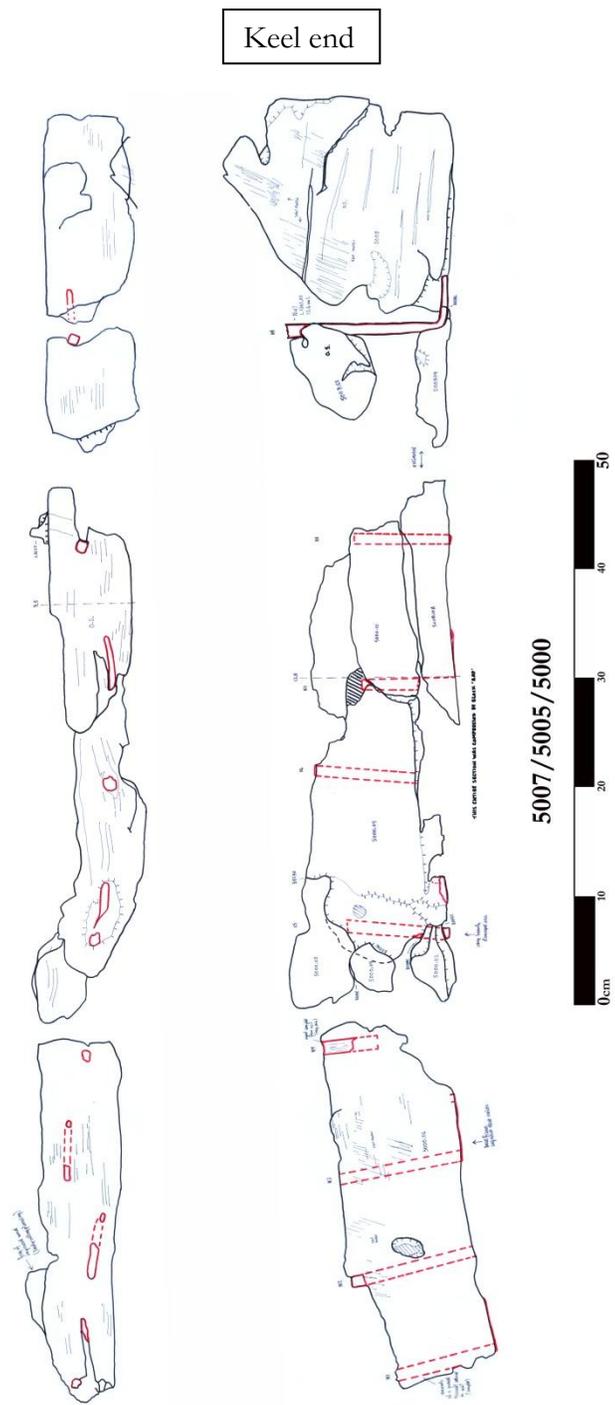
Figure 3.10. Frame 5000/5005/5007 showing sculpted shape towards the keel. Drawing by the author.

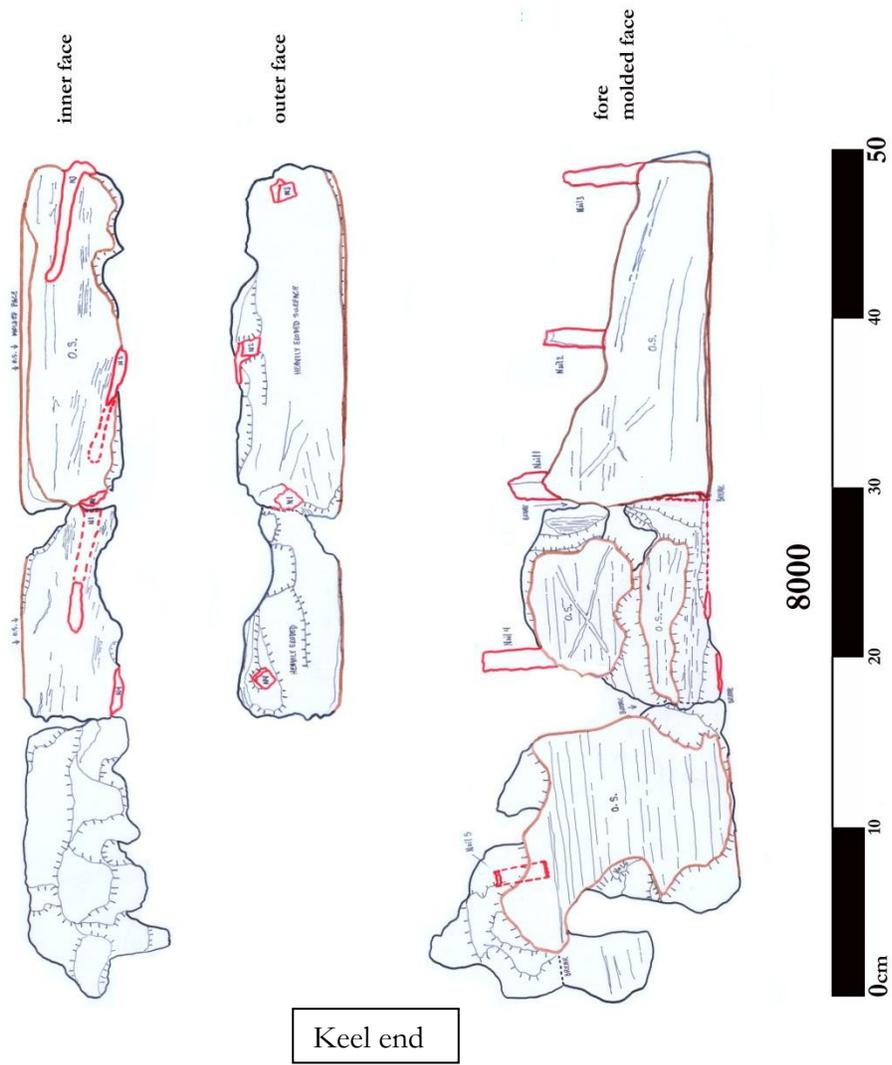
Figure 3.11. Frame 8000 showing increased molded dimension towards the keel. Drawing by the author.

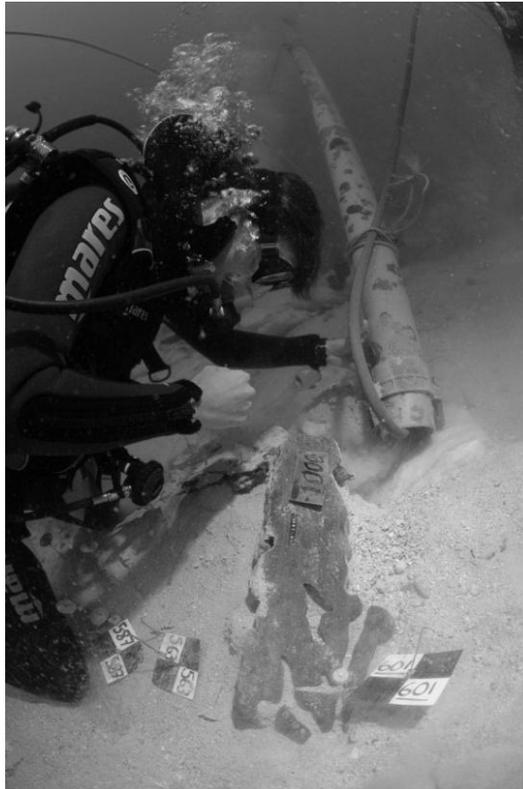
Figure 3.12. Deborah Carlson excavating timber 3001. Tag 601 marks the keel end of the timber. Photograph by Don Frey.

During excavation, all frames were found with their forward molded side up, strongly suggesting that the frames broke away from the planking and toppled 90° onto their aft molded faces in a downslope direction (Figure 3.12) as suggested by several factors. First, at the time of discovery, all transverse timbers that retained clenched nails were found with the clenched portions oriented downslope. This orientation suggested these transverse timbers may have served some unusual purpose, and thus were something other than frames, possibly a pallet system for supporting the column drums.⁷⁰ However, the widths of the preserved frame impressions on the planking do not match the width of the transverse timbers as found, but do correspond to their widths if these timbers are oriented with their nail clenches in an inboard orientation.

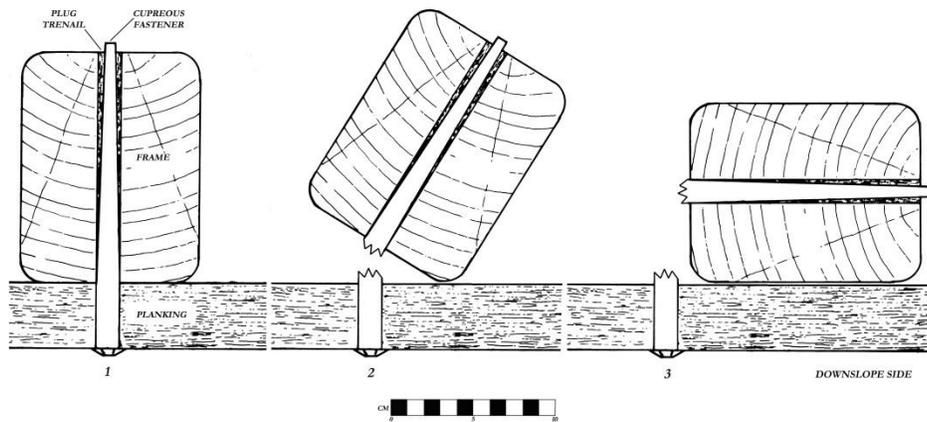
Figure 3.13. Sequence of frame/planking separation. Image by the author.

Second, the pattern of nail breakage (discussed in Chapter IV) corresponds to the thickness of the planking, which suggests that the frames sheared off from the planking. This breakage most likely occurred at the time of the ship's impact with the seafloor, but the frames may have been displaced at some later date when the deteriorating hull gave way under the substantial weight of the cargo. The sequence of this breakage is illustrated in Figure 3.13.

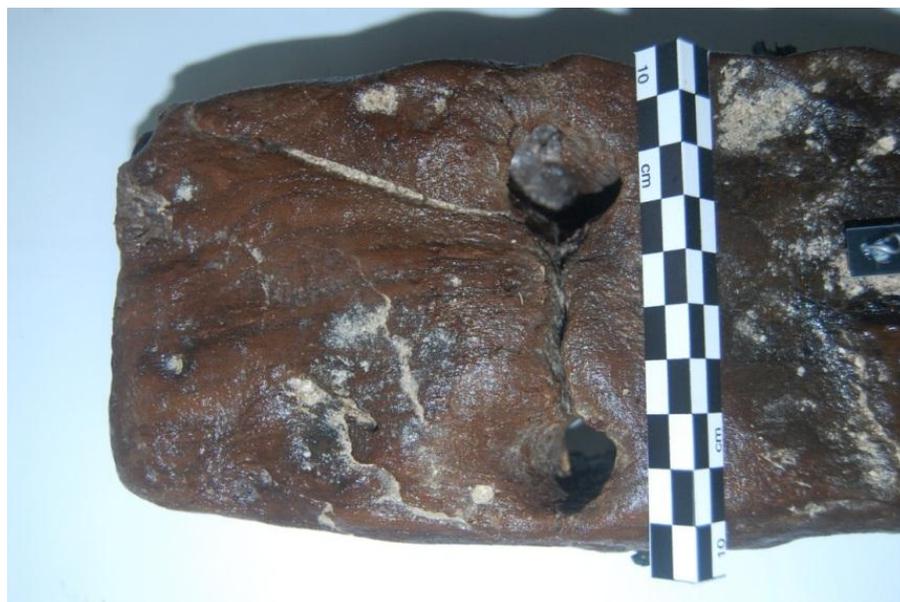
Figure 3.14. Frame 6004 showing cut end. Photograph by the author.

Molded dimensions are somewhat more difficult to define as at least some of the frames (presumably floors) were sculpted to become wider at or over the keel. Here we are forced to rely on maximum surviving dimensions. Timber 6004, which *may* represent a futtock, has a maximum width at the cut inboard end of 10.0 cm (Figure 3.14), while timbers 3000, 3001, and 5000 have maximum outboard dimensions of 10.5, 12.3 and 13.6 cm, respectively. The most telling, however, may be timber 5017, which is a disjointed outboard fragment of timber 5000 on the presumed port side of the keel. Measurements obtained from this 63 cm-long fragment are 12.6 cm on the inboard side and 13.1 cm on the outboard end. If timber 5000 is a floor, then the combination and reconstruction of 5000, joined with 5017, is a representative frame from the vessel (discussed in Chapter V).

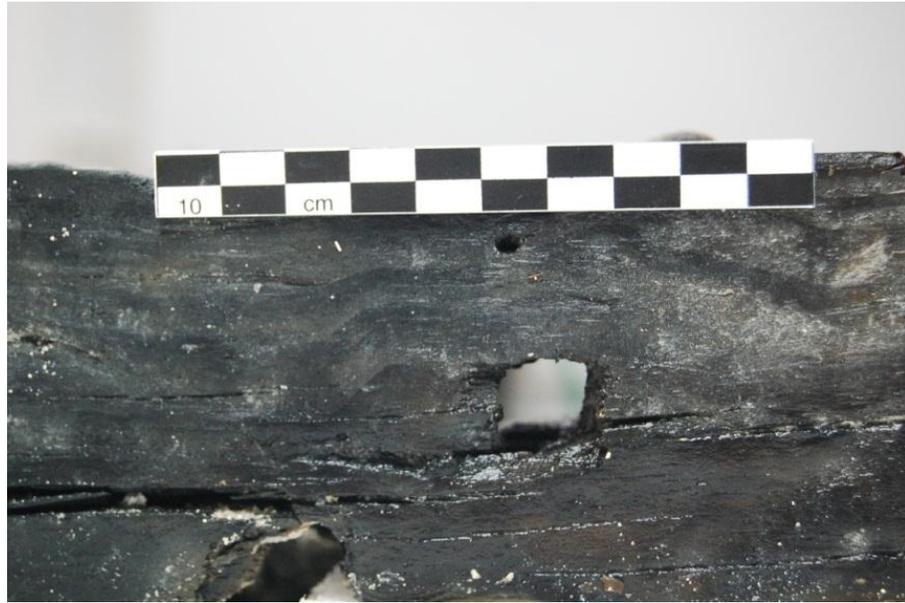
Figure 3.15. Nail hole in keel. Photograph by the author.

However, there is one clear nail hole of 1.5 cm square section preserved in keel fragment 5011.07 (Figure 3.15). This fragment of the keel was located in the area from which presumed floor 5000 was excavated. Due to heavy decomposition of keel fragment 5011.07, the nail hole is indefinable below the surface of the inner face, making it impossible to discern with certainty the direction from which it was originally driven. However, given the size of the nail hole in comparison to extant large nails from the wreck (discussed in Chapter IV), it was likely driven from the inner face of the keel. No nail head or shank fragment(s) could be positively associated with the nail hole. There are possibly at least two other nail holes with poorly defined edges in the keel. One of these non-diagnostic nail holes is in section 5011.08, which *may* be associated with frame 3001; the second is in section 5011.05 and *may* be associated with frame 5001. Additionally, there are several breaks in the preserved portion of the keel that could have accommodated nails. When viewed as a whole from the keel's inner face, these possible nail holes and potential nail stations do not seem to form a recognizable pattern (Figure 3.16) such as one might see if floor timbers were regularly nailed to the keel.

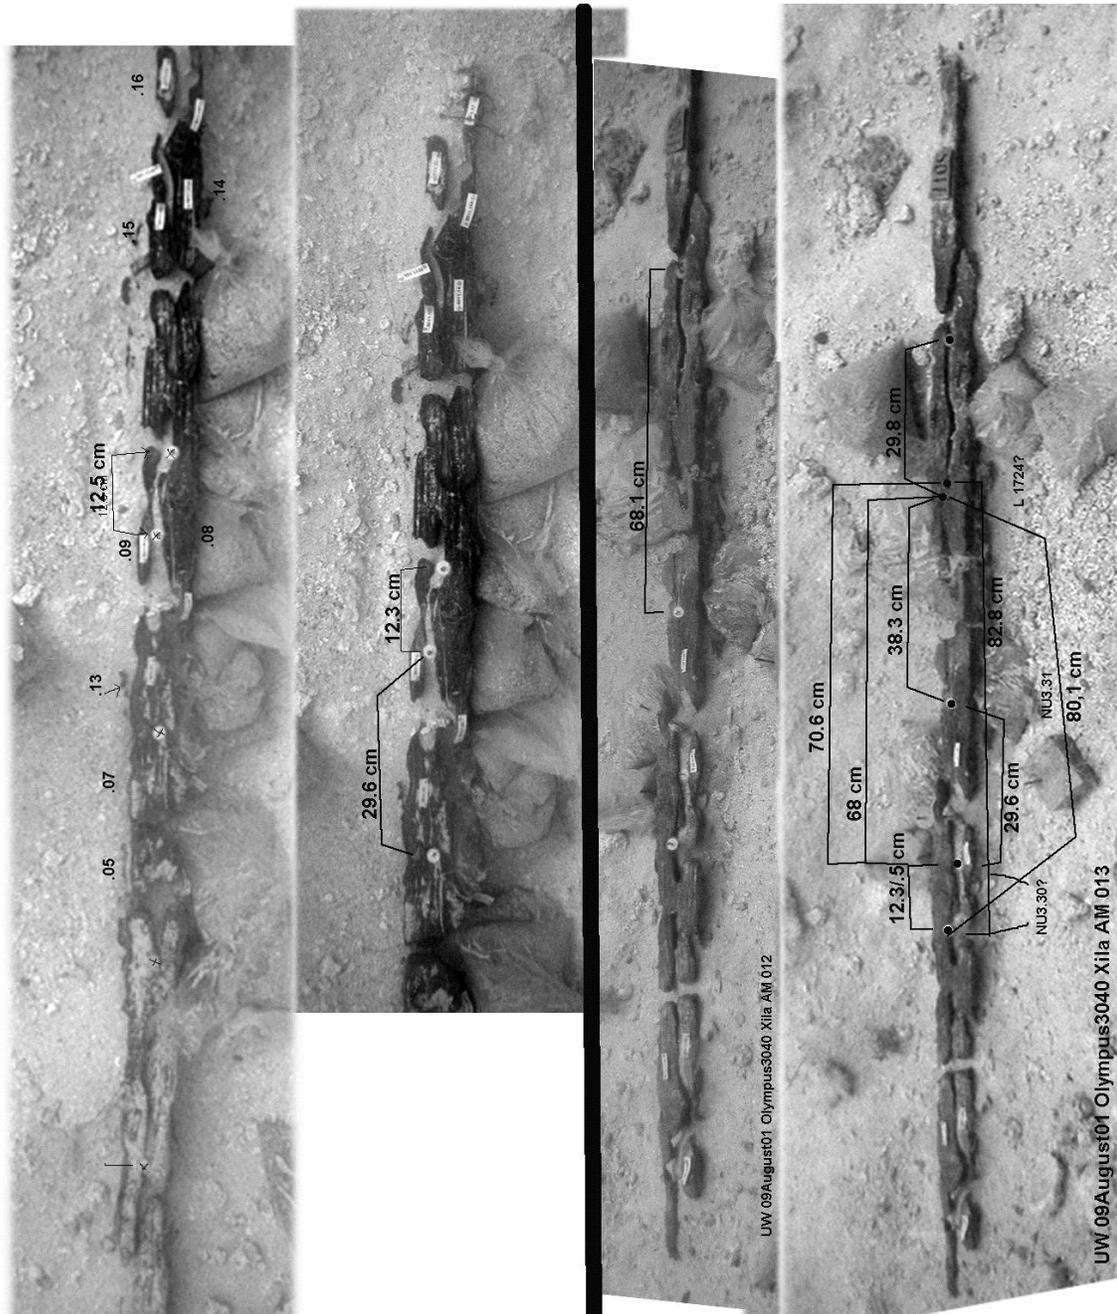
Figure 3.16. Potential nail stations for frames in the keel. Image by Sheila Matthews.

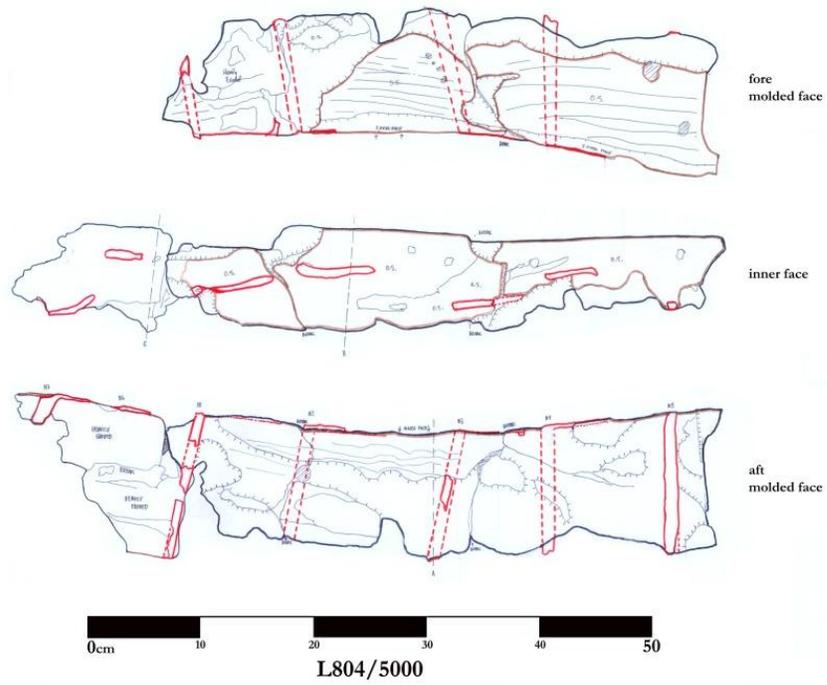
Figure 3.17. Frame fragment 5017. Drawing by the author.

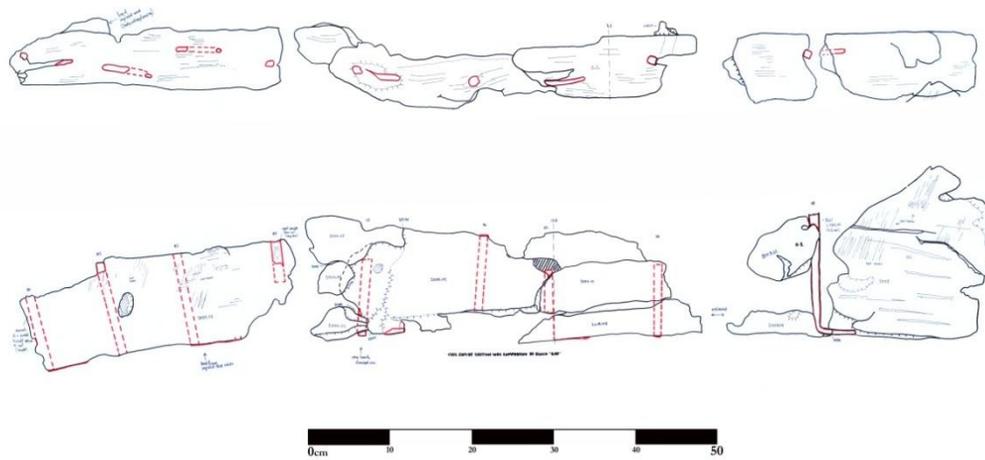
Figure 3.18. Floor fragments 5007/5005/5000. Drawing by the author.
