**THE HULL REMAINS OF THE LATE HELLENISTIC
SHIPWRECK AT KIZILBURUN, TURKEY**

A Thesis

Submitted to the Office of Graduate Studies of
Texas A&M University
in partial fulfillment of the requirements for the degree of

MASTER OF ARTS

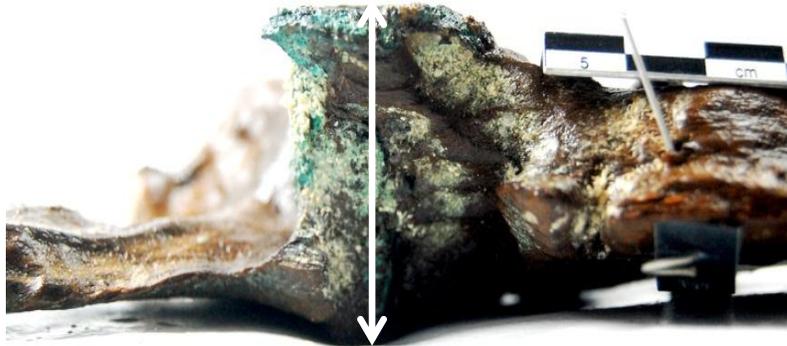
Figure 3.19. Plank fragment 3005.01 with partial nail (highlighted by the arrow) corresponding to original plank thickness. Photograph by the author.

Eighteen distinct timber sections have been identified as pieces of hull planking. Due to the decomposition of the wood, these vary in width, thickness, and length. Few edge seams are detectable. Although most of the extant planking sections or fragments are heavily compressed from the weight of the cargo, thickness dimensions were obtained from 20 fragments within the 18 sections preserved (Table 3.4). Thickness measurements ranged from 2.0 to 4.8 cm; the former is clearly from a compressed fragment and the latter is from the garboard strake, which is often slightly greater in thickness than other pieces of planking. With these outliers removed, the 18 remaining measurements give an average of 3.6 cm, and a mode of 4.1 cm occurring five times. Plank fragment 3005.01 (Figure 3.19) retained a nail fragment with a head and partial shank broken at 4.0 cm below the head. Another small fragment of planking from area U4 (plank fragment 6009.04) retained a

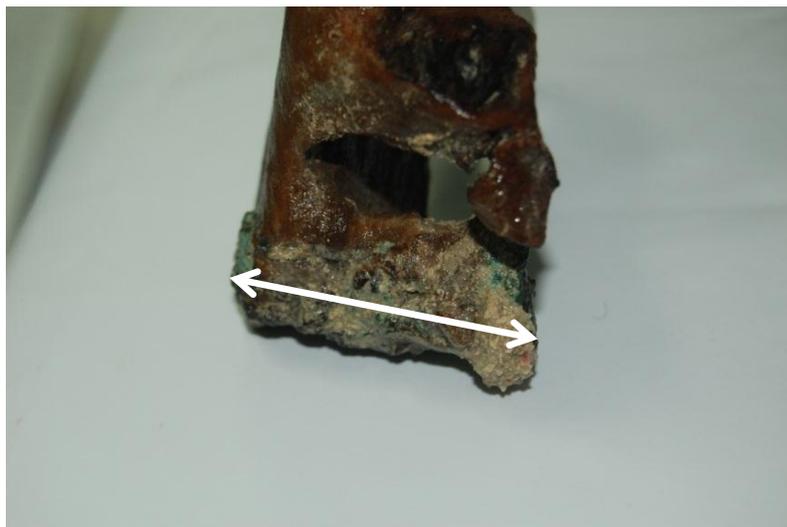
Figure 3.20. Planking fragment 6009.04 with broken nail (highlighted by the arrow) corresponding to original plank thickness. Photograph by the author.

partial nail with head, broken at 4.1 cm below the head.⁷⁵ It also retained small portions of original surface from the plank's outer and inner faces (Figure 3.20) This fragment was located on the seafloor over one meter away from the keel and its thickness is representative of the planking strakes as opposed to the garboard strake that is often of greater thickness (4.8 cm in this case). These figures correspond well with those obtained from examination of the nails discussed in Chapter IV, as well as figures obtained from the examination of the keel rabbets (4.0-5.0 cm). It should be noted that some variation in planking thickness is to be expected, as thicknesses often vary depending on a plank's position on the vessel.⁷⁶

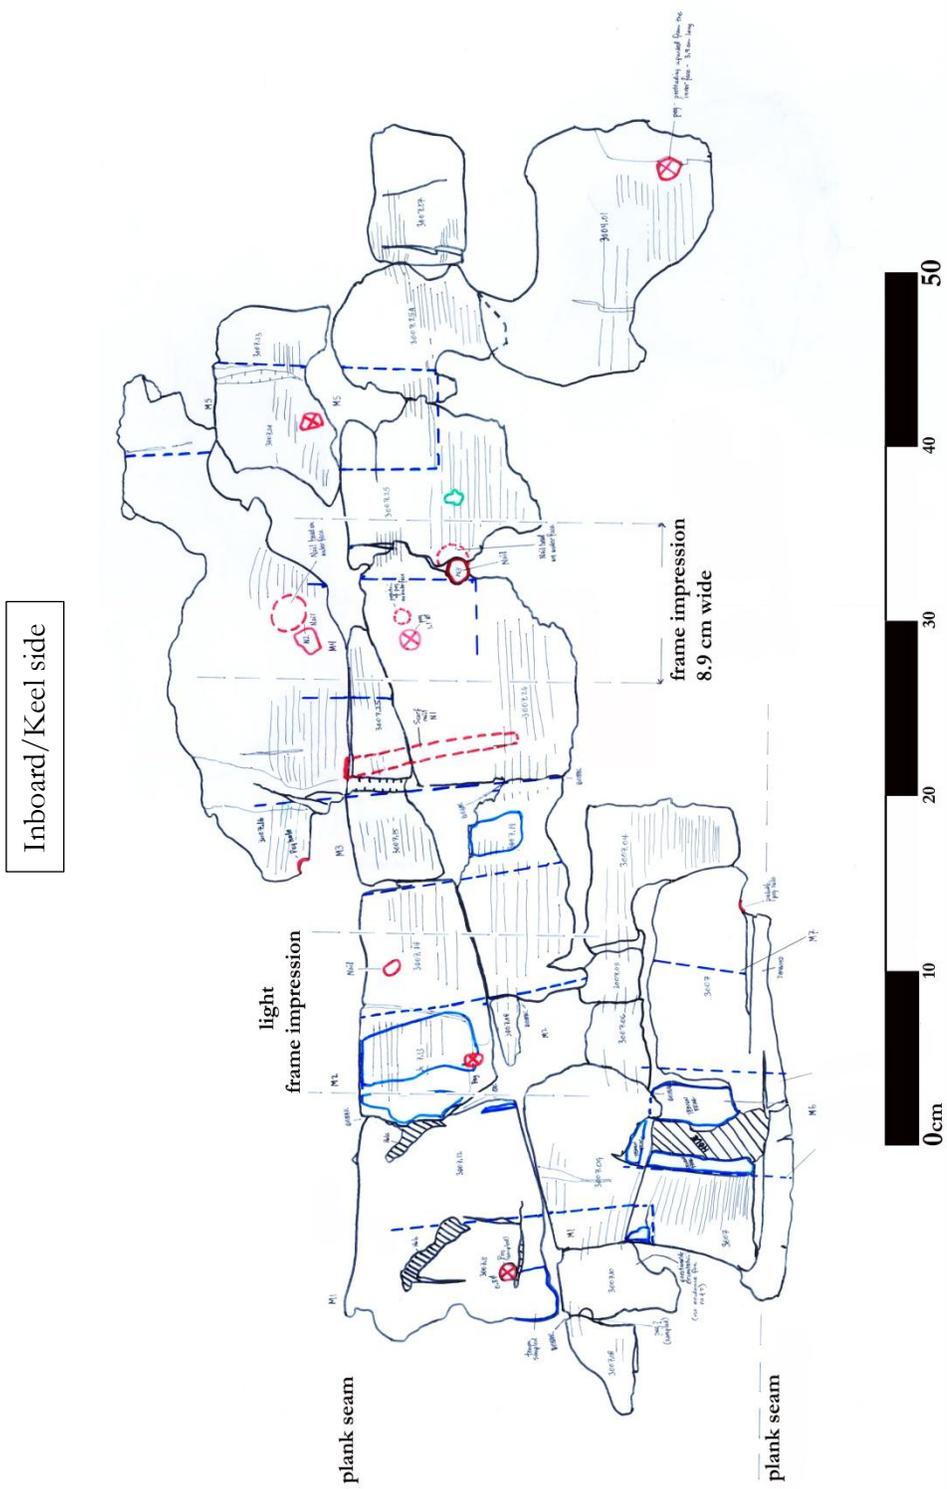
Figure 3.21. Plank section 3007 with diagonal scarf. Drawing by the author.

Several planking seams have survived. Most of the planks that retain a seam, however, lack an opposing plank seam. In these cases, maximum surviving plank widths range from 7.5 to 19.1 cm. Planking section 3007 (Figure 3.21) is a scarfed section of planking and is the most diagnostic of the planking fragments. Both planks on either side of the scarf survive, making it possible to reconstruct a strake with a width of approximately 24 cm. This was obtained by projecting the opposing plank seams and measuring the perpendicular distance between them. A small fragment of this planking section has a thickness of 3.9 cm. This section also contains fragments of framing nails, and multiple mortise-and-tenon joints. One light frame impression and a second more pronounced impression are also retained and offer information about frame spacing. These impressions indicate the distance between frame edges to be 14.6 cm. This figure was used to calculate the center-to-center distance between frames (discussed above in the frame spacing section).

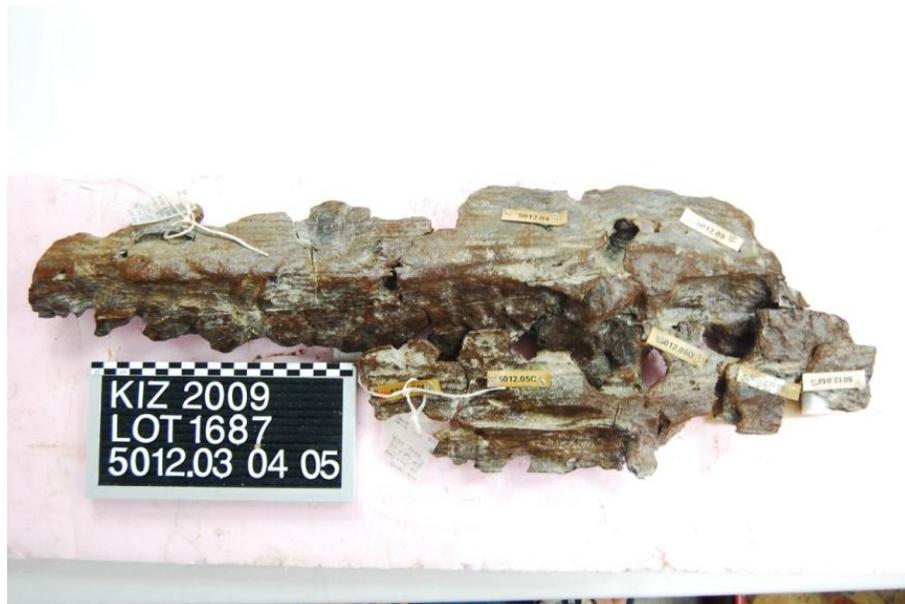
Figure 3.22. Garboard fragment- timber 5012. Photograph by the author.

A 62 cm-long section of the disarticulated port side garboard strake was excavated from under Drums 3 and 5 (areas U3 and U5) (Figure 3.22). This area corresponds to approximately the longitudinal central point of the cargo. Comparing the location of the keel, to that of the cargo's central axis, one can see some shifting toward the starboard side. This may simply be a result of the ship listing to starboard before the collapse of the hull. The downslope movement of the heavy load cannot be stated with certainty, although I do not believe the shift to have been substantial.⁷⁸ Regardless, the garboard fragment should be representative of its shape from, or within relatively close proximity to, amidships.

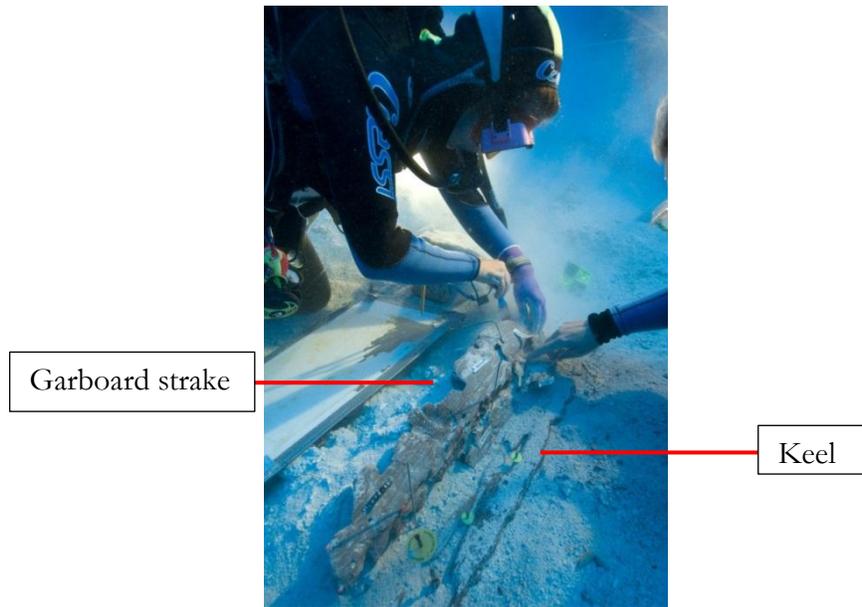
Figure 3.23. Garboard strake in situ. Photograph by Eric T. Kemp.

The lower portion of the garboard's inner face is so eroded and deteriorated that no original surface is discernible and none of the mortise-and-tenon joinery that once connected the garboard to the keel survives in the garboard fragment. Although separated completely from the keel, the garboard was only slightly removed from its rabbet (Figure 3.23).

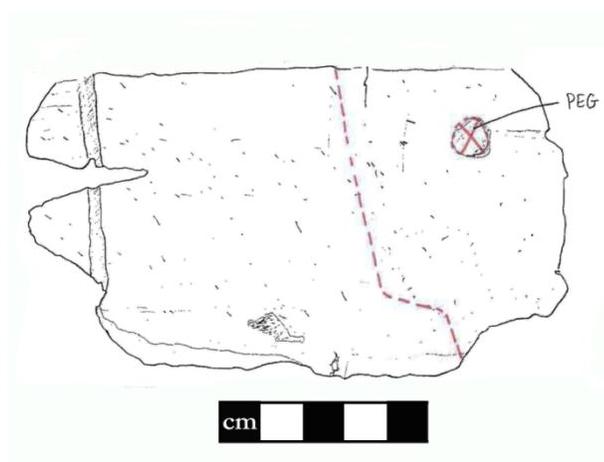
Figure 3.25. Planking fragment 3007.29 illustrating a partial tapered mortise. Drawing by the author.

Although original edges are poorly defined and often difficult to discern on both tenons and mortises, these average figures correspond well to one another and suggest they are indicative of their original dimensions. In several examples, mortise edges are better defined and clearly show distinct tapering (Figures 3.25 and 3.26), as do several tenon fragments.

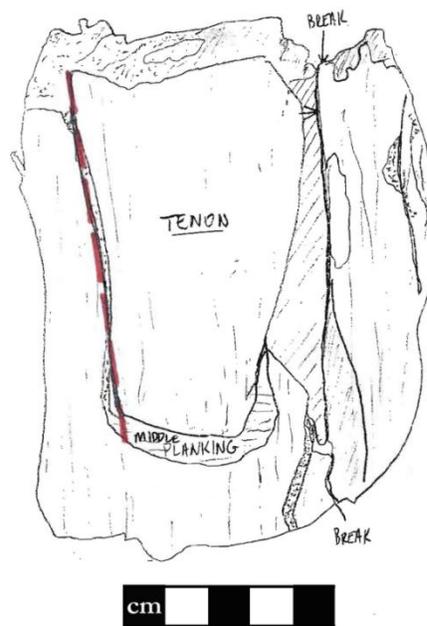
Figure 3.26. Planking fragment 3011.01 illustrating a partial, tapered mortise. Drawing by the author.

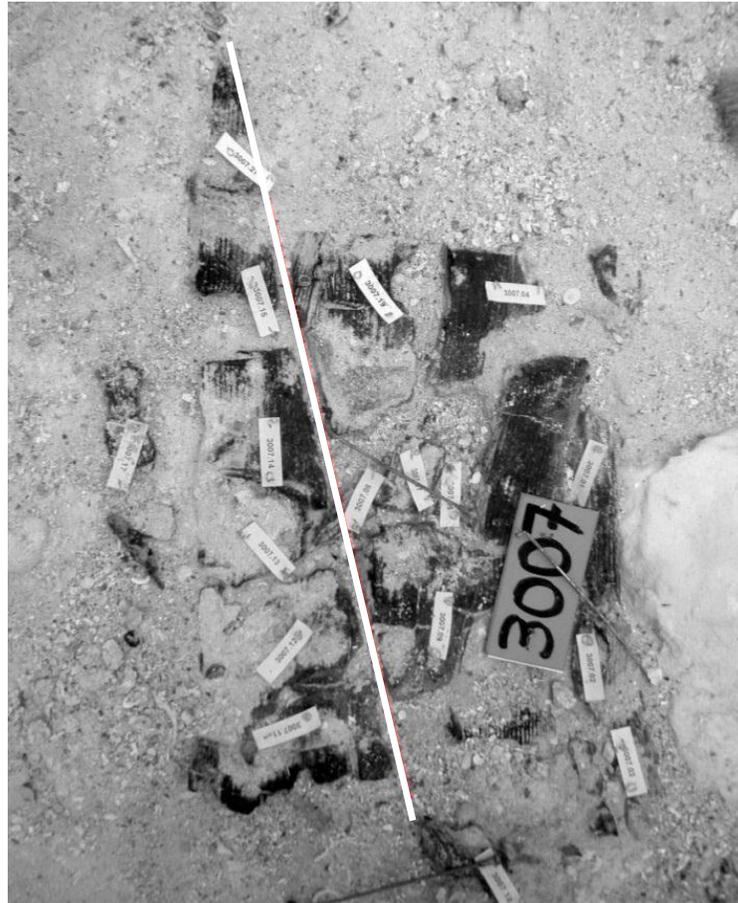
Figure 3.27. Diagonal scarf on plank section 3007 shown in situ, with the scarf marked by line. Photograph by Deborah N. Carlson. Also see Figure 3.22 for drawn version.

The single, partially extant planking scarf is of the common diagonal version.⁸⁰ Although its full length has not survived, it can be reconstructed as having a length of 80 cm in a strake that is estimated to have been 24 cm wide.⁸¹ Pegged mortise-and-tenon joints aided by a single nail secured the two planks of the scarf. The nail, used to secure the scarf tip, was driven from the lower plank into the upper one (Figure 3.27). Strengthening scarfs with nails is a common feature of Graeco-Roman shipbuilding and lasted well into the seventh century C.E.⁸²

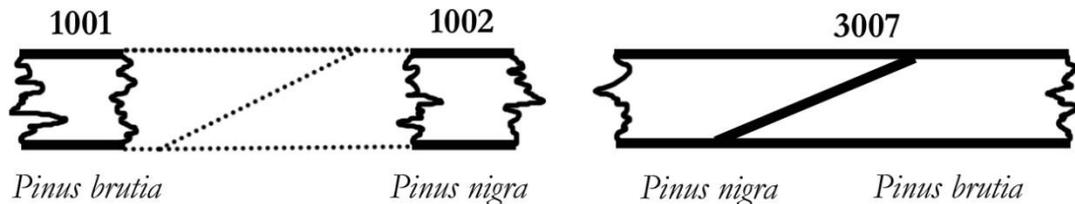
Figure 3.28. Wood identification of planks in scarf 3007 and location of possible scarf between plank fragments 1001 and 1002. Image by the author. Wood identification by Nili Liphshitz. Image not to scale.

The diagonal scarf in planking section 3007 is the only scarf that has survived among the Kızılburun planking. However, there is evidence for the presence of a second planking scarf. Plank fragments 1001 and 1002 were found in line and were presumably parts of the same strake. Both fragments have been identified as pine but of differing species; 1001 is of *Pinus brutia* and was found upslope of 1002, which is of *Pinus nigra*. These timber fragments likely represent a continuation of strake section 3007, which was also sampled on either side of the scarf for wood identification purposes. In 3007, the same situation was discovered, with the plank on the upslope side (fragment 1002) being of *Pinus nigra*, and thus matching the wood species of plank fragment 1002. The plank lying on the downslope side of the scarf in section 3007 is of *Pinus brutia*. (Figure 3.28)

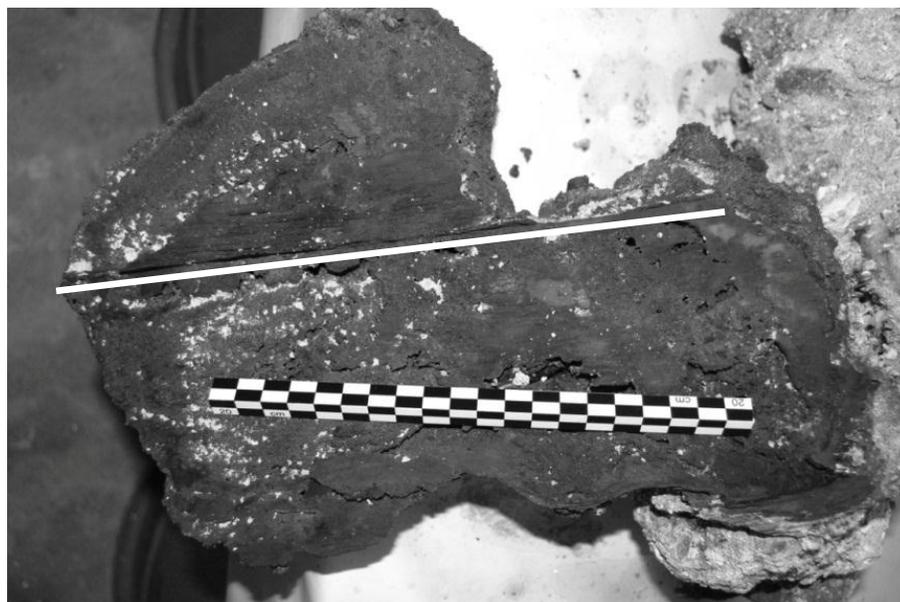
Figure 3.29. Ceiling plank seam impression preserved in iron anchor concretion. Photograph by the author.

The remains of an iron anchor, with its disassembled stock lying next to it, were located just forward of Drum 2 on the starboard side of the keel. Although the original iron anchor itself does not survive, its shape is preserved in the form of a natural concretion mold composed mostly of calcium carbonate.⁸⁶ The anchor shaped concretion preserved the impression of a plank that included one of its seams (Figure 3.29). Measuring perpendicularly from the seam to the widest point of the impression yielded a width of 19.2 cm. As the anchor could not have been resting directly on hull planking due to the presence of frames, the plank impression most likely represents of ceiling planking.⁸⁷ Although fragments of ceiling planks were identified elsewhere in the hull, the impression left on the iron anchor concretion provides the widest preserved piece from which a minimum width is obtained for the ship's ceiling planking.

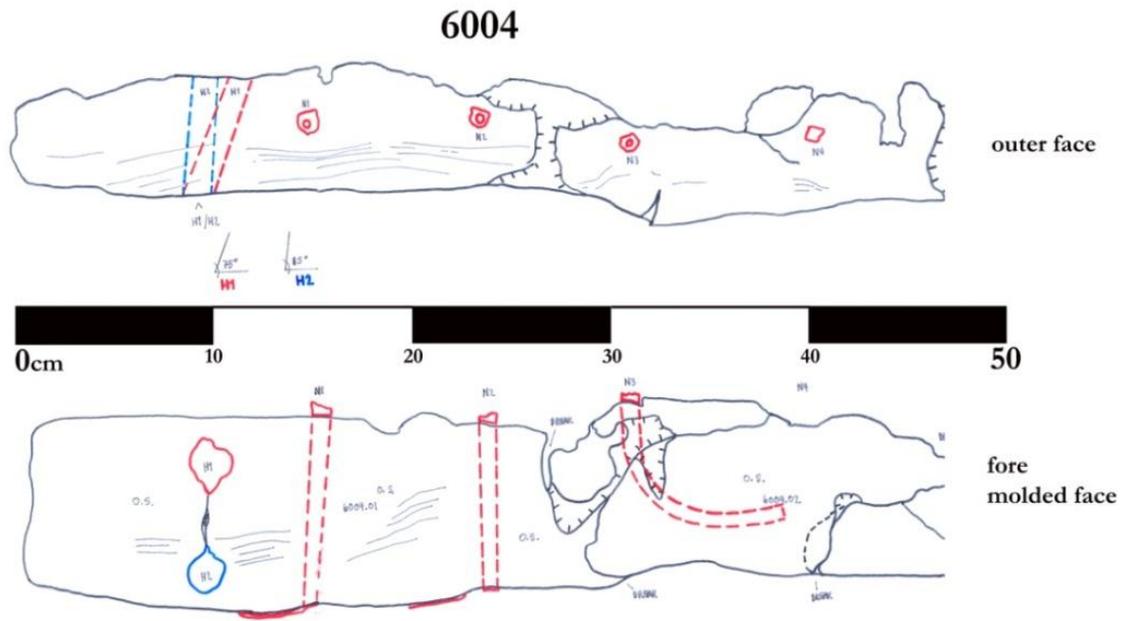
Figure 3.30. Frame fragment 6004 showing vertical holes of unknown purpose at its finished end. Drawing by the author.

Timber 6004 is a frame fragment, possibly from a futtock, and has a cut inboard end with two vertical holes of small diameter (2.0, 1.8 cm) (Figure 3.30). Given the vertical placement of the two holes in relation to each other, they were likely drilled from the foreword face as this relationship is not shared on the aft face. Each hole is drilled at slightly different angles with respect to the forward face of the timber. The upper hole is drilled at 105° while the lower hole is drilled at 95°.

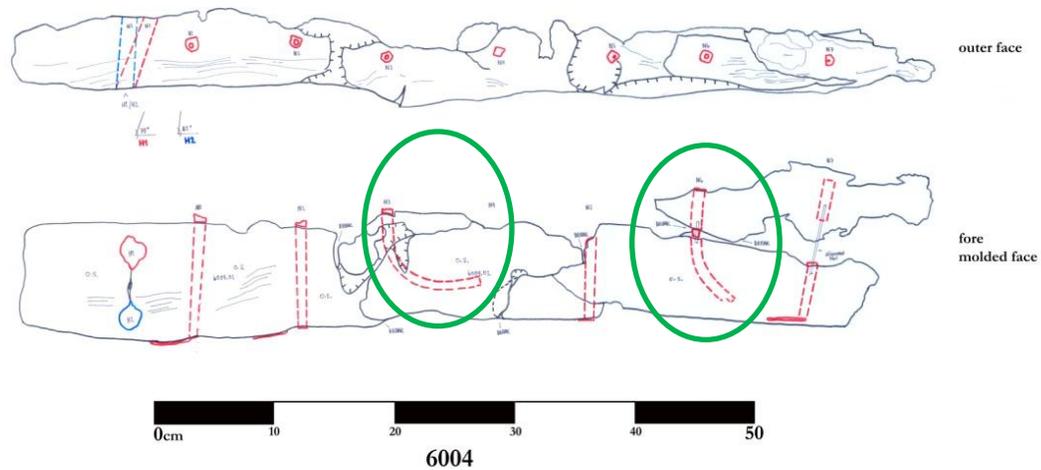
Figure 3.31. Timber 6004 with bent nails of unknown purpose. Drawing by the author.

A second possibility to explain the two holes in frame piece 6004 is that the timber was reused, either from an earlier construction or from another vessel. This idea is supported by two nails serving no apparent function (Figure 3.31). They are spaced appropriately to serve as clenched planking-to-frame nails, but instead of penetrating through the inner face of the frame for clenching, they are embedded within the timber. There are no trenails on the inner face of the timber to guide these nails through the thickness of the timber. However, it is also possible that these nails were simply mis-driven and left in place. No other instances of mis-driven nails or those of dubious purpose were observed in the other timbers.

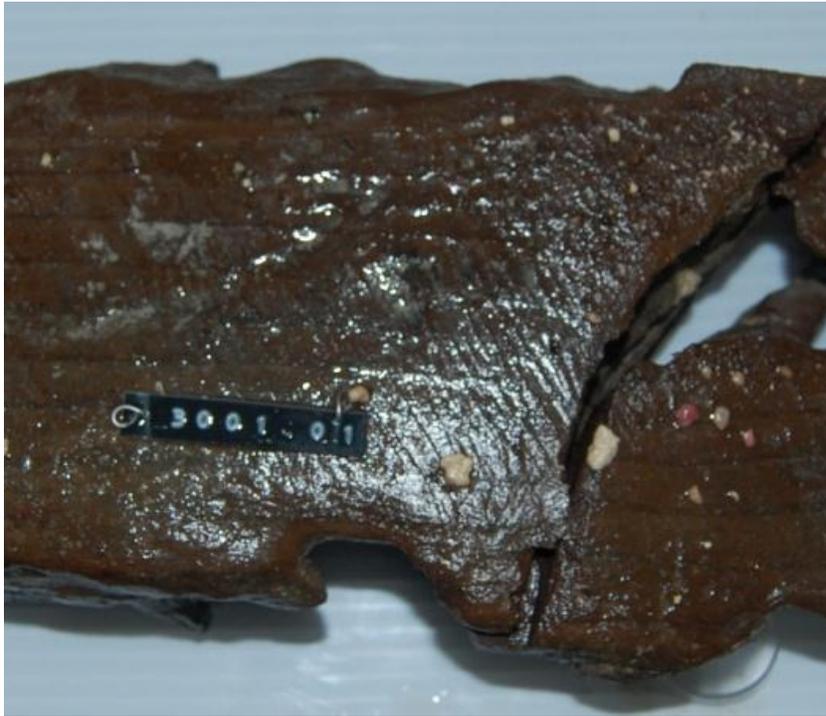
Figure 3.32. Saw marks on frame fragment 3001. Photograph by the author.

There are a limited number of tool marks preserved on the hull remains, including the already discussed score mark on the port side rabbet of the keel. A small area with saw marks has also been found on the inner face of the keel, illustrating the manner in which the keel was shaped. Saw marks were also found on other timbers from the ship. Ceiling planking fragments 3002 and 5006 also exhibit saw marks on their inner faces, but saw marks are most clearly seen on frame fragments 3001 (Figure 3.32) and 5000 (Figure 3.33). These were made by a fine-toothed finishing saw with teeth spaced approximately 1 mm apart. No clear evidence of a coarse-toothed saw was discovered, nor was there any direct evidence for the use of an adze to shape or finish the timbers. Absence of evidence does not constitute evidence of absence; therefore, it is only possible to say that the timbers of this ship were at least finely shaped with the use of finishing saws.

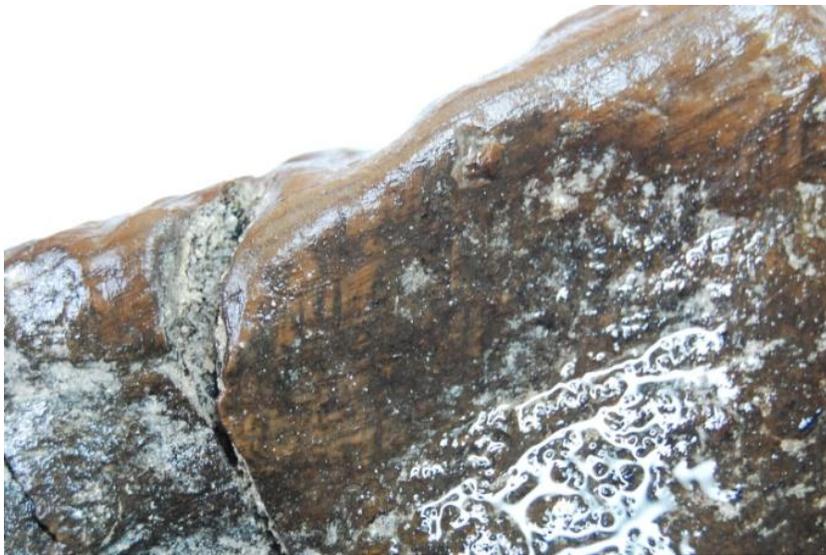
Figure 3.33. Saw marks on frame fragment 5000. Photograph by the author.

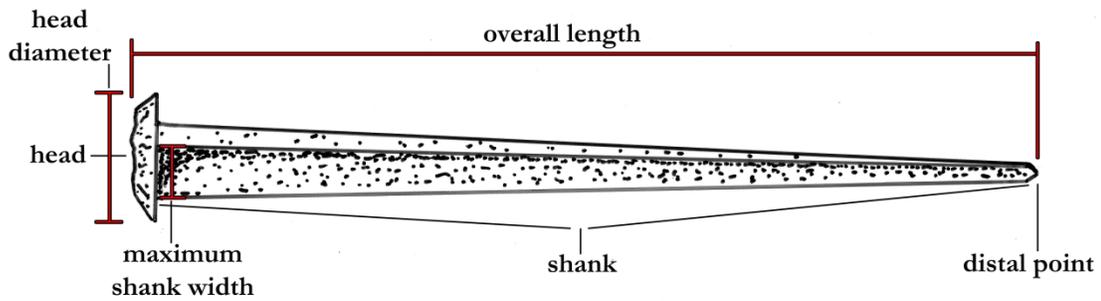
Figure 4.1. Anatomy of a nail and measurement points. Image by the author.

Attributes of existing iron fastener typologies are: head shape, head diameter, shank shape, shank width, and length (Figure 4.1). Head shape can be indicative of function,¹⁰⁰ and is therefore a diagnostic typological attribute. Head size is variable, but generally it is another good attribute to consider. Most ancient nails have a maximum shank width just below the nail head. The head is adjoined to a square-sectioned shank that tapers towards the distal end. However, cylindrical shanks are not unprecedented, so one must also distinguish shank shape for typological analysis. As ancient nails were hand-forged, variation in length is inevitable.¹⁰¹ Therefore, length is of limited utility in categorizing fasteners.

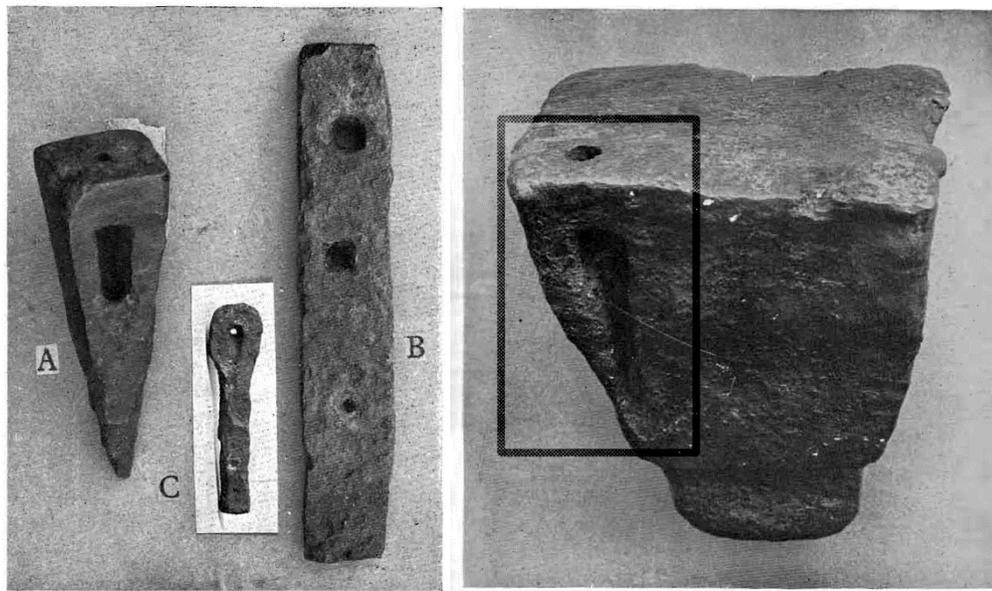
Figure 4.2. Roman nail headers and anvil. Reprinted with permission from *Ancient Carpenter's Tools*, by Mercer, Mercer Museum/Bucks County Historical Society, Doylestown, PA. 1960.

Shank width may be the most consistent attribute of a hand-forged nail, at least within individual assemblages.¹⁰² With forged nails, the blacksmith forms the nail head by driving the fastener through a square hole in an anvil,¹⁰³ swage block,¹⁰⁴ or nail header¹⁰⁵ (Figure 4.2) until the width of the shank fits snugly in the hole and so that a short length of the nail protrudes above the anvil or swage block. The smith then hammers the remaining metal into the desired shape of a head¹⁰⁶ (Figure 4.3). As the maximum shank width of a nail is dictated by the size of the hole in the swage block/anvil/heading tool, the finished nails will have a uniform maximum width and therefore may be more easily compared and categorized, at least within a single assemblage (assuming a single source of production). However, shank widths will likely vary only slightly between independent smiths having different sized slots cut into their swage blocks, anvils, or nail headers. As there may be a correlation between nail shank width and length, these two variables are generally functions

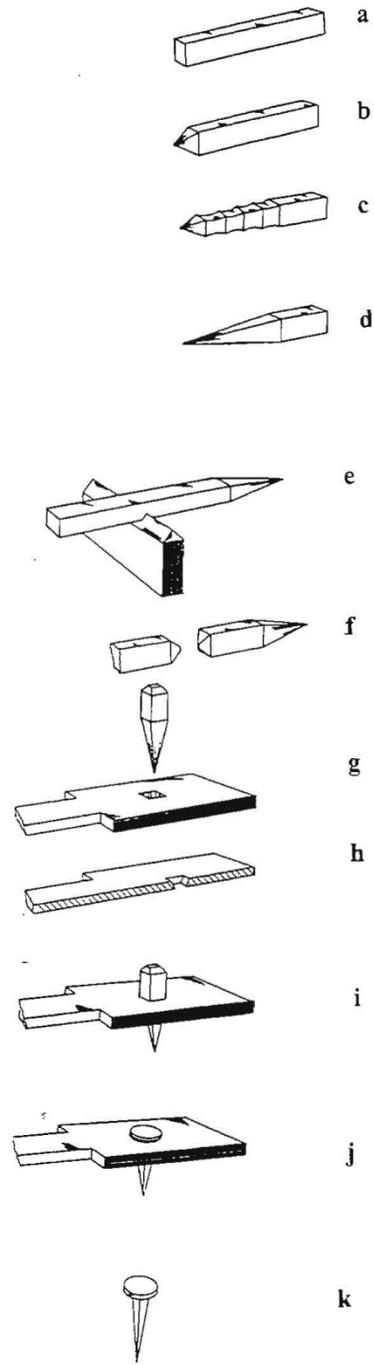
Figure 4.3. Nail production process. Reprinted with permission from *Beyond the Bloom: Bloom Refining and Iron Artifact Production in the Roman World*, by Sim, 1998.

¹⁰⁸ Sim 1998, 61-4. Sim further demonstrated that nail heads, particularly of larger nails, required a skilled smith to manufacture as opposed to assistants.

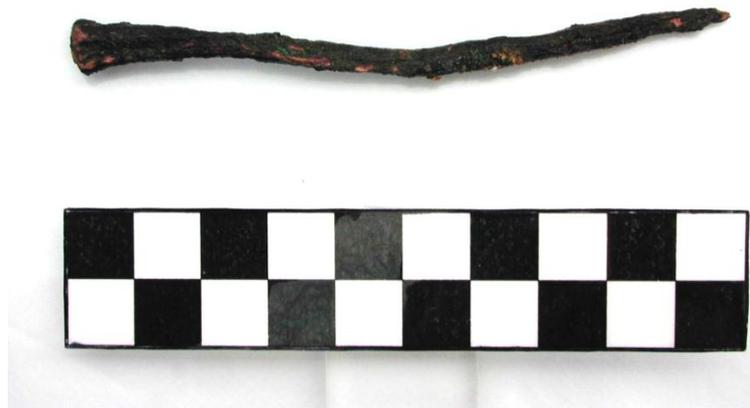
Figure 4.4. Cupreous nail (Lot 019) from Kızılburun. Photograph by the author.

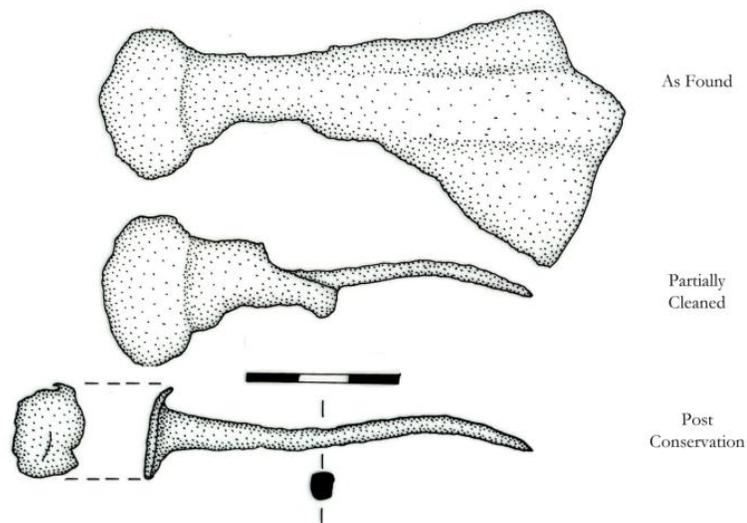
Figure 4.5. Lot 655.03- stages of concretion buildup. Drawing by Mustafa Korkmaz.

A second process that can cause copper to become concreted normally results in higher amounts of concretion. A cathodic protection, induced upon the cupreous metal by adjacent iron artifact(s), spurs an increased amount of calcareous accumulation on the cupreous fastener.¹⁴⁰ This, in turn, has two effects to help reduce, albeit not halt, corrosion of the cupreous metal. First, it reduces the amount of oxygen available to the surfaces of the metal, thus creating an reduced oxygen, if not completely anaerobic, environment. This new environment explains the black powdery surface on several of the fasteners after their removal from the concretion.¹⁴¹ This covering is by-product of the devolution of the metal and gives the fastener an appearance much like that of iron. Second, the calcareous matrix reduces the normal pH of the seawater (8.0 ± 0.2) by as much as two full points.¹⁴² Fresh water is the defining point for pH neutrality at 7.0. By reducing the pH to a level closer to 7.0 or a neutral pH figure, the metal fastener is provided more protection. This process can also be seen within the Kızılburun nail assemblage (Figure 4.5). One specific example of the process involves nail Lot numbers 655.03 (cupreous) and 655.04 (ferrous). These were found side by side, with the cupreous fastener having substantial amounts of concretion protecting a relatively well preserved small nail.¹⁴³

¹⁴³ Nail Lot 758 was found directly beneath the iron anchor stock and also had significant amounts of concretion.

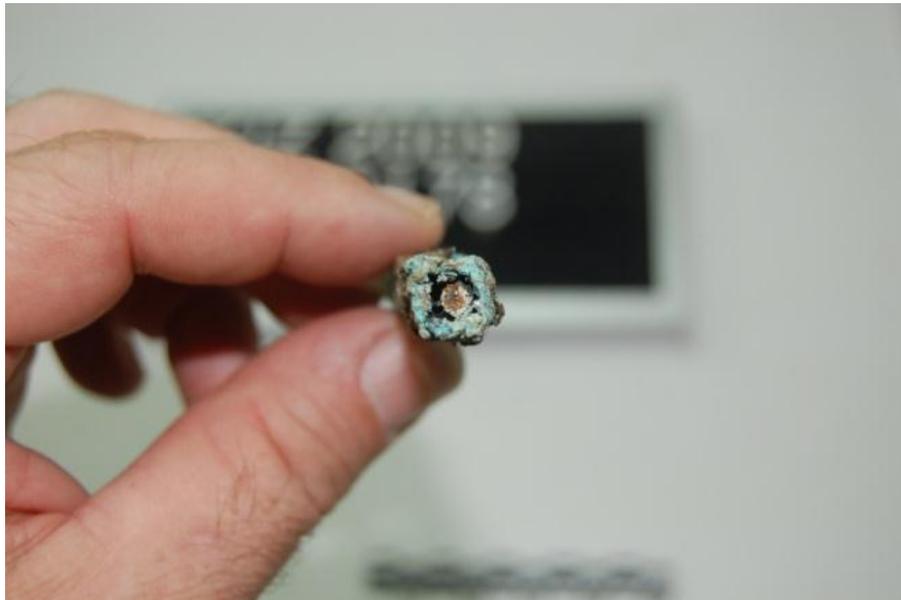
Figure 4.6. Square nail section- Photograph by the author

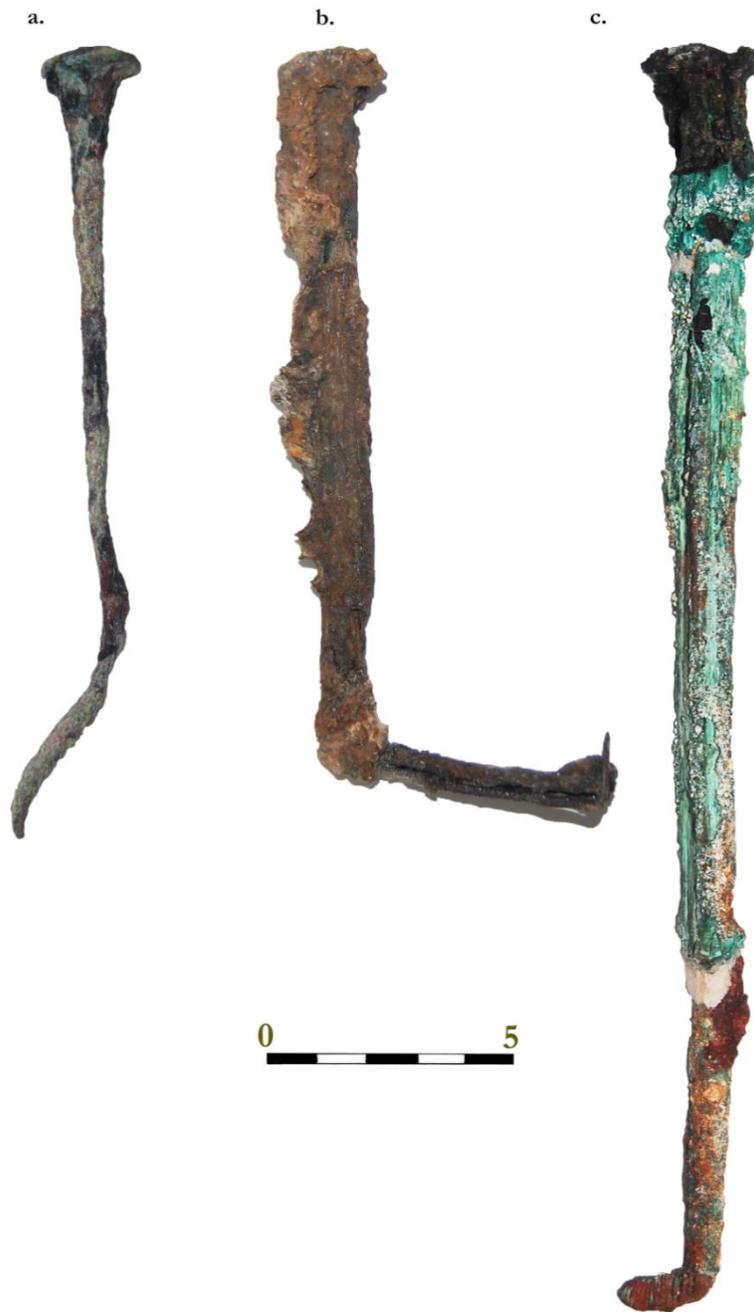
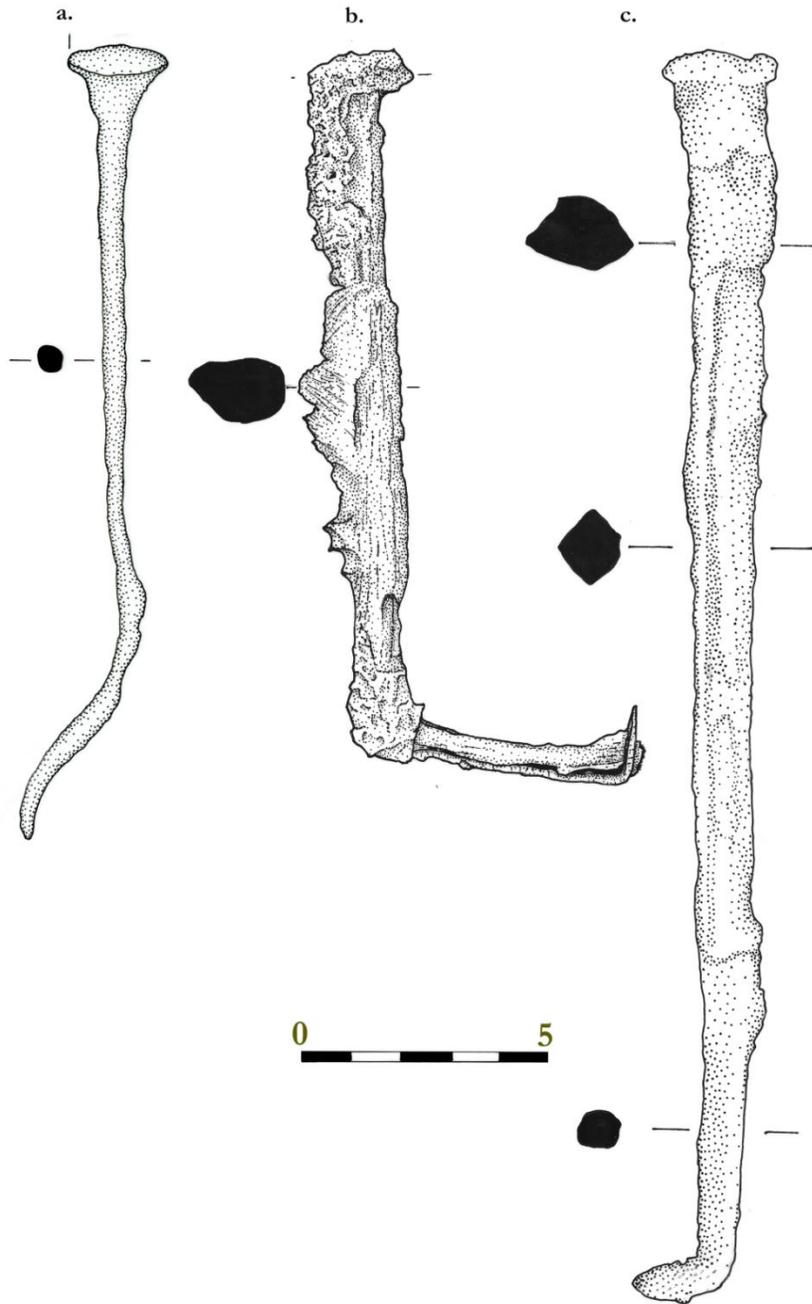
Figure 4.7. Photographs of large cupreous nails from the Kızılburun shipwreck; a. Lot 920 b. Lot 177.03 c. Lot 1329. Photographs by the author.

Figure 4.8. Drawings of large cupreous nails from the Kızılburun shipwreck; a. Lot 920 b. Lot 177.03 c. Lot 1329. Drawings by Mustafa Korkmaz (a and c) and Seçil Kayacık (b).

Nail head shape is not easily defined in the Large Fastener category, as nearly every nail head that survives is covered by concretion or has degraded to the point that the head shape is no longer discernible. The few nail heads that survive without concretion have a flattened pyramidal shape (Figures 4.7a and 4.8a). The flattening of the head is most likely the result of the force exerted on the nail to drive it into the timber as demonstrated in tests conducted by Angus and his colleagues.¹⁵⁴

Only six large nails from Kızılburun survive sufficiently for direct measurement of length. Lengths range from 21.3 (Lot 177.03) to 25.4 cm (Lot 1329). Since most of the clenched portion of fastener Lot 1329 is missing, the actual unclenched length would be approximately 7 cm longer,¹⁵⁷ making the total length approximately 32 cm before it was clenched. Although the Kızılburun nail lengths are limited to only a few examples, the dimensions fit within the length ranges provided by both the typology of the Inchtuthil group A nails (22 - 37 cm) and that of the Brading Type I nails (19 – 31 cm).

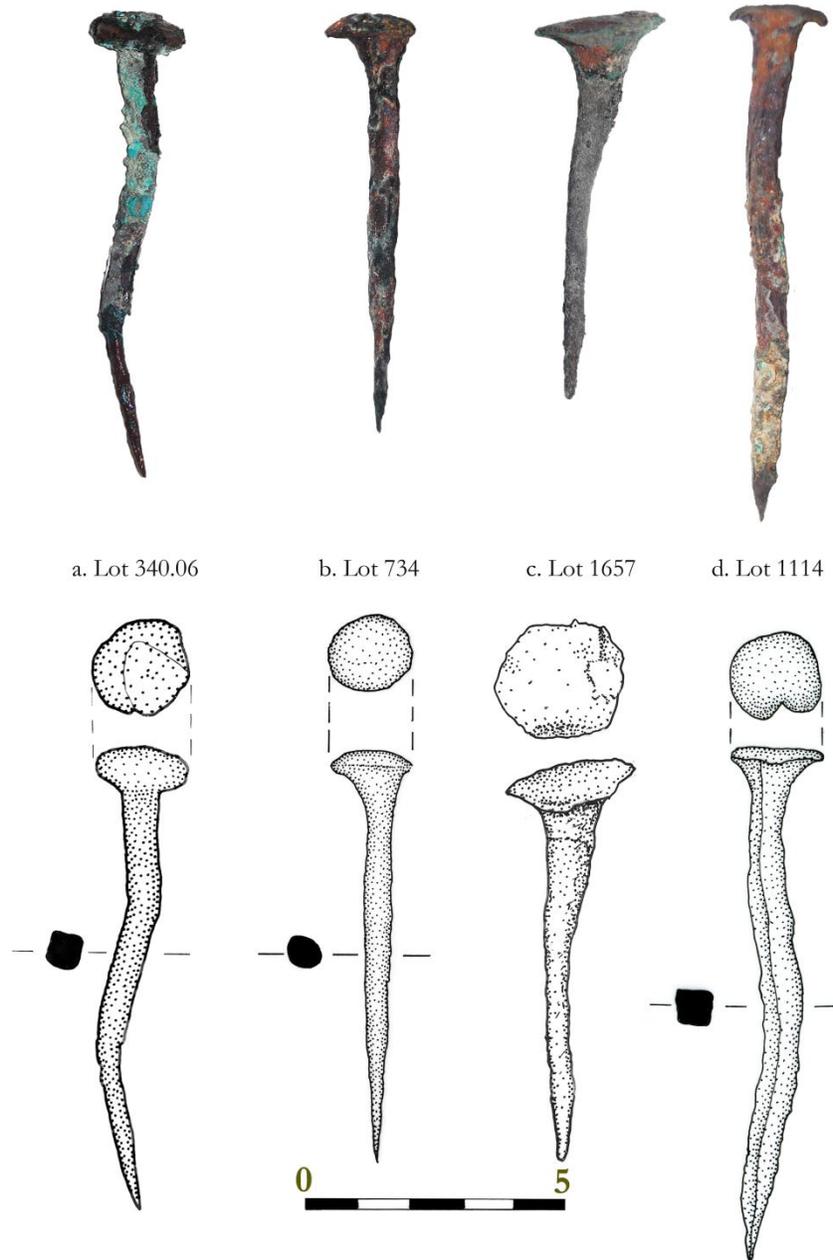
Figure 4.9. Small cupreous nails from the Kızılburun shipwreck.. Photographs by the author. Drawings by Mustafa Korkmaz (a and b) and Seçil Kayacık (c and d).

As with the large fasteners, the small nails have a square cross section and taper towards the distal end. This group consists of 12 nails having a shank width ranging between 0.6 and 1.0 cm; nine of which (75%) fall between 0.6 and 0.7 cm. Lengths range between 5.2 and 9.8 cm. Head diameters range from 1.5 to 1.9 cm, with one outlier at 2.5 cm (Lot 1657). However, small fasteners have two distinct nail head shapes; a pyramidal shape that is often flattened in the center, presumably from the force of driving the nail into a timber (Figure 4.9a,b), and a flat shape (Figure 4.9c,d). The distinct shapes of the nail heads suggest the nails served different purposes, although those specific purposes are not known. It is reasonable to presume that one of the two types was used to secure the ceiling planking to frames, as a square nail hole of small dimensions (0.55 x 0.64 cm) was located in a section of ceiling planking (6023) (Figure 4.10). The nail hole dimensions are consistent with shank widths in the small nail category.

The Brading type III fasteners are reported to be the most common Roman nails. They have a flat head, lengths between 5.1 and 15.2 cm, and a square sectioned shank. Small nails in Groups B-E of the Inchtuthil typology correspond to type III of the Brading assemblage. The small nails with flat heads from the Kızılburun group fit well into these groups, however, neither group is reported as having small nails with pyramidal heads comparable to those from Kızılburun. Lot 1657 is potentially anomalous in that its shank tapers sharply from its large head (2.5 cm), and has a larger shank width (1.0 cm), making it slightly more robust than the other 11 in this category.

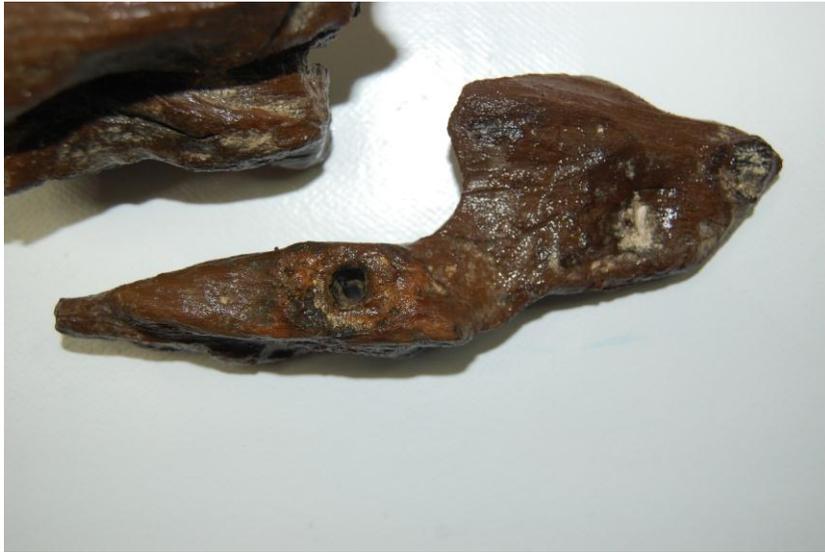
Figure 4.10. Ceiling planking fragment (6023) with small nail hole and nail head impression. Photograph by the author.

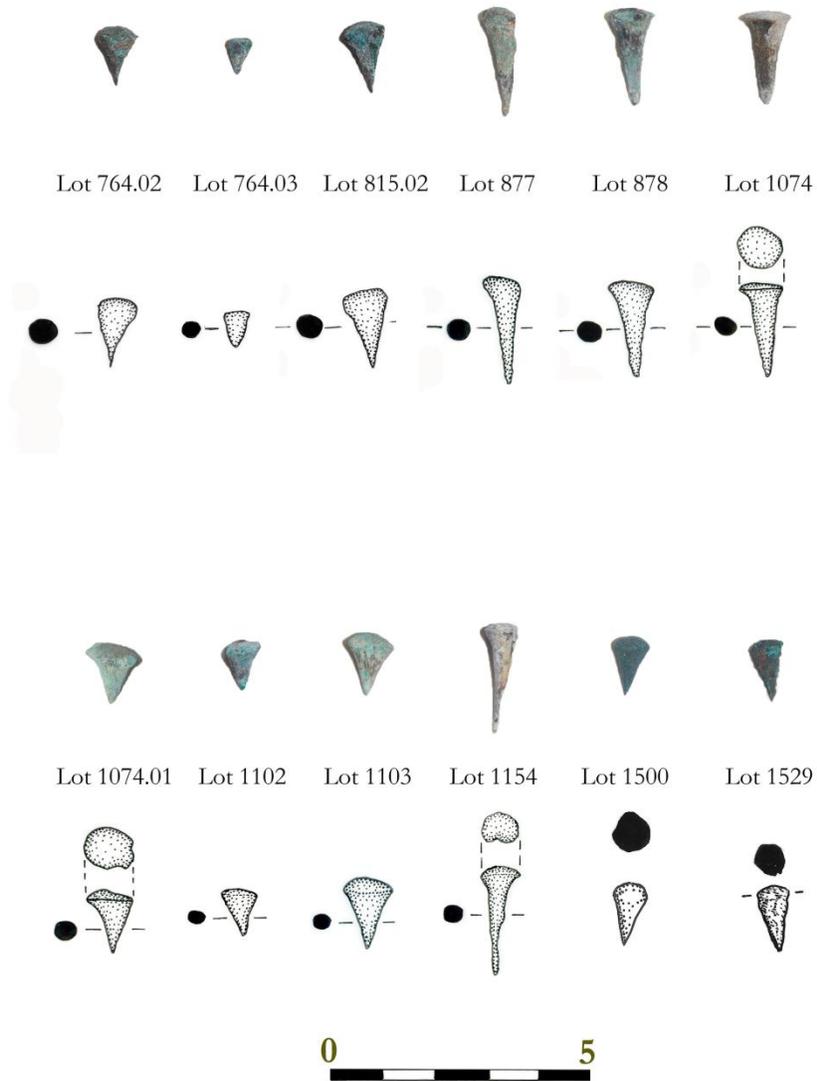
Figure 4.11. Other cupreous fasteners from the Kızılburun shipwreck.. Photographs by the author. Drawings by Mustafa Korkmaz.

Forty eight fasteners have been assigned to this category of which 46 have an overall diamond or conical shape with no distinct shank and are generally of very small size, with lengths ranging from 0.7 - 3.7 cm and head diameters ranging from 0.4 - 1.7 cm (Figure 4.11- Other Fasteners).

These were measured for length and maximum diameter, which is always at the top of the nail unless it exhibited a diamond-shaped profile (e.g. Lot 1103). As demonstrated in the analysis of the copper nails from the fifth-century B.C.E. shipwreck at Tektaş Burnu, these fasteners consist primarily of deteriorated nail heads, the original dimensions of which cannot be determined with any certainty.¹⁵⁸

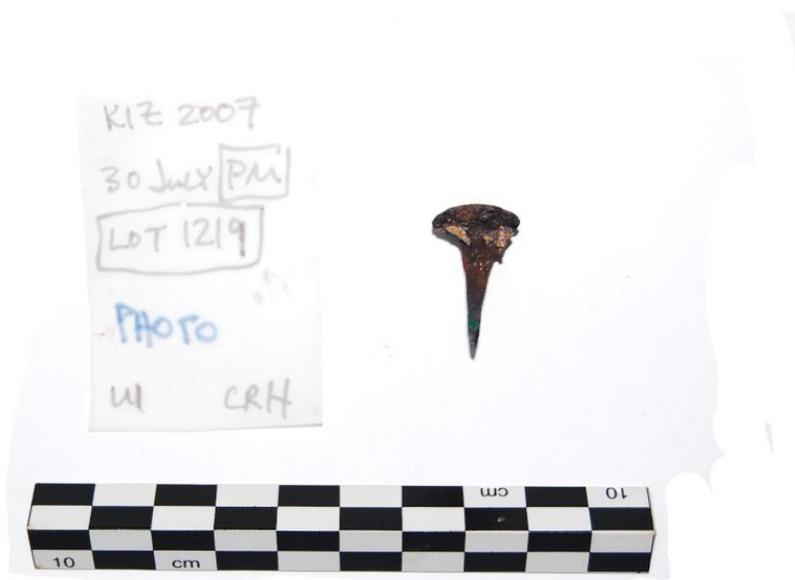
Figure 4.12. Fastener Lot 1219. Photograph by the author.

One fastener, clearly of a different type than the rest (Lot 1219) (Figure 4.12), has a maximum length of 2.4 cm, a maximum shank width of 0.5 cm along clearly defined edges, and head diameter of 1.5 cm. As with many of the nails in the Small Fastener category, the head of this tack has a flattened, pyramidal shape. It is possible that many of the degraded, indefinable nails originally had this form and similar dimensions. Similar objects have been described as tacks used for securing lead sheathing to hulls, albeit there is no evidence of lead sheathing from the Kızılburun site.¹⁵⁹

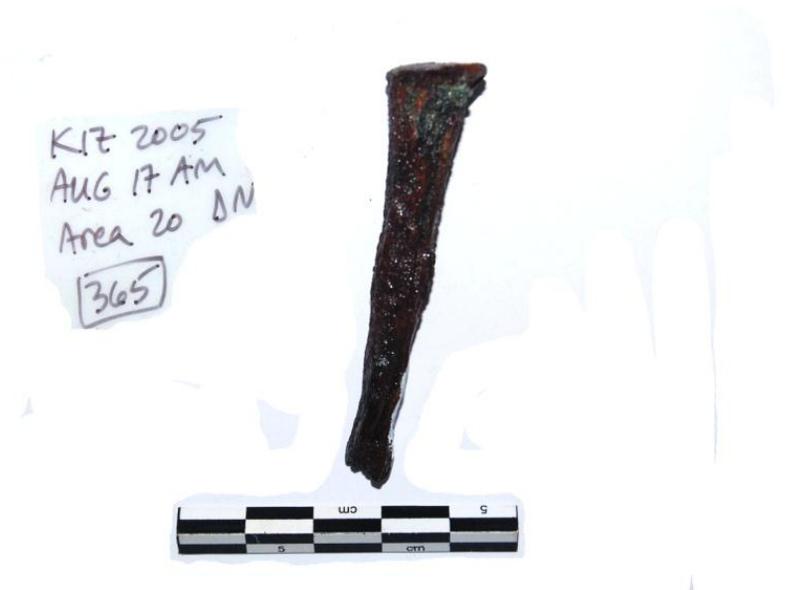
Figure 4.13. Fastener Lot 365. Photograph by the author.

One final nail type (Lot 365) has a large shank with a very flat, poorly defined head, if it can be considered a head (Figure 4.13). The fastener is incomplete, so it is not possible to comment on its overall length, but given the shank width (1.1 cm), it was likely a rather long nail. Its head is vaguely defined, being only slightly wider than the shank. It is possible that this is a broken nail that had been reused in another capacity, although this remains speculative.

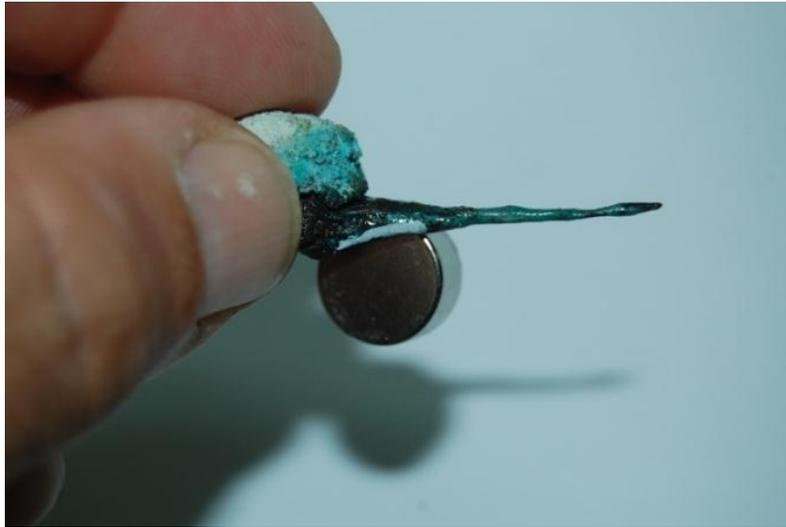
Figure 4.14. Ferro-magnetic cupreous nail (Lot 181.04). Photograph by the author.

All fasteners and fastener fragments were tested using a small, simple rare-earth magnet in order to discern possible ferro-magnetism in the seemingly cupreous nails (Figure 4.14).¹⁶² Six specimens (Table 4.1), of the 1062 inventoried items in the assemblage were found to be ferro-magnetic. Through close examination and removal of all corrosion products and concretion deposits, where such existed, these fasteners were determined to have been made of cupreous materials.

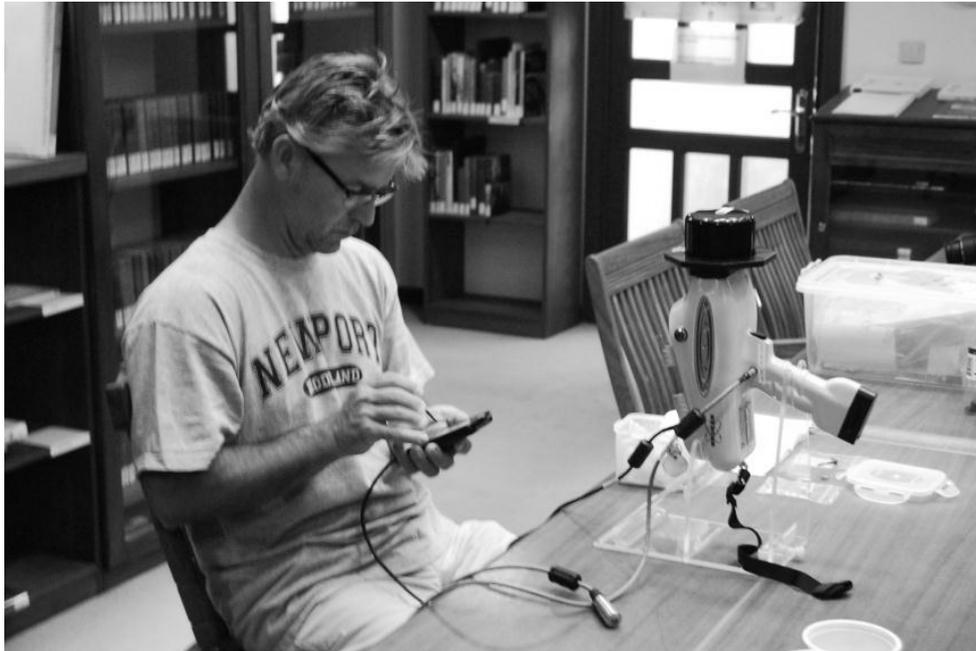
Figure 4.15. The author analyzing nails using the Bruker pXRF. Photograph by Ryan C. Lee.

Of the eight fasteners from which data were retrieved (Table 4.2), all showed a percentage of copper (Cu) ranging from 87.60 to 95.55%. Seven nails had Cu percentages ranging from 93.6 to 95.55%. The 87.60% value came from one of the ferro-magnetic nails (Lot 1219), which contained 3.53 to 4.80% iron (Fe), nickel (Ni), and zinc (Zn). The iron and nickel inclusions are the source of ferro-magnetism and all are natural by-products of the smelting of chalcopyrite ore, from which copper is obtained.¹⁶⁵ The second ferro-magnetic sample showed similar results, but in smaller percentages. Since a pXRF samples a localized portion of the nail, different values could be obtained by analyzing different spots on the nail. Although more formal compositional analysis is pending, it has been demonstrated that these six fasteners are ferro-magnetic due to inclusion of iron and nickel, even though the fasteners of this ship were manufactured from a very high-percentage copper (base metal). Once formal analyses are undertaken, which may include analysis by Inductively Coupled
