**THE HULL REMAINS OF THE LATE HELLENISTIC
SHIPWRECK AT KIZILBURUN, TURKEY**

A Thesis

Submitted to the Office of Graduate Studies of
Texas A&M University
in partial fulfillment of the requirements for the degree of

MASTER OF ARTS

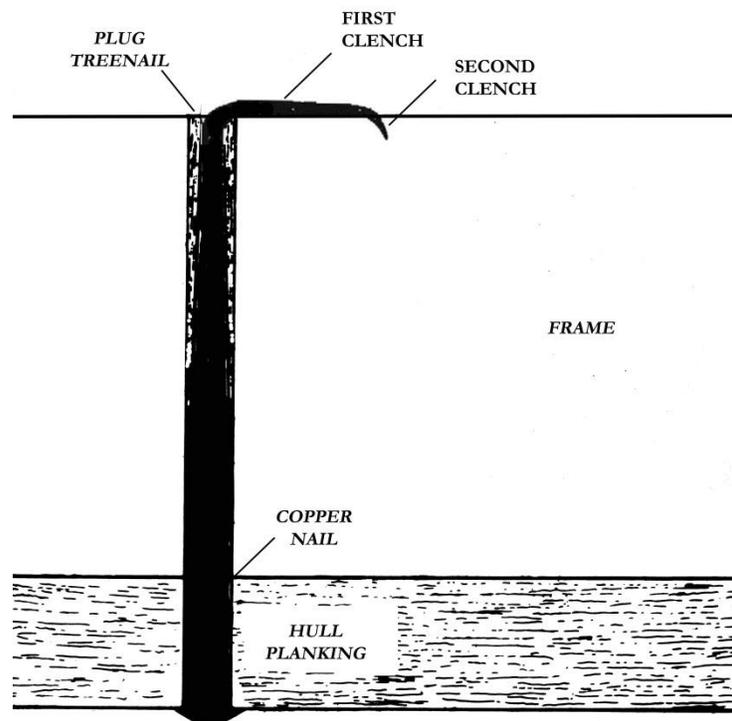
Figure 4.16. Nail double clenched to inner face of a frame (profile view). Drawing by the author.

Plug-treenails prevent splitting of the timbers through which nails are driven.¹⁷¹ This is accomplished by pre-drilling holes from the interior of the vessel, through the frames and through the hull planking. A cylindrical wooden dowel or treenail is then driven through the hole and cut flush with each surface. Next a nail with a maximum width close to that of the diameter of the treenail is driven from the exterior, through the wooden treenail and double clenched to the inner face of the framing element (Figure 4.16).¹⁷²

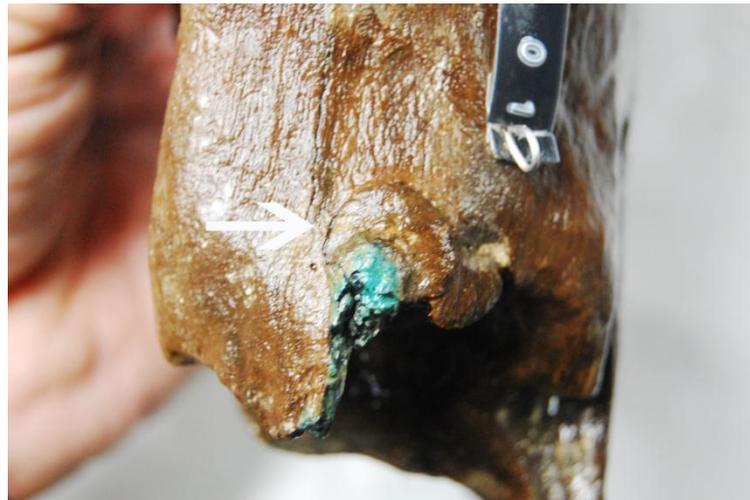
Figure 4.17. Plug-treenail. Photograph by the author

During initial examination of the ship's timbers, no treenails were observed. In degraded wood, plug-treenails can be especially difficult to see with the naked eye,¹⁷³ particularly on the outer face of a frame, as the treenail and the nail are of such similar sizes. However, during analysis of the copper nails, it was noted that many retained fragments of wood along their shanks, which suggested the use of plug-treenails. Closer examination of the wood fragments confirmed their use in the vessel (Figure 4.17). Treenails that survive (16 clear examples) are cylindrical in shape and have diameters ranging between 1.1 and 1.7 cm, with an average of 1.3 cm and a mode of 1.2 cm occurring five times. One would presume the treenails to be of the same or approximately the same diameter if a single auger was used to drill the holes into which these treenails were driven, but there is some variation in their diameters. This variation may be due to preservation processes, to augers of different diameters used in drilling the holes, or the roughly shaped treenails were of slightly different sizes, which, when driven into the uniformly drills holes, fit snugly into some and more tightly in others, expanding the diameter of the hole.

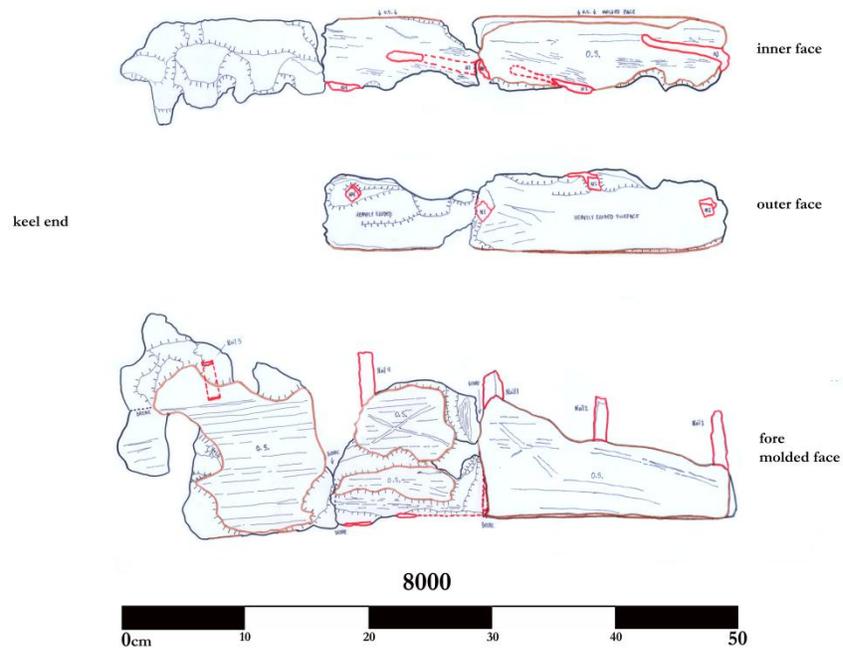
Figure 4.18. Frame 8000 showing nail staggering. Drawing by the author.

Nails were staggered across the central axis of the inner face (width) of frames with an alternating pattern; one nail being closer to the foreword edge and the next closer to the aft edge of the frame (Figure 4.18). As with the staggering of the tenon pegs in the keel, the purpose of staggering framing nails is presumably to reduce the effects of possible perforation along the length of the frame and to prevent splitting of the timber. This staggered nail pattern can also be seen in planking section 3007 where two nails exist within a frame impression left on the interior surface of the planking.

Nail clenches were oriented either roughly parallel to one another and the edge of the frame, or with both the upper and lower clenches parallel and slightly angled in the same direction. In both variations the clenches pointed toward the keel along the length of inner face of each frame (Figures 4.18 and 4.19b). This is a different pattern than is seen in the frames of the Kyrenia ship,¹⁸⁰ the Blackfriars ship,¹⁸¹ or the New Guy's House boat,¹⁸² each of which also had staggered framing nails, yet each fastener's clench was oriented towards the center of the frame in a herringbone pattern (Figure 4.19a).¹⁸³ Whether there is a functional difference between the nailing pattern seen in the Kızılburun frames and the herringbone pattern has not been determined. However, the herringbone pattern may offer a slight increase in torsional pulling resistance, but this remains to be tested.

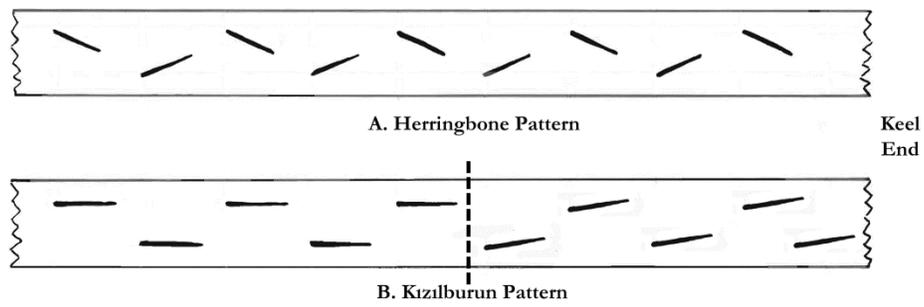
Figure 4.19. Frame nail patterns. Image by the author.

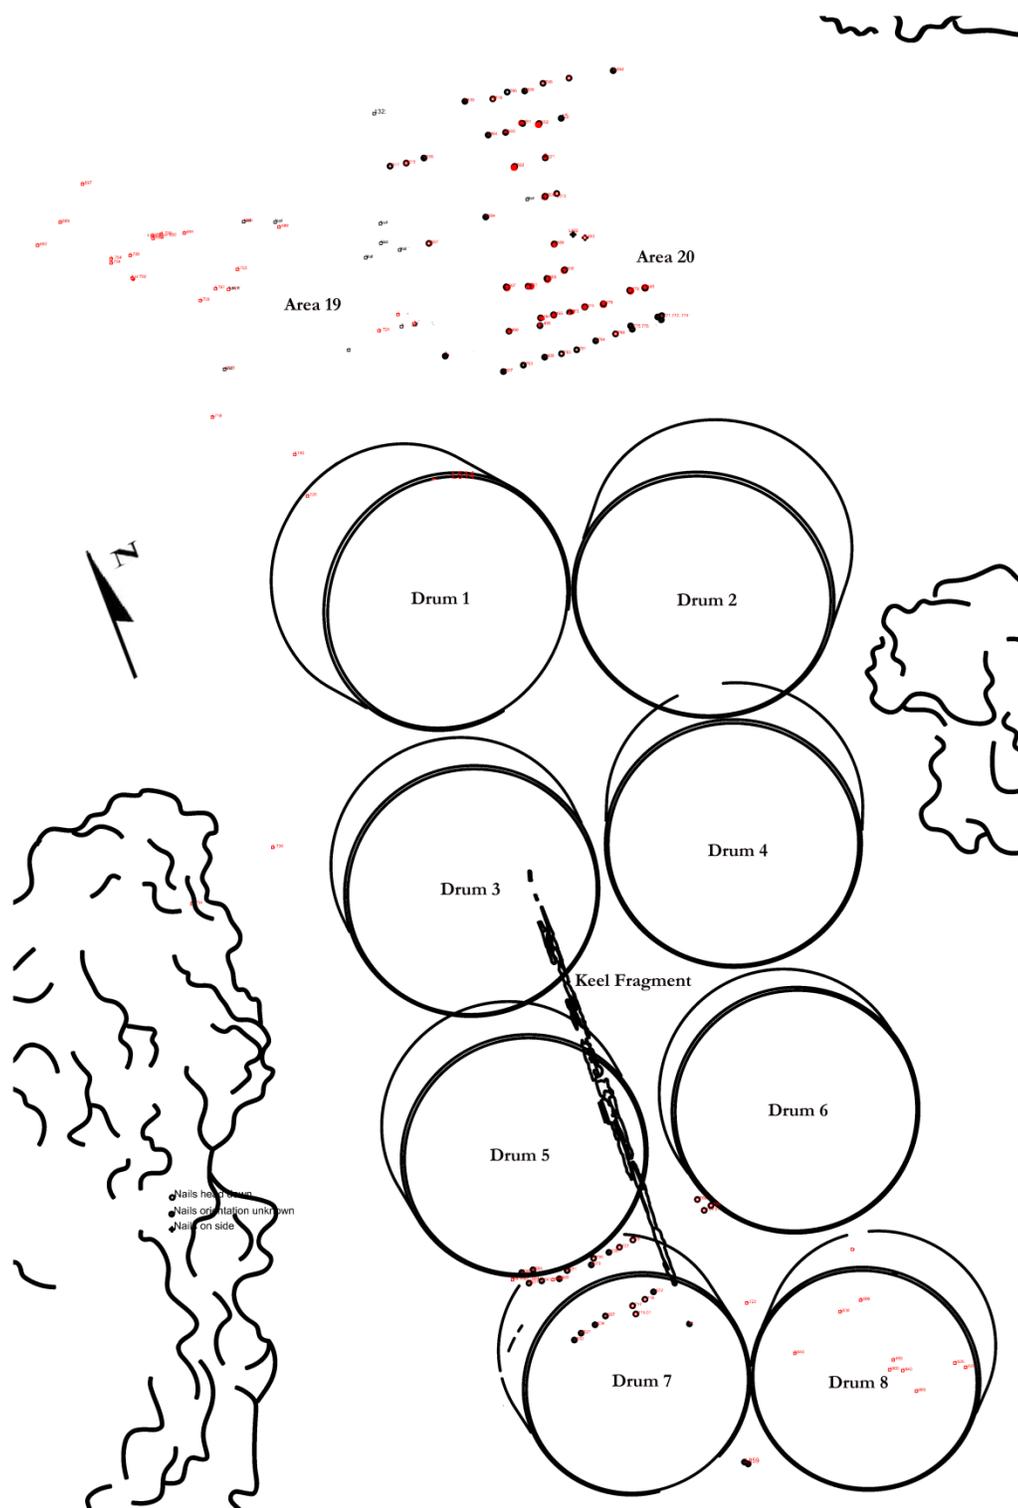
Figure 4.20. Site plan with nails found heads down. Image by Sheila Matthews and the author.

Rows of nails were discovered in situ stretching across the east-west axis of the site in several areas. In areas 19/20 there were 55 nails (46 with heads) in nine rows found with their heads down (Figures 4.20 and 4.21). Area U7 had 14 nails forming two parallel rows. Areas U1 and U8 had patterns of similarly aligned nails. With the confirmation of the keel running in a north-south direction and the absence of other wood remains or artifacts beneath these nails, they are almost certainly planking-to-frame nails. Thus, from the patterns of these nails, an average frame spacing of 25 cm was determined. This figure was observed early in the excavation, although it was unclear if the frame pieces from which the measurement was derived had been displaced from their original positions in the hull. This spacing figure is further supported by examination in the laboratory of planking fragments from area U1 that retain impressions of frames.

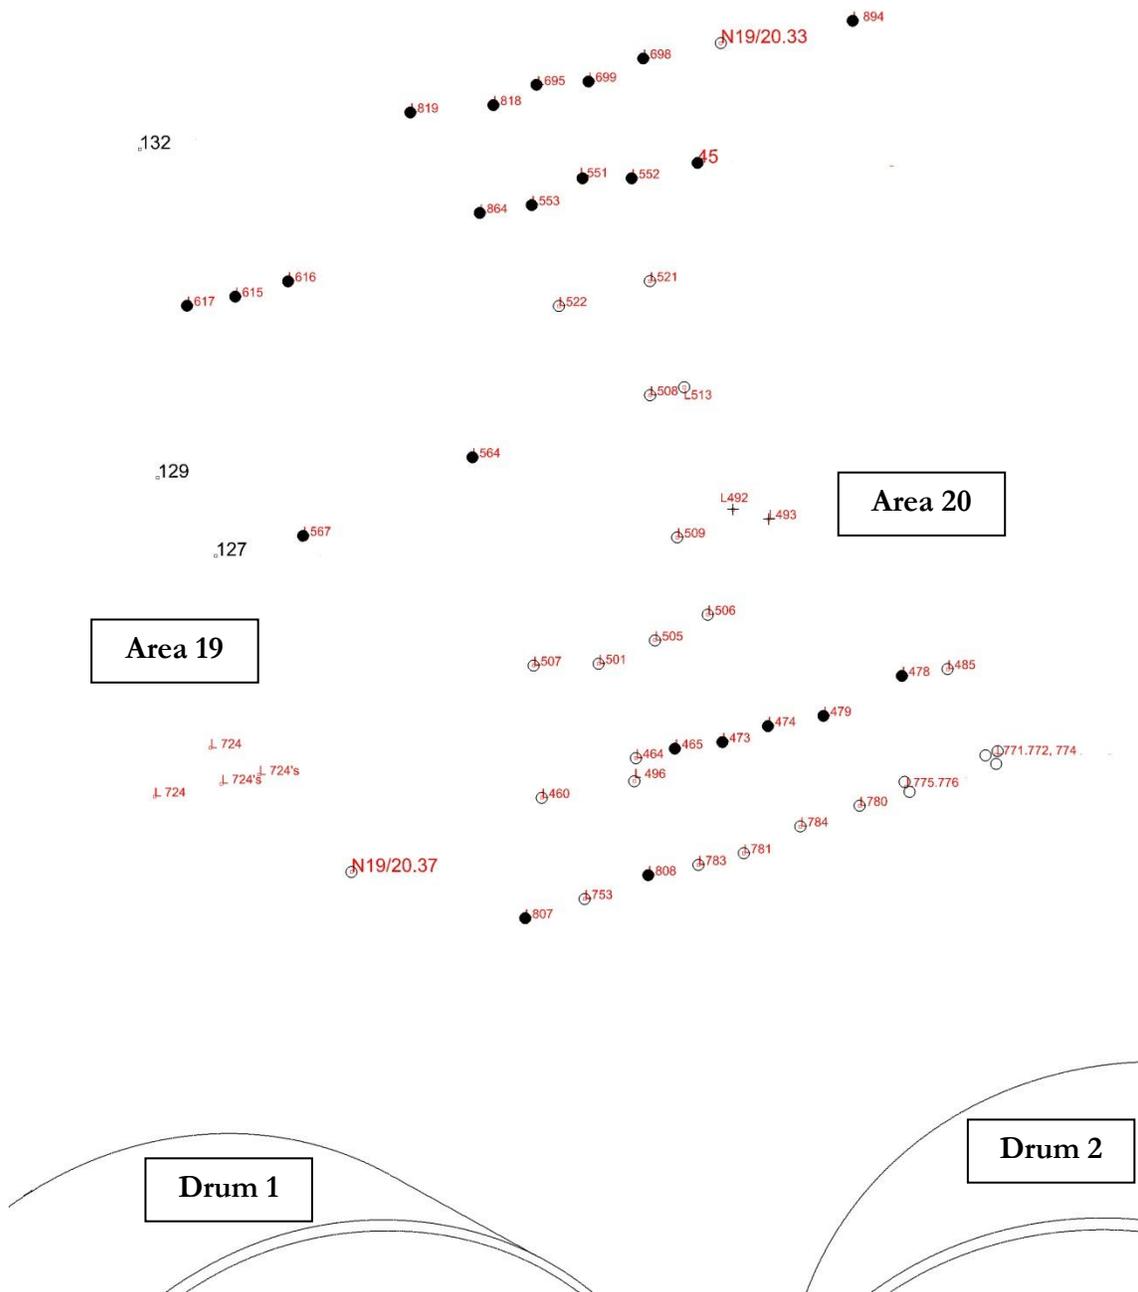
Figure 4.21. Detail of Figure 4.20 showing rows of nail on the seafloor in areas 19 and 20. Image by Sheila Matthews and the author.

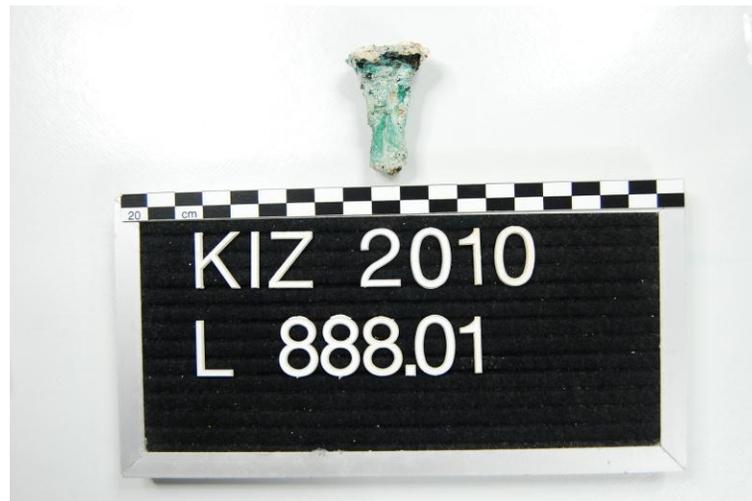
Figure 4.22. Nail Lot 888.01 with head. Photograph by the author.

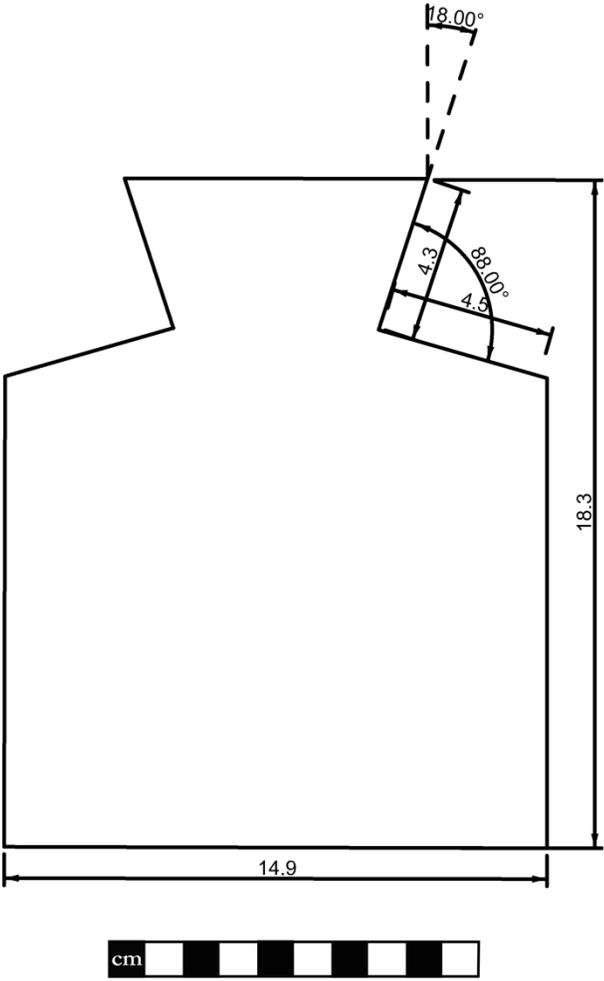
Figure 5.1. Cross-section of the Kızılburun keel. Image by the author.

The maximum *surviving* dimensions of the keel (8.3 cm wide on the inner face, 11.5 cm sided, and 18.3 cm molded) may give the impression of a keel with gracile dimensions. To understand the original dimensions of the keel, these data, coupled with measurements from 21 cross-sections, were used to project the minimum original size of the keel that was at least slightly greater than the surviving dimensions as shown in Figure 5.1. This projected profile was used to create a 3-D model of a section of the Kızılburun ship’s keel in Rhinoceros 4.0 software (Figures 5.2 and 5.3).

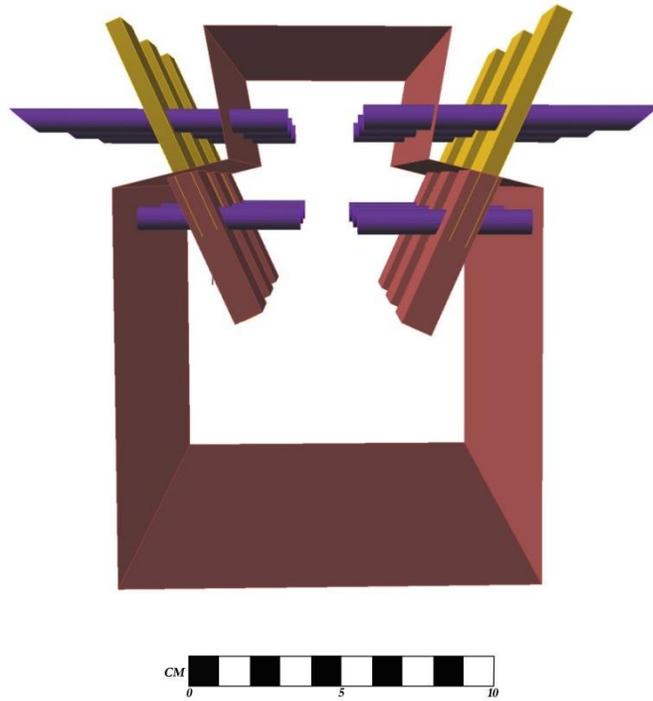
Figure 5.2. 3-D model of the Kızılburun keel cross-section. Image by Sheila Matthews and the author.

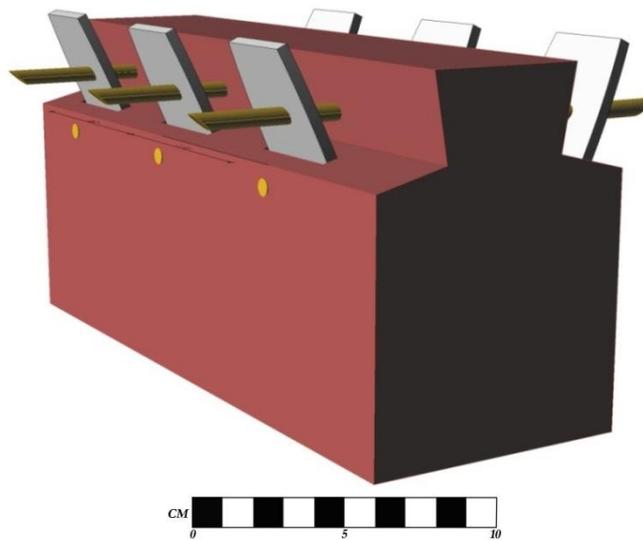
Figure 5.3. 3-D model of the Kızılburun keel. Image by Sheila Matthews and the author.

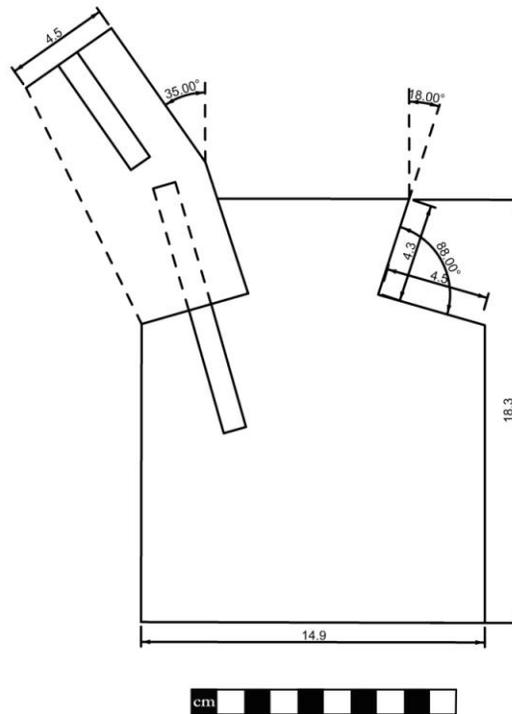
Figure 5.4. Garboard strake and keel in profile. Image by the author.

In my examination of the keel, the sharp deadrise (75-80°) of the garboard was clear and this became even more prominent in the model. This initially suggested a wine-glass hull shape, like that of the ship excavated at Kyrenia, Cyprus. Since the garboard had been disarticulated from the keel, it was necessary to fit the two together in order to understand their relationship to each other and gain a better understanding of the shape of the lower portion of the hull. However, due to the highly degraded nature and fragility of both timbers, this was not physically possible. As an alternative, information gleaned from its 3-D keel profile was coupled with information from the garboard fragment in order to make a drawing of the keel and garboard junction (Figure 5.4)

The upper portion of the port side garboard strake is shaped to form an angle of approximately -35° (145°) from vertical. There is no extant original outer surface; it has been entirely destroyed by biological activity and degradation processes. However, knowing the rabbet width in which the garboard was seated (4.5 cm) and using the planking thickness of 4.5 cm, the outer face could be reconstructed. The hypothesized reconstruction gives the garboard a robust five-faceted section.¹⁸⁷ This is a conjectural shape, as the outer face may have been a sculpted surface like the inner face. However, the five-faceted (pentagonal) shape would have afforded more strength to the garboard and appears to be a common and therefore perfectly feasible shape to consider for modeling purposes. Whichever shape the original garboard employed does not change its function in this discussion.

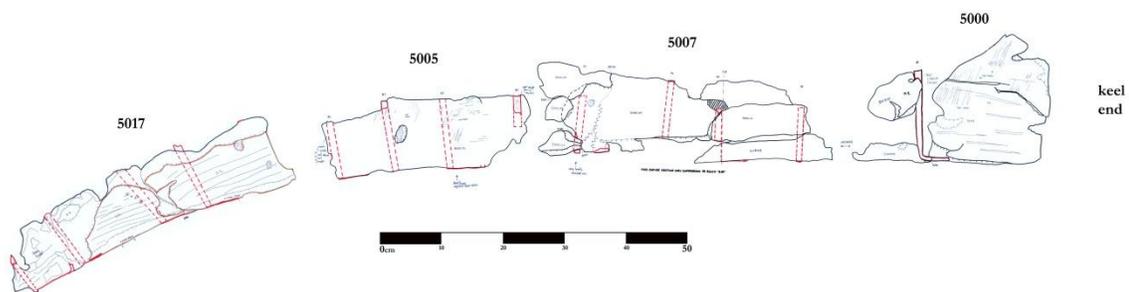
Figure 5.5. Frame fragment 5017 joined with floor fragments 5007/5005/5000 (forward molded face up as found). Image by the author.

As noted by McGee, “sweet wooden curves follow mathematical rules and the spline is the analogue for these rules.”¹⁸⁹ By using the curvature of the fragments and average nail spacing of 9.3 cm on the outer surface, seen not only in fragments of this floor, but among many of the other Kızılburun frame fragments as well, fragment 5017 can be approximately positioned in relation to the other pieces of the floor timber by extending its natural curvature with a spline, thus allowing for a reconstruction of the port side of a floor timber (Figure 5.5). The timber is drawn as found with the molded forward face up (i.e. toppled 90° downslope).

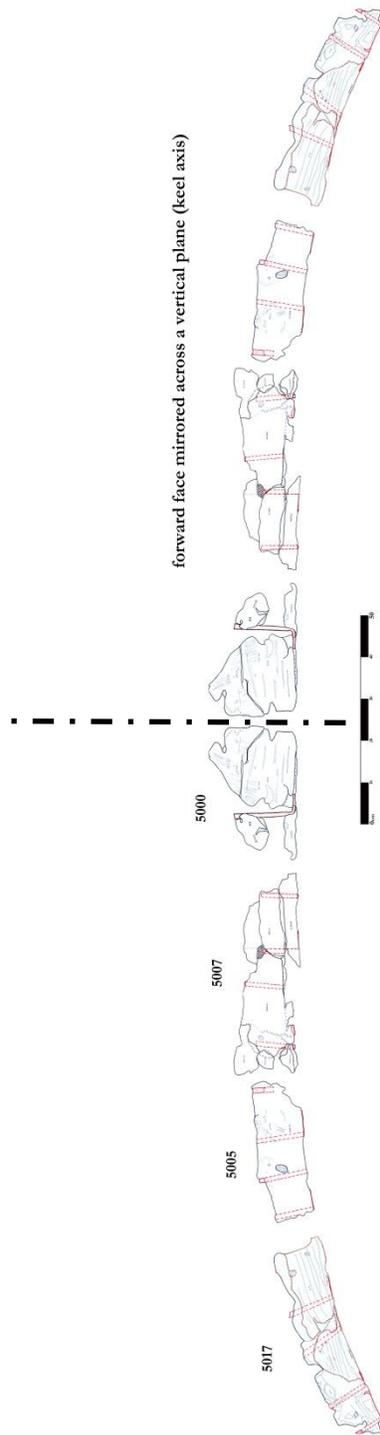
Figure 5.6. Floor fragments 5017/5007/5005/5000 mirrored across a vertical plane. Image by the author.

Presuming a fair amount of symmetry, the reconstructed portion of the floor timber can be mirrored across a vertical plane (the keel) to simulate a full or nearly full floor timber as it would have been originally under Drums 5 and 6 (Figure 5.6).¹⁹⁰ Expanding on this idea, the reconstructed floor timber can be superimposed upon the garboard/keel reconstruction

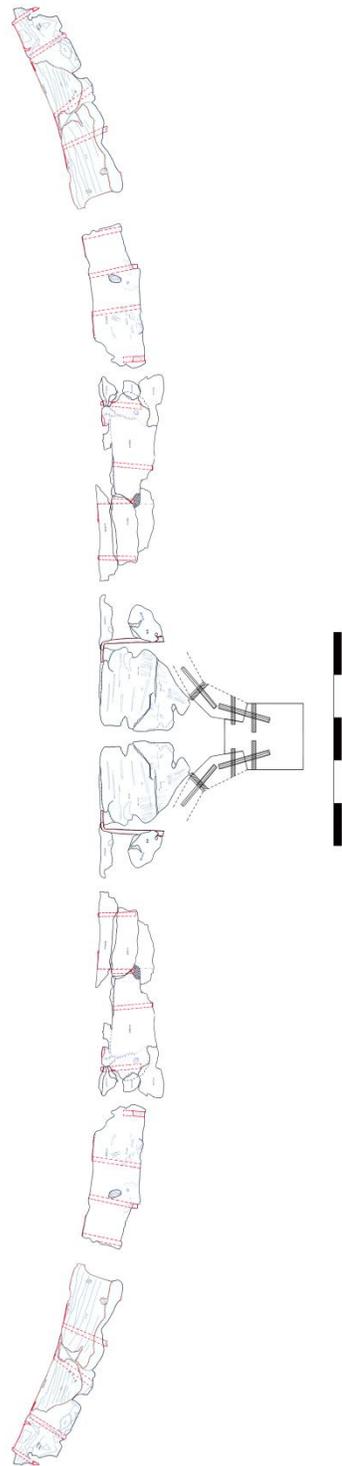
Figure 5.7. Reconstructed floor rotated and superimposed onto the garboard and keel. Image by the author.

presented earlier. In this manner, one reconstruction is used to support or refute the other and informs the reconstruction's viability (Figure 5.7). The resulting combined reconstruction hints at the bottom shape of the vessel, but this is still less than conclusive. Therefore, one more element may be added to the model to further test its feasibility.

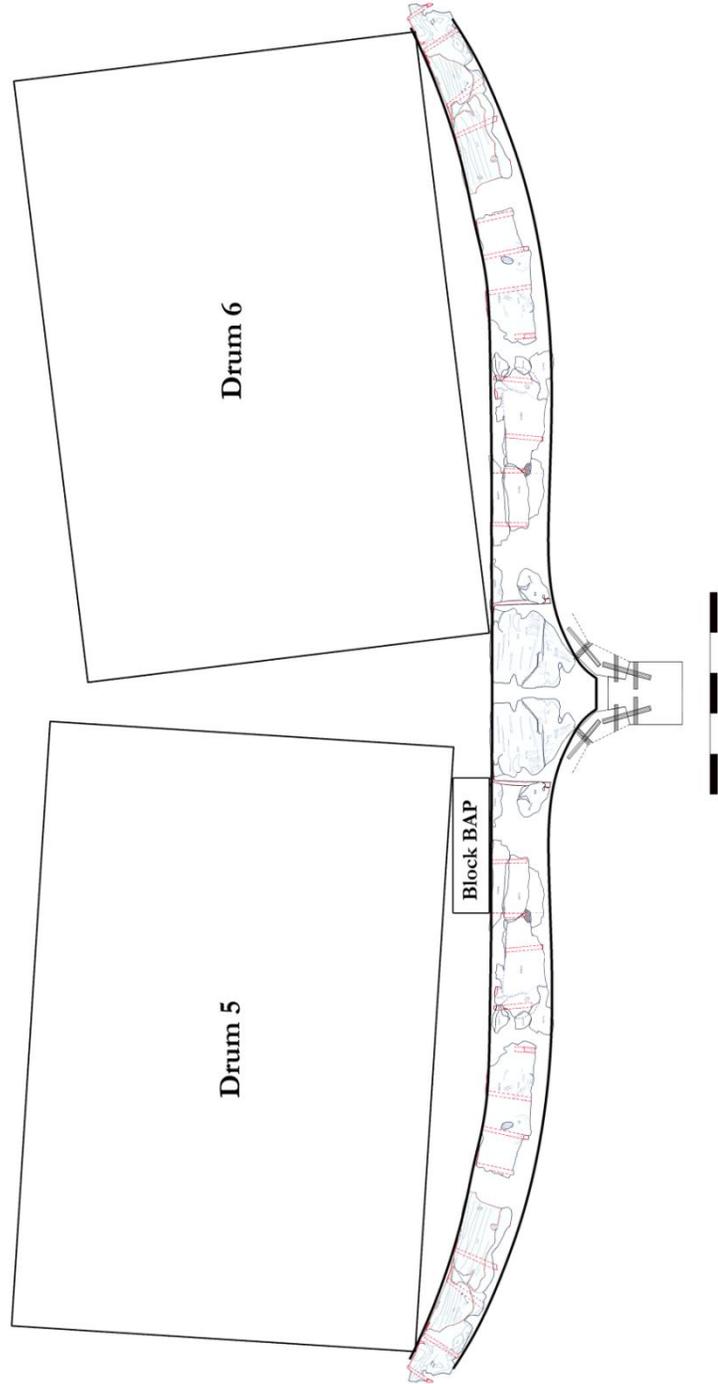
Figure 5.8. Reconstructed floor timber with column drums in place. Image by the author.

The canted, in situ positions of the column drums suggest the drums were of a greater diameter than the bilge dimension. This hypothesis can be tested by superimposing Drums 5 and 6 (row 3 of the drums) onto the combined reconstruction of the keel, garboard, and floor timber (Figure 5.8), using measurements published in 2010.¹⁹¹ Additionally, a row of marble blocks was placed under the port side column drums before the drums were loaded onto the vessel. These may have been needed to create slightly more space between the two files of drums in the hold. Another possibility is that Drum 6 rested on the mast step (assuming the use of a mast) and the port side blocks were used to raise Drum 5 to the same level and thus, help balance the load for improved sailing quality.¹⁹² There are two looming problems that stem from this idea. First, there is no evidence of a mast step and second, there seems to have been no room for a mast to have been erected within the presumed central cargo area as there was little room between the column drums, and the capital was placed atop Drums 1, 2, 3, and 4 with two large marble blocks occupying the space atop Drums 3, 4, 5, and 6 (Figure 5.9). Since the heavy cargo could not have moved upslope, against gravity, the only space the mast could have possibly occupied in the central portion of the ship is between Drums 7 and 8, thus placing it aft of midships, making this scenario unlikely.

Returning to the position of the drums in the Kızılburun vessel, if the third row (Drums 5 and 6) of column drums is superimposed on the reconstructed floor timber that they covered, it is evident that the drums would have fit into a hull with the suggested bottom shape, that the drums would have canted in a similar manner as found, and that the reconstructed hull-section presents a feasible profile of the vessel. Presuming a centrally positioned cargo and assuming a minimal downslope shift of the cargo (less than 2 m), this location would have approximately corresponded to amidships.

Although there were no definable extant hull remains from above the bilge (e.g. the sides of the ship, decking, etc.), the distance between the port and starboard bilges must have at least equaled the diameter of two column drums plus a space between them, roughly 3.25 m as shown in the floor reconstruction (Figure 5.8). The sides of the vessel clearly flared out from the turn-of-the-bilge and had to be of a height greater than that of the column drums (approximately 1 meter) plus an appropriate amount of freeboard (likely at least an additional meter at midships). Gassend et al. support this idea in their examination of the Laurons 2 vessel, stating that the depth of hold below the main beam was 1/3 of the breadth of the vessel.²⁰⁵ Parker adds, "...this convention for the hull-form of a sailing vessel

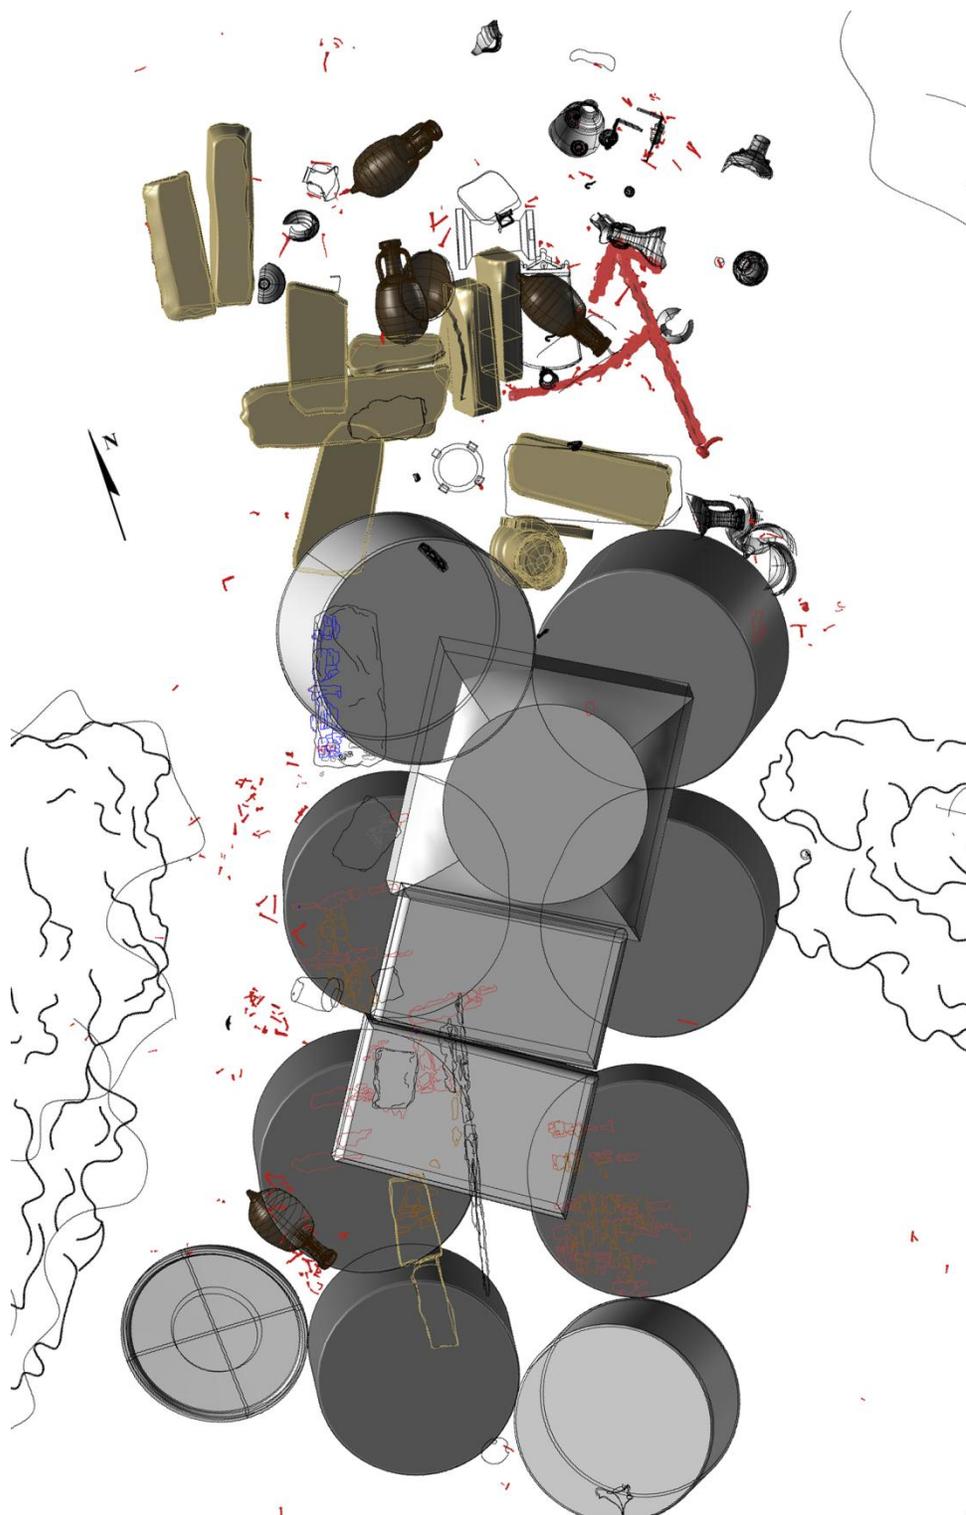
Figure 5.9. Lading of the Kızılburun cargo. Image by Sheila Matthews.

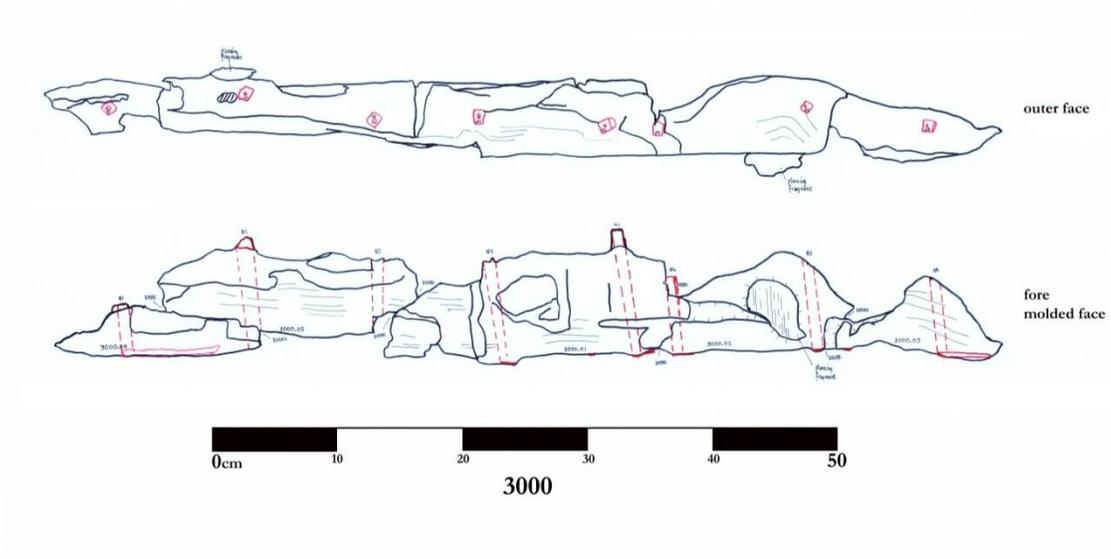
Frame heavily worn eaten and deteriorated. Edges appear rounded or beveled. No original after molded surface. Two small patches of pitch on distinct surfaces. Staggered, but regular planking-to-frame nail pattern.

Pres. l. 76.3; s. 6.8; m. 10.5. Eight partial nails: N1 l. 3.85, w. 0.9; N2 l. 7.6, w. 1.05; N3 l. 5.0, w. 1.0; N4 l. 9.7, w. 0.9; N5 l. 10.8, w. 1.0; N6 l. 6.0, w. 1.0; N7 l. 7.2, w. 1.0; N8 l. 6.8, w. 1.1. Nail spacing: N1-N2 inner 10.2, outer 10.6; N2-N3 inner 9.9, outer 10.6; N3-N4 inner 10.2, outer 8.4; N4-N5 inner 10.6, outer 10.2; N5-N6 inner 3.4, outer 4.2; N6-N7 inner 11.0, outer 10.6; N7-N8 inner 9.8, outer 9.8. Three discernible plug-treenails diam.: 1.6, avg. of three examples ranging from 1.4-1.8. Three partial nail clenches: l. 2.2, 3.4, 4.7. One complete nail clench: l. 8.2. Ceiling planking nail (l. 3.5 x w. 0.5) embedded in inner face.

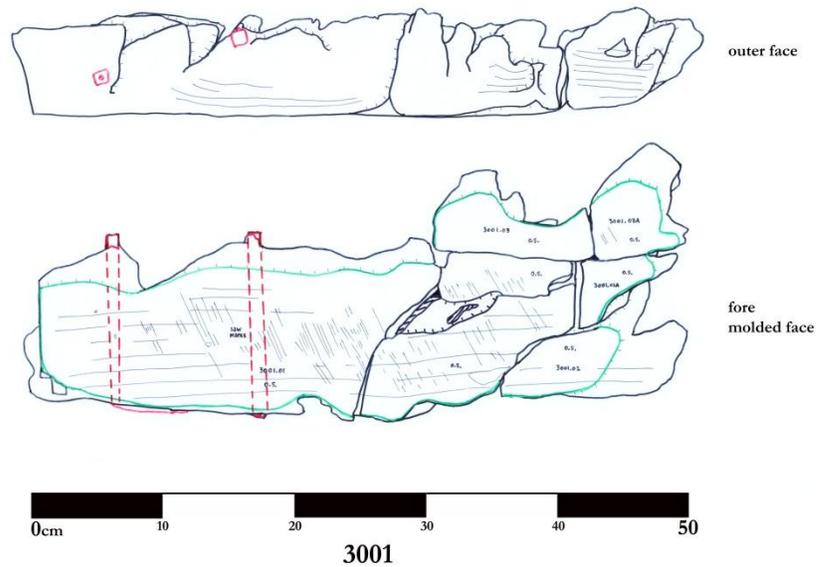
FR 3001

Well preserved forward molded face. No original after molded surface. Saw marks clear and abundant on same surface. Staggered nails in the outer face. Lack of nails in last 30 cm of inboard end. Frame molded dimension increases toward keel.

Pres. l. 50.8; s. 8.1; m. 12.3 outboard, 19.4 inboard. Two nails: N1 l. 13.3 w. 1.1; N2 l. 14.1, w. 1.2. Nail spacing: N1-N2 11.0 inner, 10.4 outer. One nail clenched: l. 6.0.

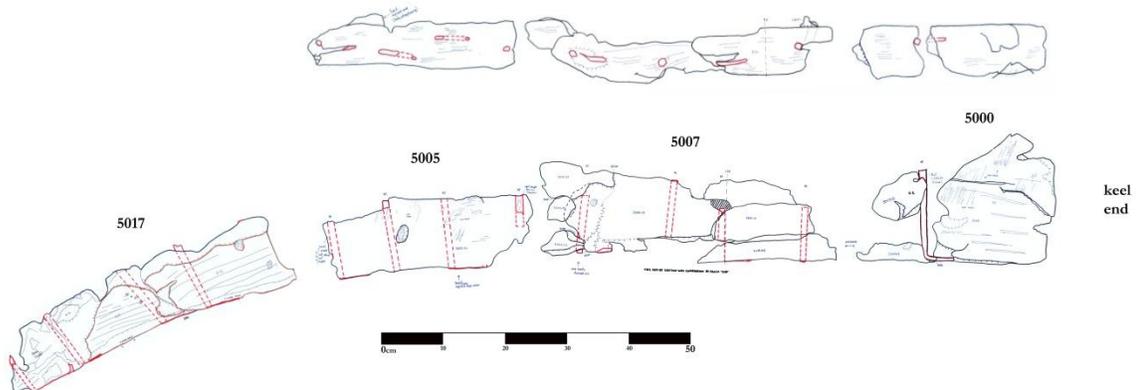
FR 5000

Fragments 5017 and 5000 well preserved. Timber appears to have rounded edges. Nails staggered on inner and outer faces. Saw marks on forward molded face.

Reconstructed l. 161; s. 13.6 outboard, 21.4 inboard; m. 8.6. Sixteen partial nails: N1 l. clenched only; N2 clenched only; N3 l. broken, w. 1.1; N4 l. 10.0, w. 1.2; N5 l. 11.8, w. 1.4; N6 l. 11.5, w. 1.4; N7 l. 12.6, w. 1.3; N8 l. 9.7, w. 1.2; N9 l. 11.9, w. 1.2; N10 l. 11.5, w. 1.3; N11 l. 5.8, w. 1.2; N12 l. 9.1, w. 1.0; N13 l. 9.6, w. 1.2; N14 l. broken, w. 0.8; N15 l. broken, w. 0.8; N16 l. 13.6, w. 1.1. Nail spacing: N3-N4 9.7 inner, 10.2 outer; N4-N5 13.5 inner, 13.4 outer; N5-N6 7.8 inner, 10.2 outer; N6-N7 10.9 inner, 11.0 outer; N8-N9 9.3 inner, 9.5 outer; N9-N10 8.9 inner, 9.5 outer; N10-N11 11.2 inner, 12.1 outer; N12-N13 14.0 inner, 14.0 outer; N13-N14 9.1 inner, 8.4 outer; N14-N15 13.1 inner, 13.5 outer. Four plug-treenails: 1.2, 1.2, 1.4, 1.5. Nine nail clenches: 7.3, 7.0, 6.3, 6.0, 6.5, 7.8, 6.3, 6.2, 6.1.

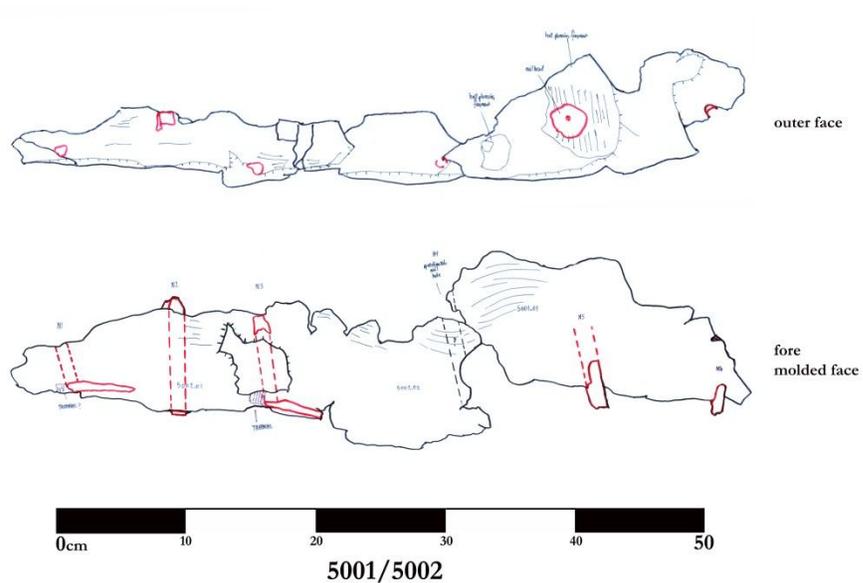
FR 5001

Poorly preserved timber with little preserved original surface. Frame is twisted and heavily worm damaged.

Pres. l. 57.6; s. 9.8; m. 16.1. Six nails: N1 l. 3.7, w. 0.6; N2 l. 9.3, w. 1.4; N3 l. 7.2, w. 0.8; N4 nail hole only; N5 l. 11.5, w. 1.3; N6 l. 6.0, w. 0.8. Nail spacing: N1-N2 8.0 inner, 9.7 outer; N2-N3 7.4 inner, 5.9 outer; N5-N6 9.1 inner, 9.2 outer. Four plug-treenails diam.: 1.3, avg. of four examples ranging from 1.1-1.4. Two partial nail clenches: 4.7, 4.1.

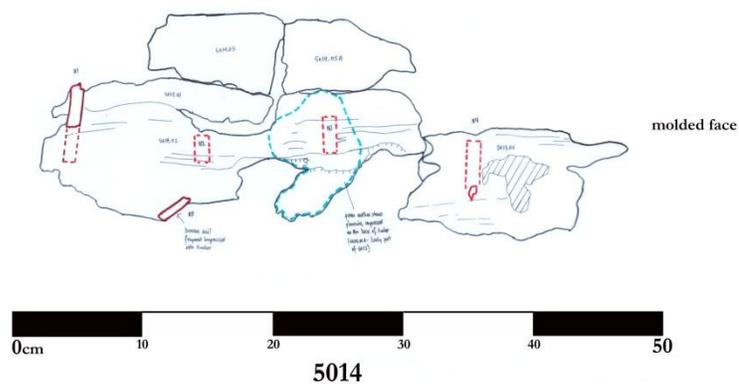
Poorly preserved frame. Frame 5018 a likely extension of this timber, but could not be placed in relation to FR 5014 with certainty.

Pres. l. 45.3; s. 5.1; m. 20.6. Four nails: N1 l. 6.0, w. 1.0; N2 l. 2.0, w. 0.9; N3 l. 2.7, w. 0.9; N4 l. 4.5, w. 1.0. Nail spacing: (measured centrally due to broken nails) N1-N2 9.5; N2-N3 10.0; N3-N4 11.1. No plug-treenails. No nail clenches.

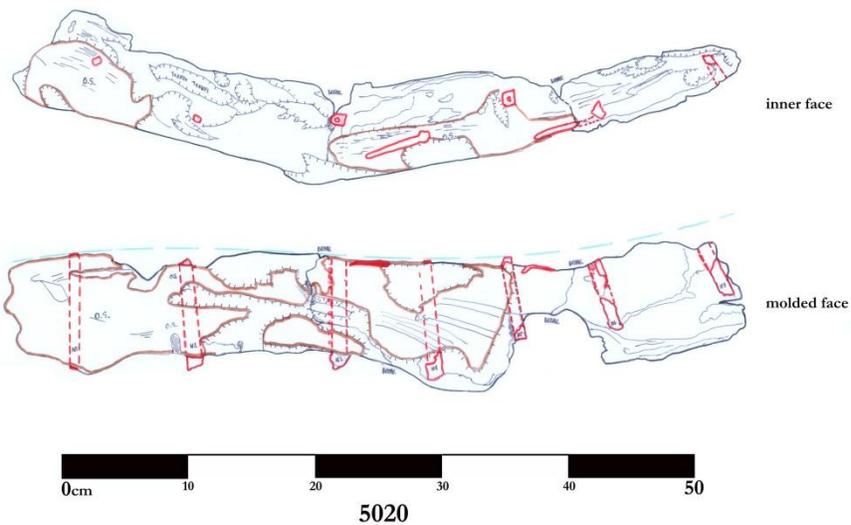
FR 5020

Poorly preserved frame displaying compound curve. Distorted from impact. Staggered nail pattern in inner and outer faces. No pitch retained.

Pres. l. 59.7; s. 7.9; m. 13.9. Seven partial nails: N1 l. 9.0, w. 0.9; N2 l. 8.7, w. 1.3; N3 l. 8.8, w. 1.3; N4 l. 9.4, w. 1.4; N5 l. 6.7, w. 1.0; N6 l. 5.9, w. 1.2; N7 l. 4.8, w. broken. Nail spacing: N1-N2 8.7 inner, 9.5 outer; N2-N3 12.2 inner, 11.5 outer; N3-N4 6.7 inner, 7.5 outer; N4-N5 6.2 inner, 7.4 outer; N5-N6 6.9, 7.5 outer; N6-N7 9.0 inner, 9.3 outer.

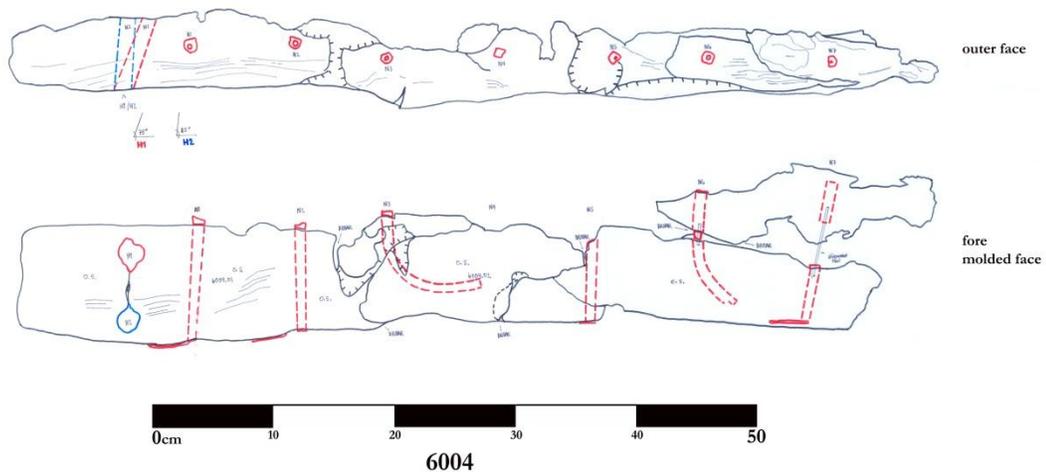
FR6004

Keel end (with two vertical holes) has well preserved forward molded face, inner face, and outer face, otherwise the inner face poorly preserved along remainder of frame. After molded face poorly preserved. Two vertical holes in the keel end: H1, diam. 1.8, drilled at 75° angle with reference to forward molded face. H2, diam. 2.0, drilled at 85° with reference to forward molded face. No pitch retained. No tool marks. Two mis-driven nails embedded in the frame. No plug-treenails observed. Nail staggering slight, if any.

Pres. l. 71.6; s. 6.9; m. 10.5 (broken fragment placed may amend this to 13.0). Six partial nails: N1 l. 11.1, w. 1.1; N2 l. 9.3, w. 0.9; N3 embedded, w. 1.1; N4 l. 7.0, w. 0.8; N5 embedded, w. 0.9; N6 l. 5.3, w. 0.8. Nail spacing: N1-N2 9.1 inner, 8.2 outer; N2-N3 7.1 outer; N4-N5 8.2 outer, N5-N6 10.1 outer. One plug-treenail: diam. not discernible. Four partial nail clenches: 3.6, 4.1, 1.0, 3.5.

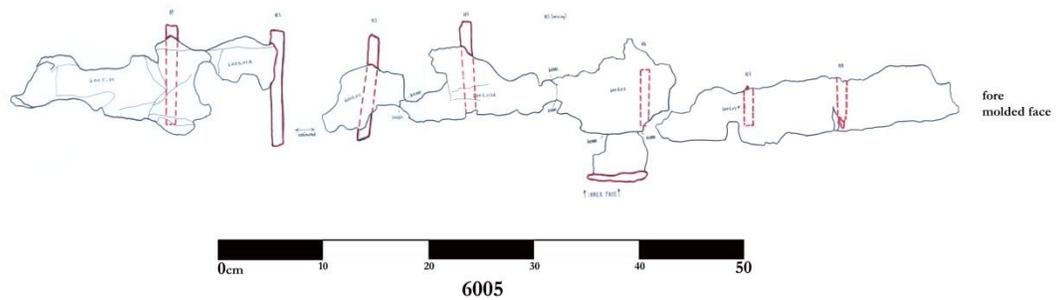
FR 6005

Heavily deteriorated and worn damaged frame. Little original surface of any face.

Pres. l. 90.3; s. 5.9; m. 14.6. Seven nails: N1 l. 9.3, w. 1.2; N2 l. 11.2, w. 1.3; N3 l. 10.3, w. 1.1; N4 l. 8.8, w. 1.2; N5 l. 5.3, w. 1.0; N6 l. 3.9, w. 0.9; N7 l. 4.8, w. 1.0. Nail spacing: N1-N2 9.9 inner, 9.8 outer; N3-N4 10.4 inner, 8.4 outer; N5-N6 9.8 inner, 9.6 outer; N6-N7 8.4 inner, 8.8 outer. No discernible plug-treenails. One partial nail clench: 5.7.

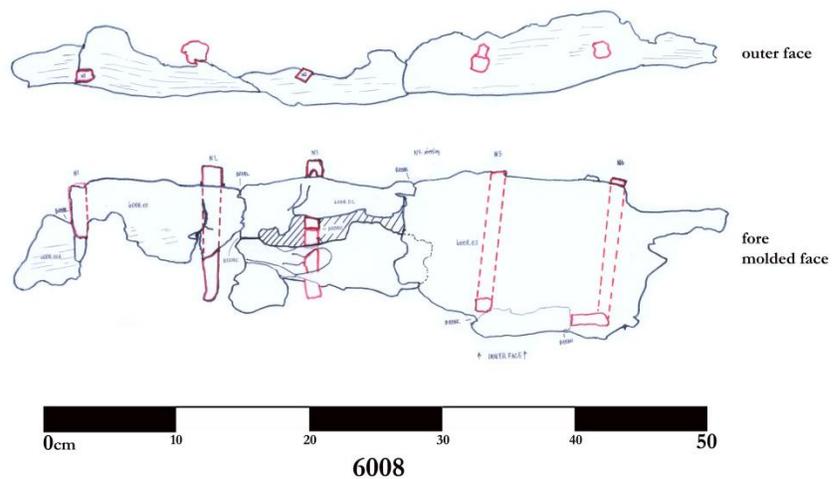
FR 6008

Poorly preserved frame. Distorted, heavily deteriorated, and worn eaten. Very little original surface. Slight nail staggering.

Pres. l. 54.2; s. 5.5; m. 12.4. Five nails: N1 l. 4.3, w. 1.2; N2 l. 10.4, w. 1.3; N3 l. 7.0 (broken), w. 1.1; N4 l. 11.6, w. 1.2; N5 l. 12.9, w. 1.2. Nail spacing: N1-N2 9.3 inner, 10.3 outer; N2-N3 6.5 inner, 7.6 outer; N4-N5 9.5 inner, 9.0 outer. One plug-treenail: 1.1. One partial nail clench: 4.1.

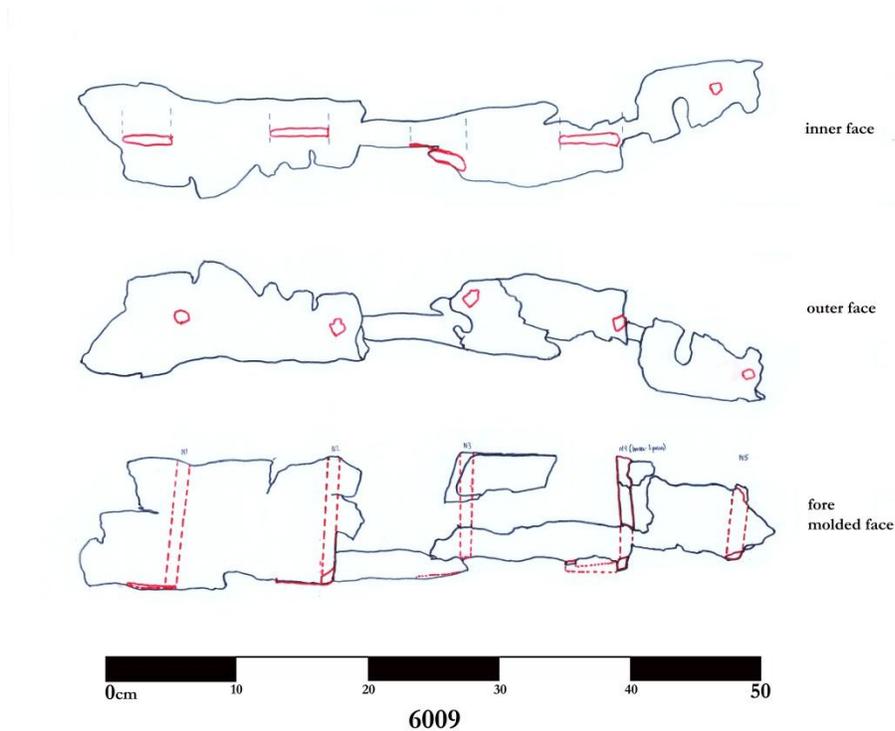
FR 6009

Poorly preserved frame. Heavily deteriorated and worn damages. Little original surface on any face. Clenches mostly parallel to axis of frame. Slight nail staggering.

Pres. l. 53.1; s. 9.0; m. 10.6. Five nails: N1 l. 10.0, w. 1.0; N2 l. 9.8, w. 0.9; N3 l. broken, w. 1.1; N4 l. 8.7, w. 1.2; N5 l. 5.9, w. 1.0. Nail spacing: N1-N2 12.0 inner, 11.1 outer; N2-N3 11.1 inner, 10.2 outer; N3-N4 12.1 inner, 12.0 outer; N4-N5 8.4 inner, 9.5 outer. No plug-treenails discerned. Two partial nail clenches: 4.3, 4.7.

*(planking fragment 6009.04 attached to the frame)

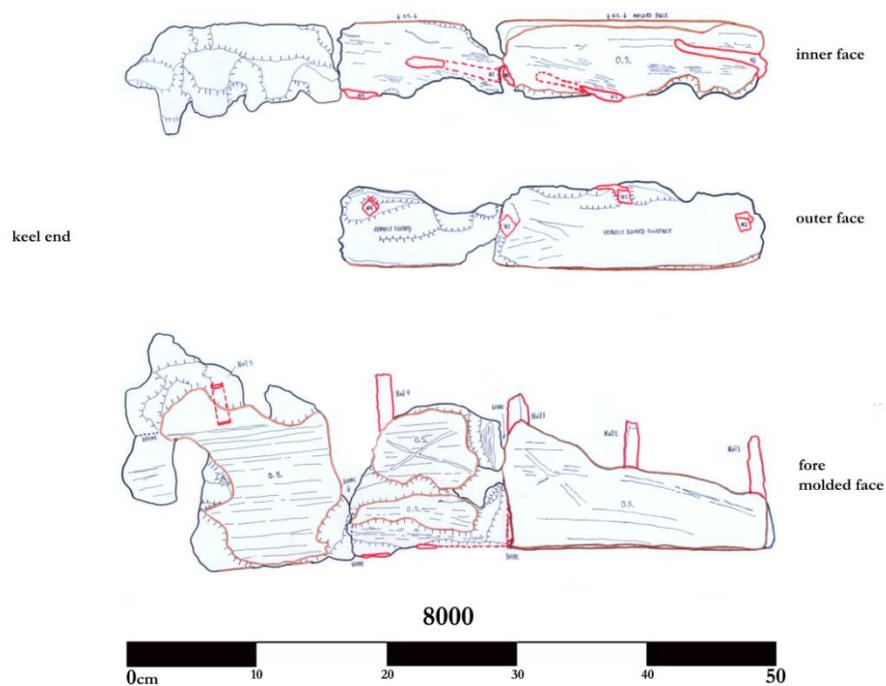
FR 8000

Fairly well preserved forward molded face. Nails staggered across inner and outer faces. All nail clenches parallel to each other but away from central axis of frame. No pitch retained. Edges appear rounded. Molded dimension increases toward the keel.

Pres. l. 50.5; s. 8.6; m. 18.0. Five nails: N1 l. 3.1, w. 1.1; N2 l. 12.34, w. 1.4; N3 l. 10.0, w. 1.2; N4 l. 9.0, w. 1.3; N5 l. 13.8, w. 1.2. Nail spacing: N1-N2 12.6 outer; N2-N3 7.6 inner, 8.7 outer; N3-N4 10.9 inner, 9.5 outer; N4-N5 10.0 inner, 10.2 outer. No plug-treenails discerned. Three nail clenches: 7.8, 6.3, 7.0.

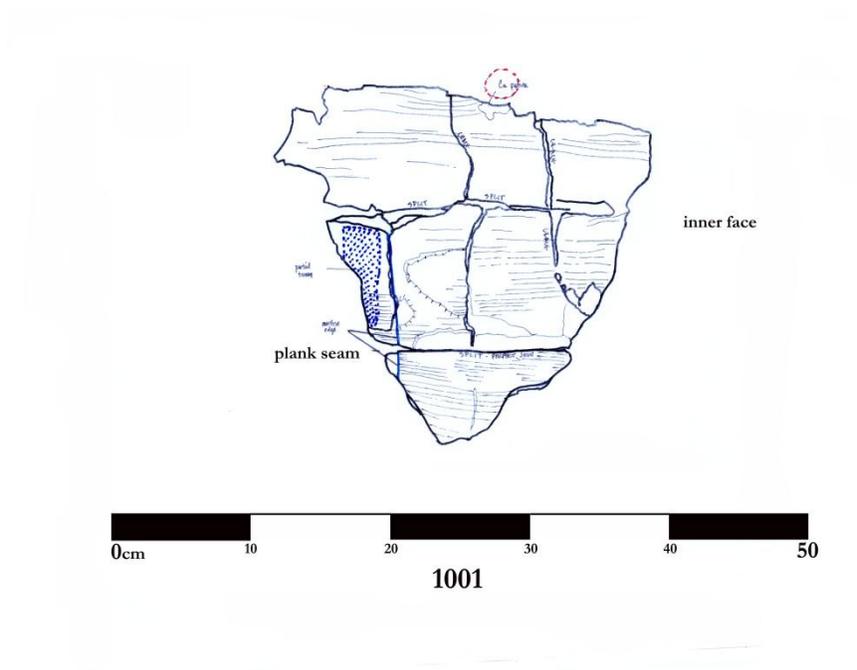
HP 1001 Hull Planking

Two partial strakes with plank seams. Compressed thickness.

Pres. l. 27.2; w. 25.9 (19.1 plank seam to plank seam); th. 2.5. One partial mortise: depth 8.7 (projected to 8.8). One partial tenon: l. 7.2 (projected to 8.7); w. 2.0; th. 0.3. No tenon pegs.
