**THE HULL REMAINS OF THE LATE HELLENISTIC
SHIPWRECK AT KIZILBURUN, TURKEY**

A Thesis

Submitted to the Office of Graduate Studies of
Texas A&M University
in partial fulfillment of the requirements for the degree of

MASTER OF ARTS

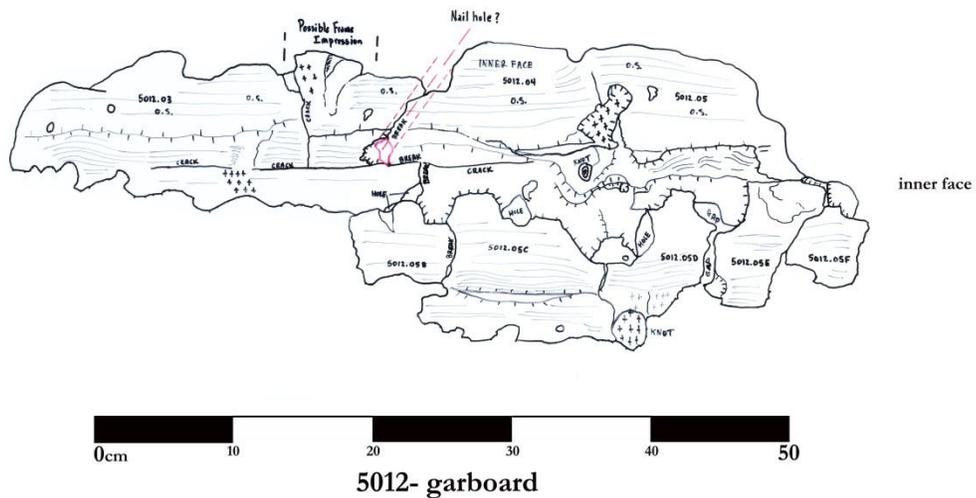
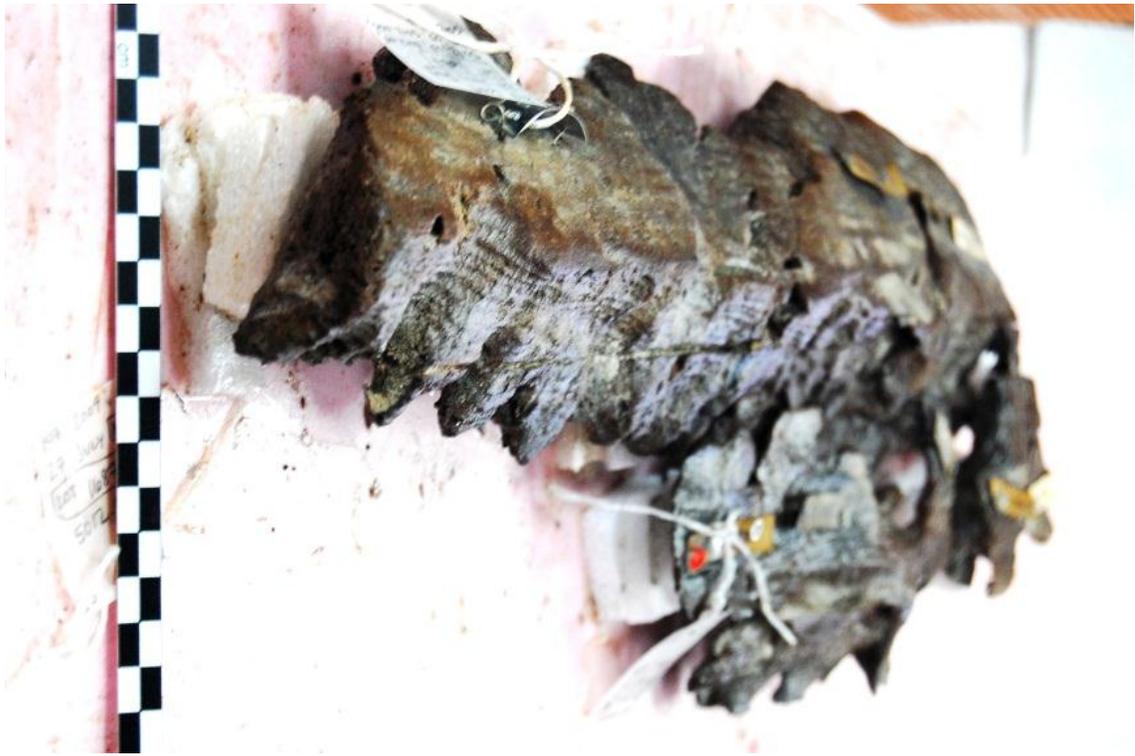
Heavily deteriorated garboard stake section. Two partial mortises. Upper section of timber angled at 35° away from vertical. Two knots retain timber thickness. Mortise 1 (M1) is eroded but complete. M2 is incomplete in both width and depth (l).

Pres. l. 62.3; w. 22.2; th. 4.8. Two partial mortises. M1 l. 5.5; w. 6.2; th. 0.7. M2 l. n/a; w. 5.2; th. n/a. Mortise spacing: M1-M2 (edge to edge) 6.1.

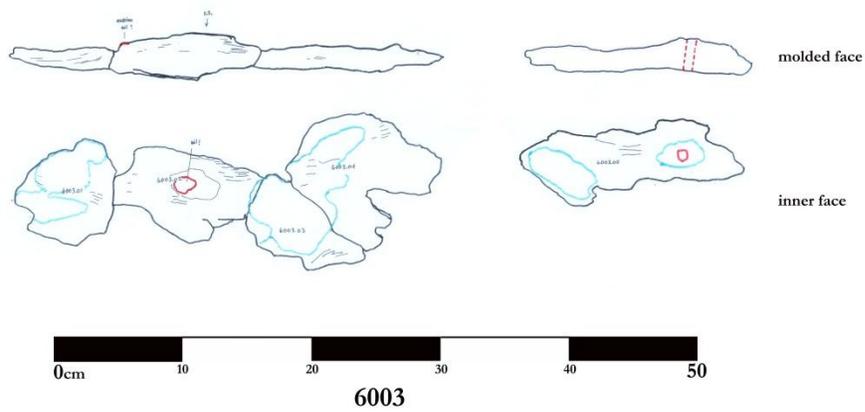
HP 6003 Hull Planking

Heavily deteriorated planking section. One framing nail hole. Residual iron stain from unknown source.

Recon. l. 46.9; w. 15.8; th. 3.8. Nail hole w. 0.9.

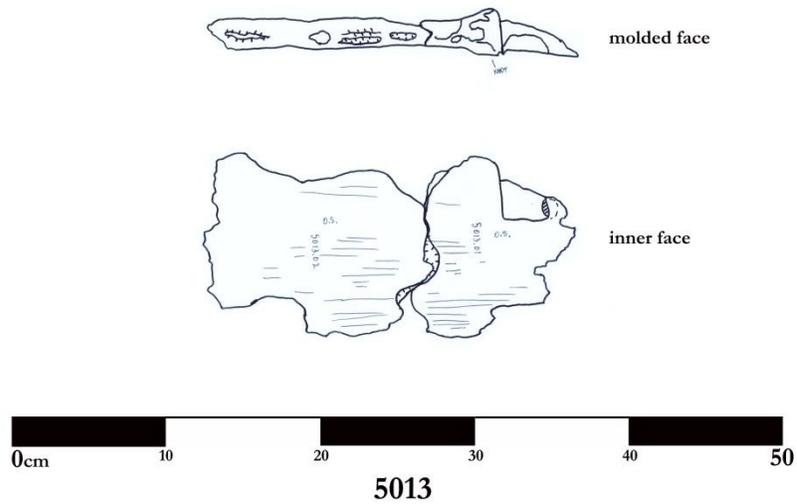
CP 5013 Ceiling planking

Thickness preserved by knot. Otherwise, featureless.

Pres. l. 34.2; w. 12.4; th. 3.1.

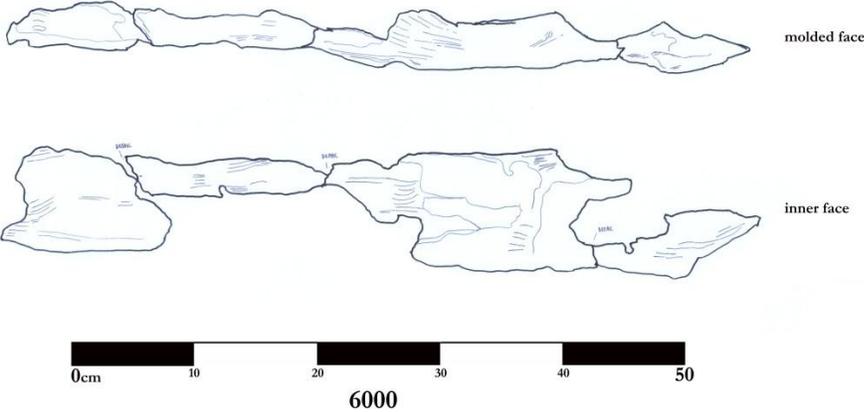
CP 6000

Featureless.

Pres. l. 61.8; w. 9.8; th. 4.1.

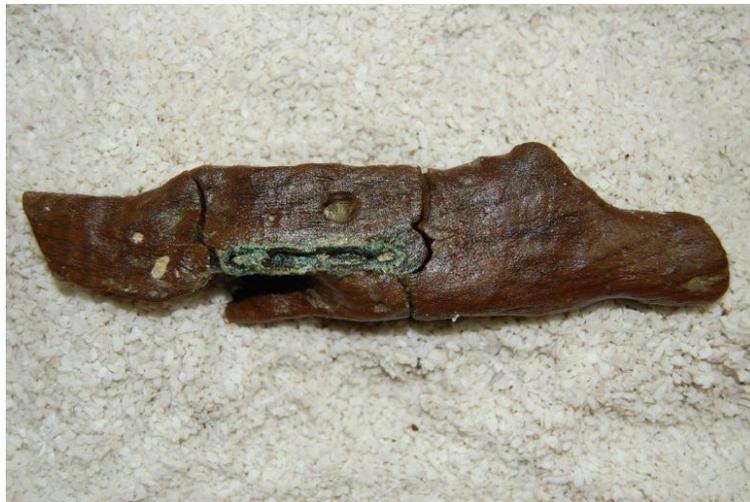
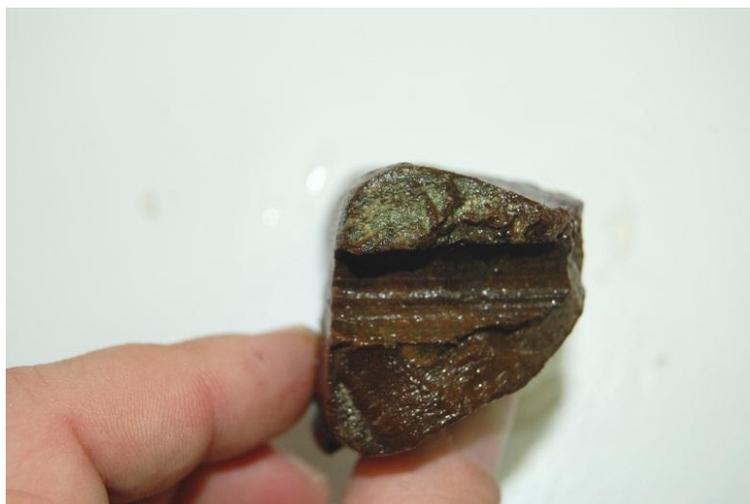
Lot Numbers 594/680/680.01

Heavily deteriorated frame fragment in three fragments, broken along a treenail. One embedded clenched nail.

Pres. l. 19.8; s. 4.3; m. 5.1. Distinct treenail diam. 1.1. Nail clench l. 4.9.

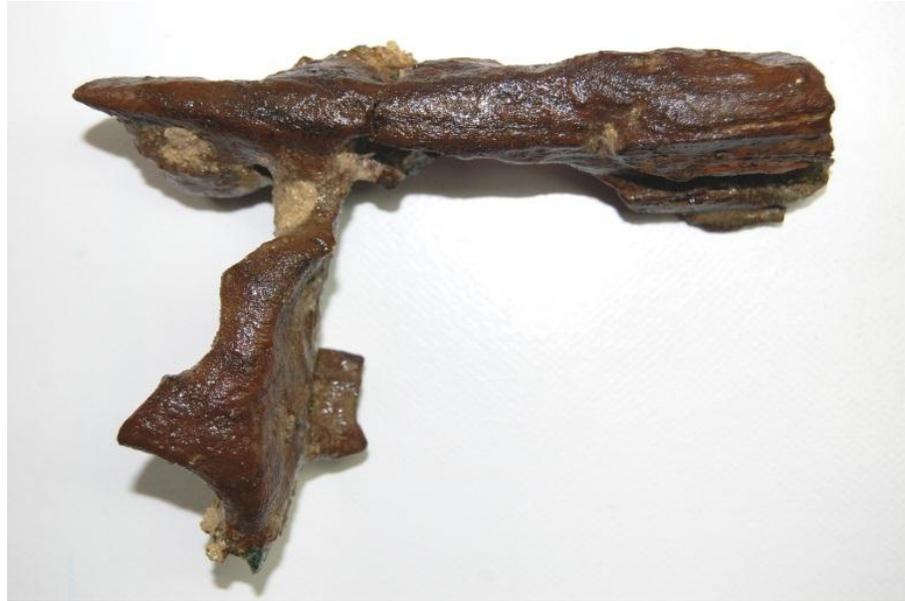
Lot Number 792

Lot Number: 792 Wood Number: 8001 Frame Not sampled

Mostly deteriorated frame fragment with one partial clenched nail demonstrating minimum molded dimension.

Pres. l. 13.6; s. 3.9; m. 9.7. One partial clenched nail: l. 9.7; diam. 1.2.

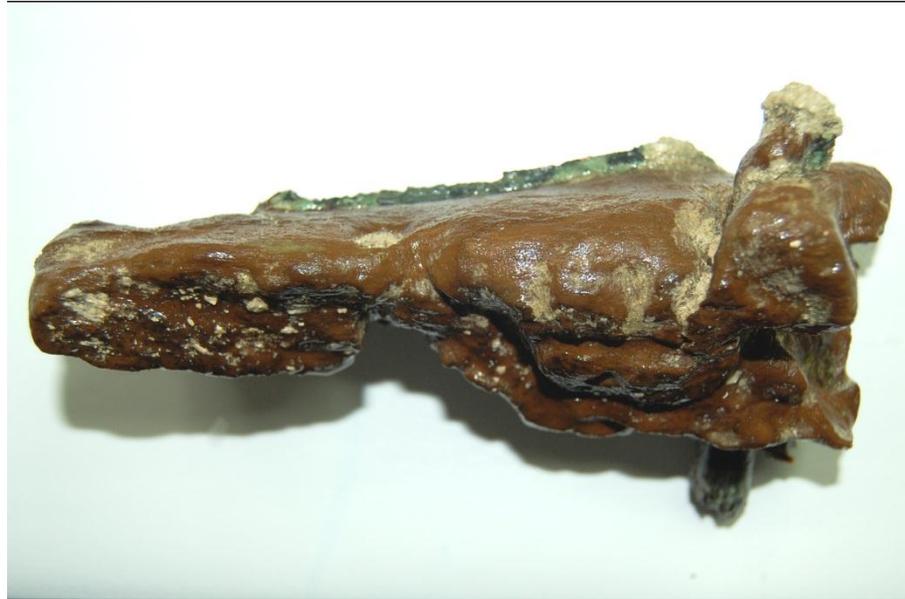
Lot Number 903

Lot Number: 903 Wood Number: 5018 Frame *Fraxinus excelsior*

Heavily deteriorated frame fragment. Two partial nails embedded.

Pres. l. 17.7; s. 8.1; m. 10.0. Two partial nails: l. 3.6, 11.0; w. 1.1, 1.3. Nail spacing: N1-N2
10.0. Nail clench: 9.0.

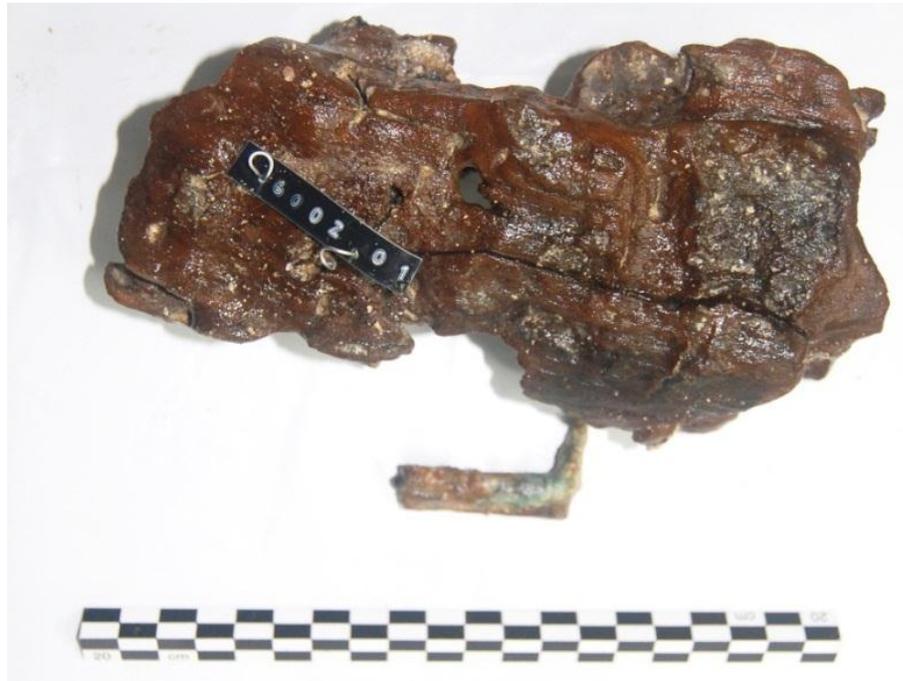
Lot Number 1259

Lot Number: 1259 Wood Number: 6002.01 Frame *Fraxinus excelsior*

Heavily deteriorated frame fragment. Two partial nails embedded.

Pres. l. 17.7; s. 6.7; m. 10.2. Two nails: l. 10.6, 9.8; w. 1.0, 1.1. Nail spacing: N1-N2 7.1 inner, 9.6 outer. Nail clench: l. 2.7 (broken).

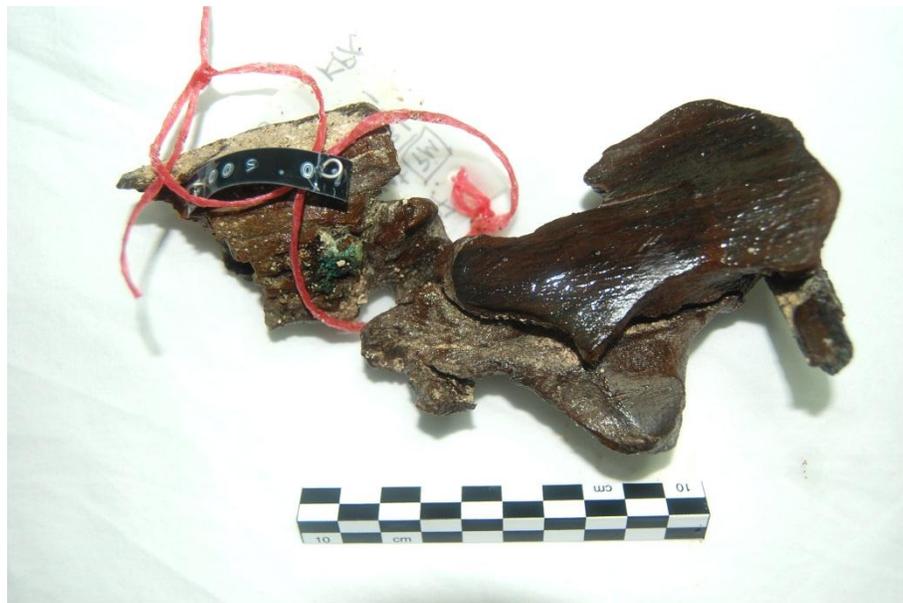
Lot Number 1303

Lot Number: 1303 Wood Number: 5009.01 Frame *Fraxinus excelsior*

Heavily deteriorated frame fragment with two partial nails. One clear plug-treenail.

Pres. l. 15.5; s. 4.8; m. 8.6. Two partial nails: dist. 10.2 inner. Plug-treenail: diam. 1.6.

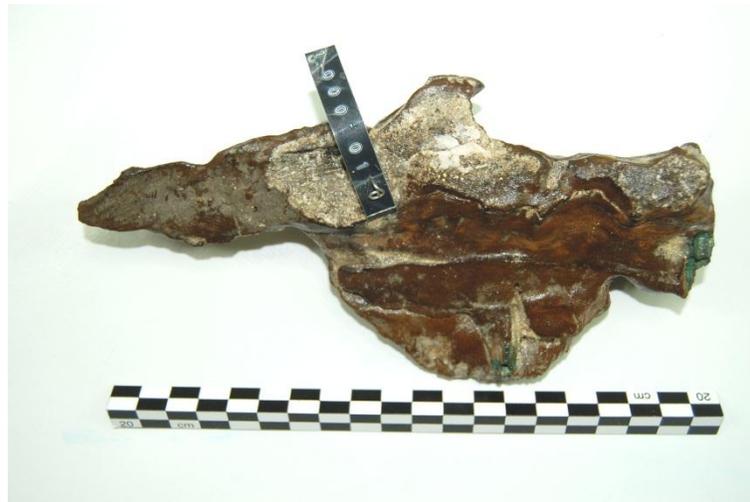
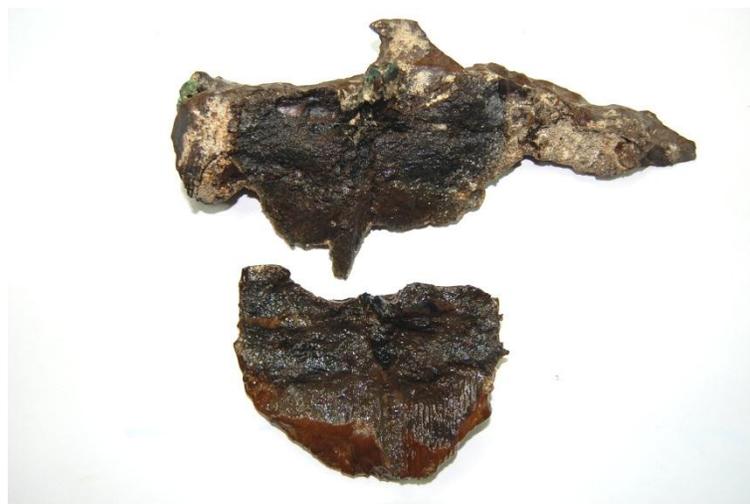
Lot Number 1347

Lot Number: 1347 Wood Number: 1000.01 Frame *Fraxinus* sp.

Heavily deteriorated frame fragment with small compressed planking section attached including partial tenon. Two partial nails embedded. Minimum mortise depth taken from partial tenon (5.8). Planking section *Pinus brutia*. Tenon fragment *Quercus cerris*.

Pres. l. 19.3; s. 3.8; m. 9.9. Two partial nails: N1 l. 8.0, w. 1.0; N2 l. 3.4, w. 0.8. One attached partial tenon: l. 5.8; w. 3.9; th. 0.3. Nail spacing: N1-N2 6.0 inner, 7.3 outer.

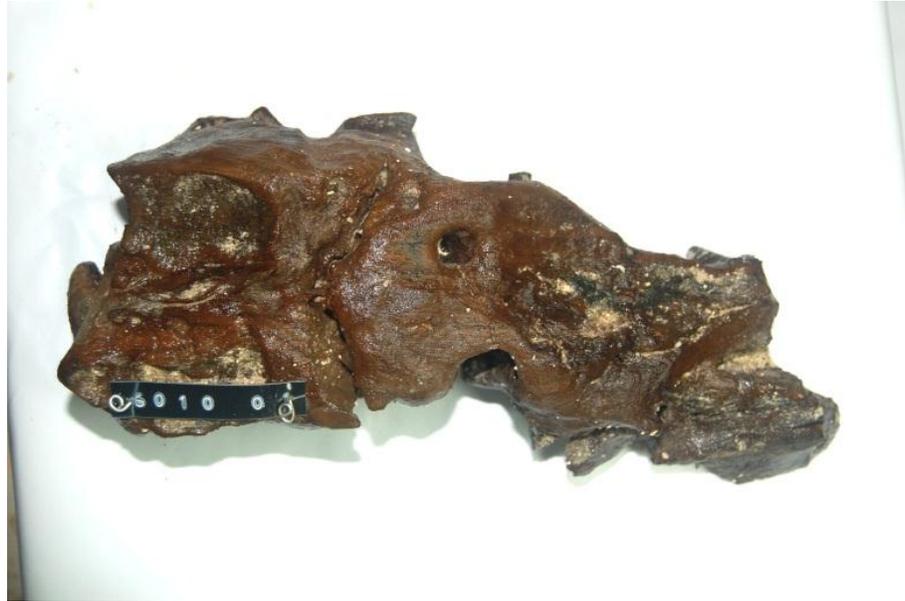
Lot Number 1444.01

Lot Number: 1444.01 Wood Number: 6010.01 Frame *Fraxinus excelsior*

Heavily deteriorated frame fragment. One nail embedded. Small amount of original forward molded surface and pitch.

Pres. l. 20.9; s. 6.1; m. 11.0. One nail: l. 8.6; w. 1.2.

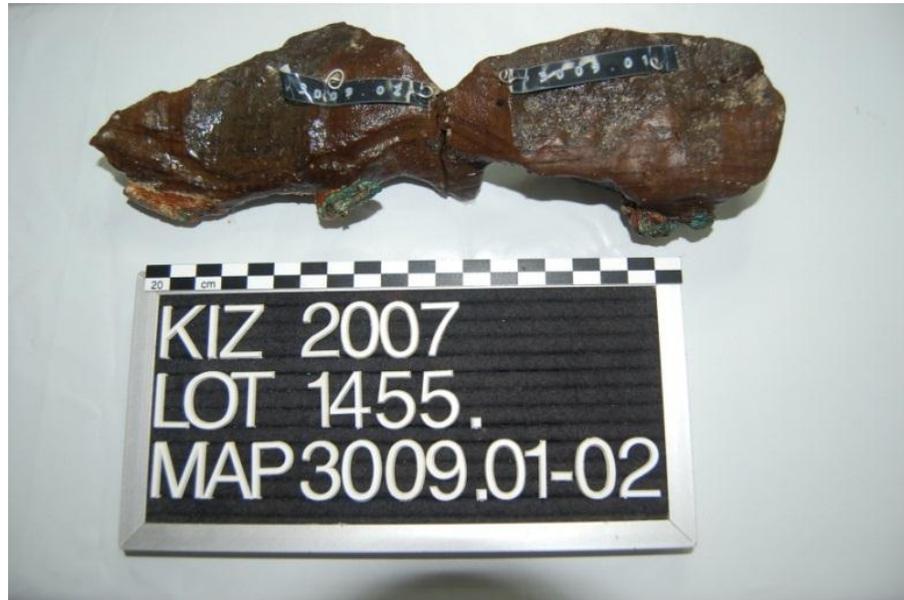
Lot Number 1455

Lot Number: 1455 Wood Number: 3009 Frame *Fraxinus excelsior*

Some original forward molded face surface. Two clenched nails embedded.

Pres. l. 25.8; s. 4.3; m. 8.2. Two nails- spacing: 12.0

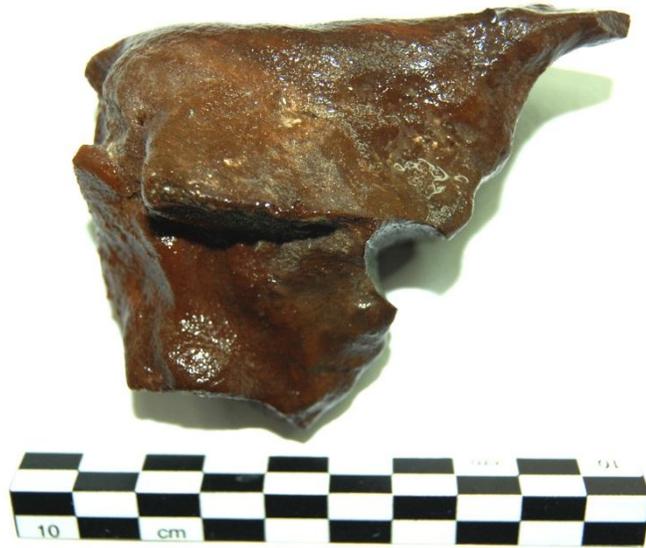
Lot Number 1562

Lot Number: 1562 Wood Number: 6018 Frame *Fraxinus excelsior*

Frame fragment with uniform diam. plug-treenail hole.

Pres. l. 8.3; s. 6.6; m. 6.5. Plug-treenail hole: diam. 1.2.

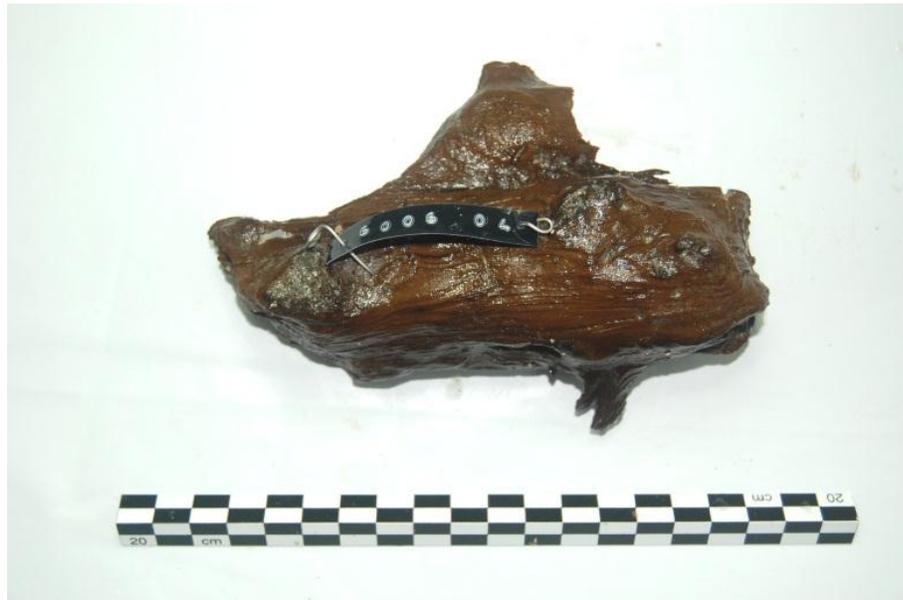
Lot Number 1132.03

Demonstrates planking thickness.

Pres. l. 16.3; w. 11.6; th. 4.1.

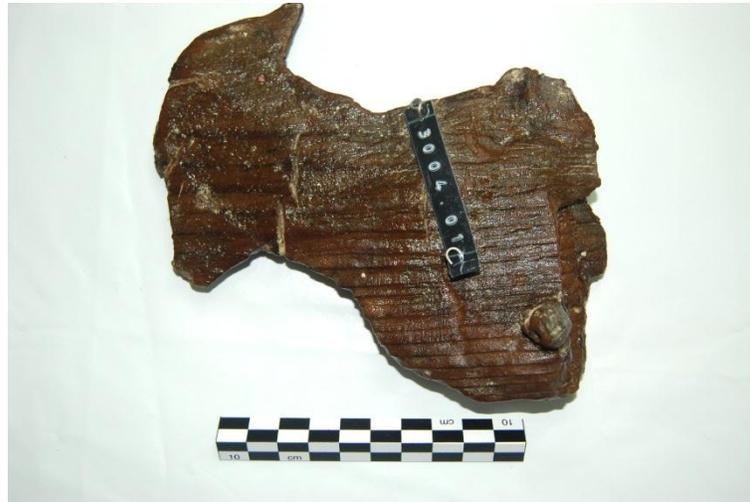
Lot Number 1314

Lot Number: 1314 Wood Number: 3004.01 Hull planking *Pinus nigra*
Heavily deteriorated hull planking fragment. Partial pegged tenon.

Pres. l. 14.8; w. 14.1; th. 3.8. Partial mortise: w. 3.2 edge to peg center (6.4). Partial tenon: l. 8.2; w. 3.2; th. 0.6. Tenon peg: l. 3.8, diam. 1.1.

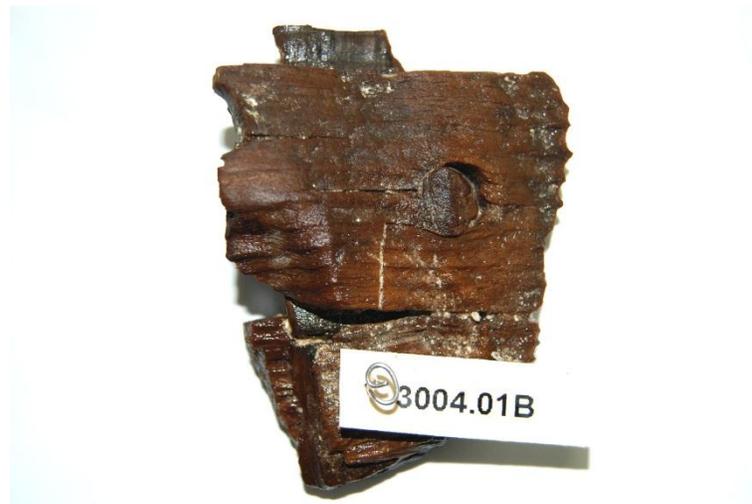
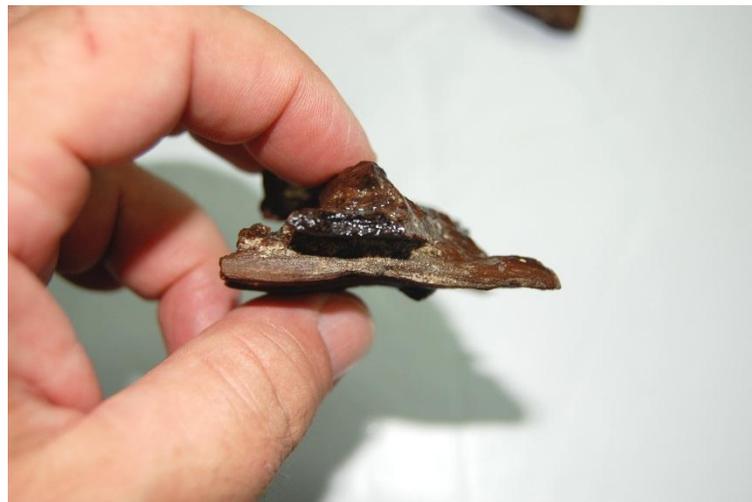
Lot Number 1314

Lot Number: 1314 Wood Number: 3004.01B Hull planking *Pinus nigra*

Tiny planking fragment with partial tenon and tenon peg. Compressed in thickness. Tenon of *Quercus cerris*. Tenon peg of *Quercus* sp.

Pres. l. 5.8; w. 7.8; th. 3.0. Partial tenon: l. 6.7; w. 4.8; th. 0.6. Tenon peg: diam. 1.2; min. peg center dist. to seam 1.7.

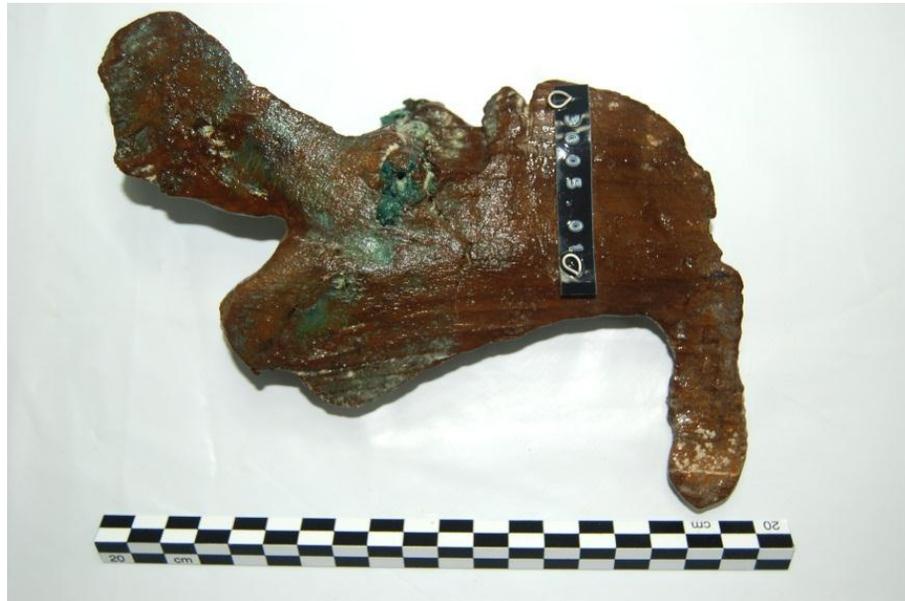
Lot Number 1340

Lot Number: 1340 Wood Number: 3005.01 Hull planking *Pinus nigra*
Heavily deteriorated planking fragment. Demonstrates both minimum width and thickness
of planking.

Pres. l. 16.7; w. 14.9; th. 3.9. One nail: diam. 1.1 driven from outer face.

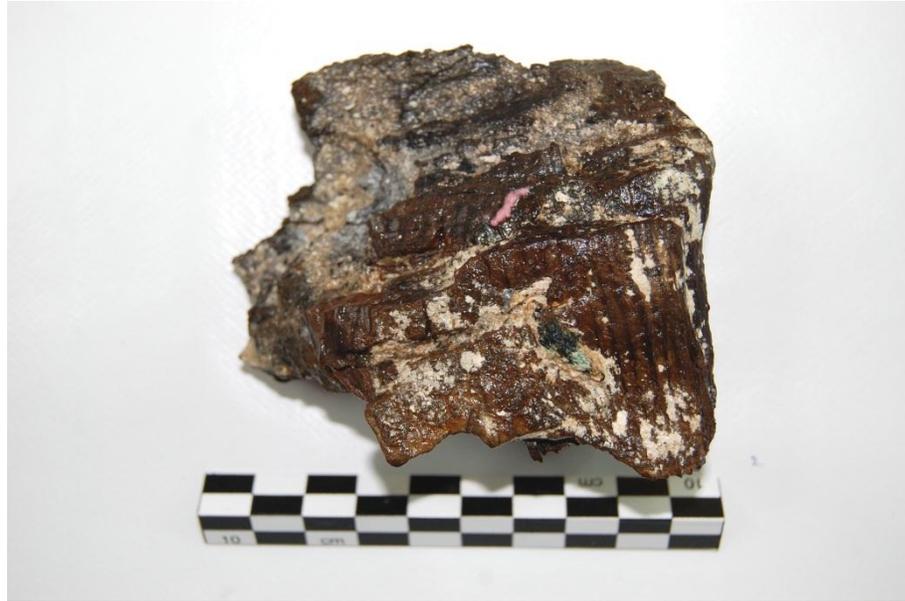
Lot Number 1350.01 Wood Number: 1003.02 Planking Not sampled
Planking fragment with partial tenon. Demonstrates minimum tenon width. Also demonstrates a thick tenon.

Pres. 1.8.8; w. 7.7; th. 3.0. One partial tenon: l. 4.2; w. 6.3; th. 1.1.

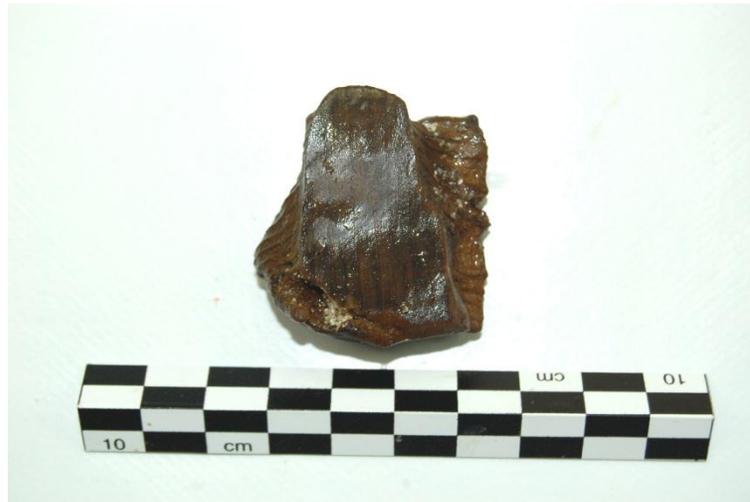
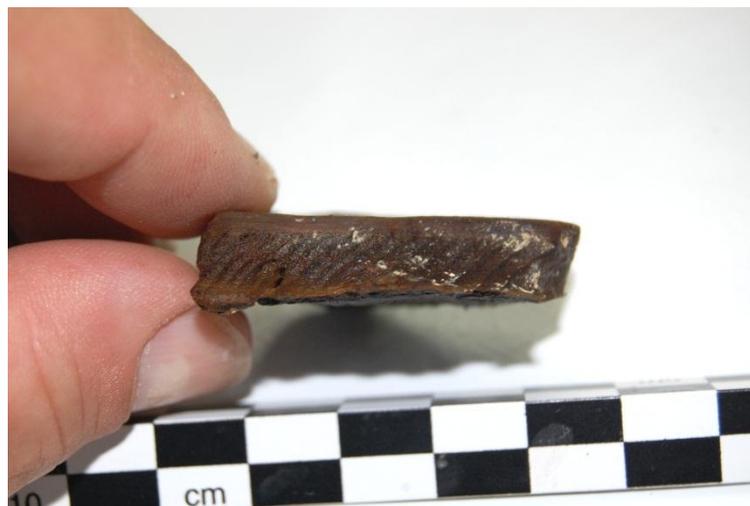
Lot Number 1445.02

Lot Number:1445.02 Wood Number: 1004.04 Planking *Pinus nigra*

Tiny planking fragment with partial tenon demonstrating tenon thickness. Planking heavily compressed, tenon less compressed if at all.

Pres. l. 4.0; w. 3.6; th. 1.1. Partial tenon: l. 4.0; w. 3.4; th. 0.9.

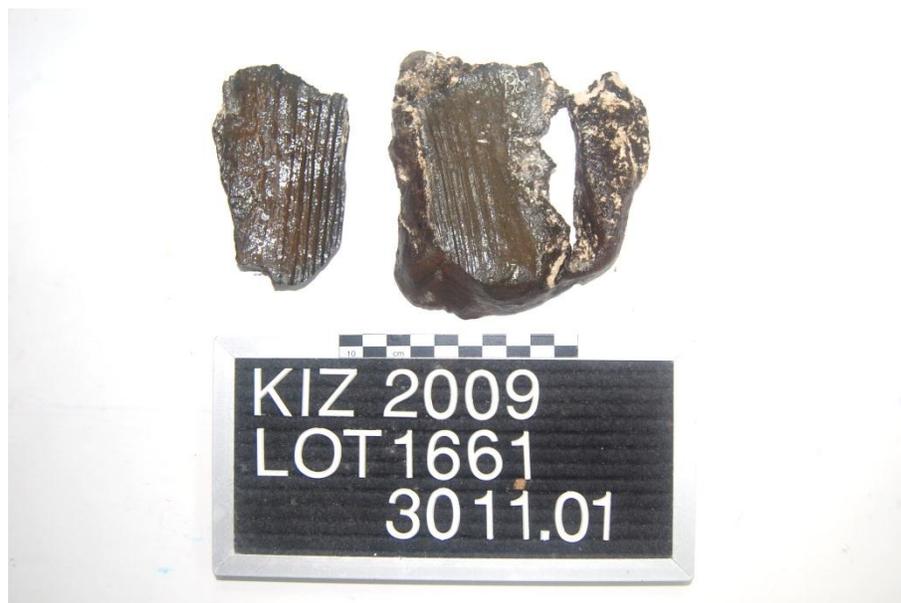
Lot Number 1661

Lot number: 1661 Wood Number: 3011.01 Planking *Pinus nigra*

Planking fragment with attached frame fragment. Mortise shows tapered shape. Partial tenon closely fitted, yet twisted and compressed.

Pres. l. 8.4; w. 11.9; th. 3.8. Half-tenon and mortise. Mortise: l. 7.2; w. 6.4. Tenon: l. 7.2; w. 6.2; th. 0.4 (compressed).

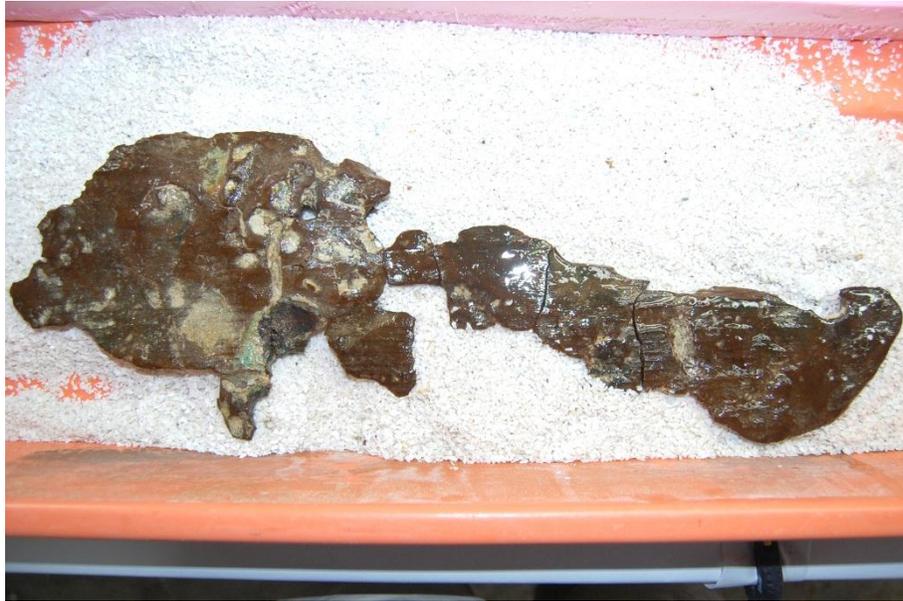
Lot Number 490

Lot Number: 490 Wood Number: n/a Ceiling Planking not sampled
Featureless.

Pres. l 42.8; w. 14.8; th. 3.0.

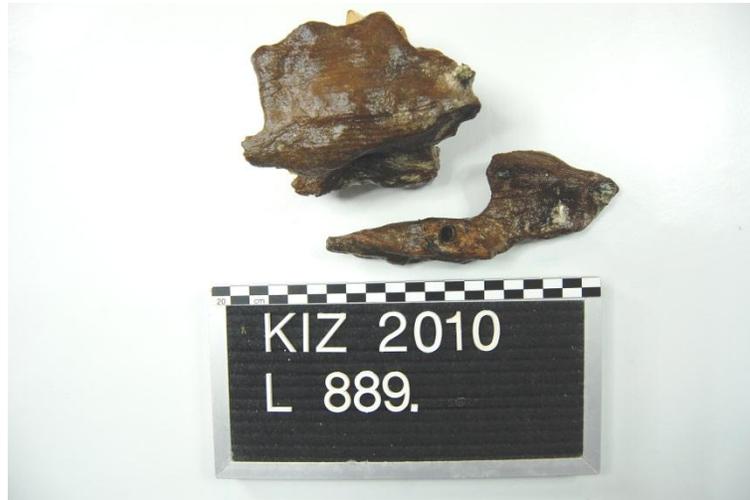
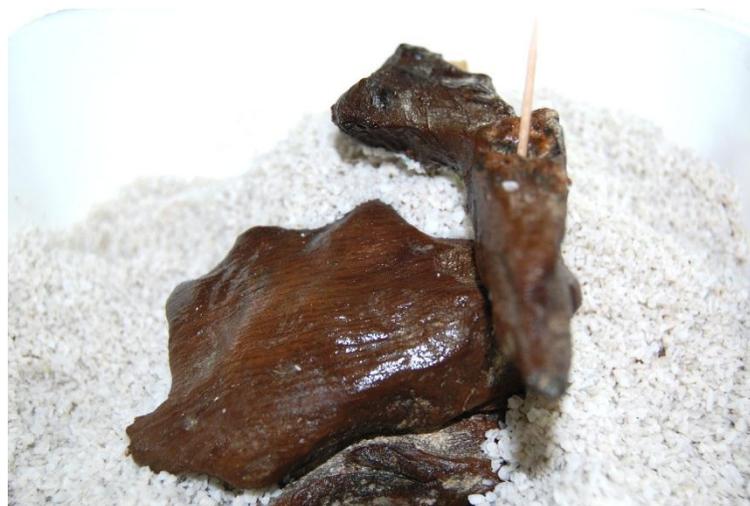
Lot Number 889

Lot Number: 889 Wood Number: n/a Ceiling planking not sampled
Frame fragment and ceiling planking fragment with nail hole. The only frame fragment with
definitive ceiling planking attachment.

Pres. l. 15.4; w. 7.0; th. 2.9. One nail hole: w. 0.6.

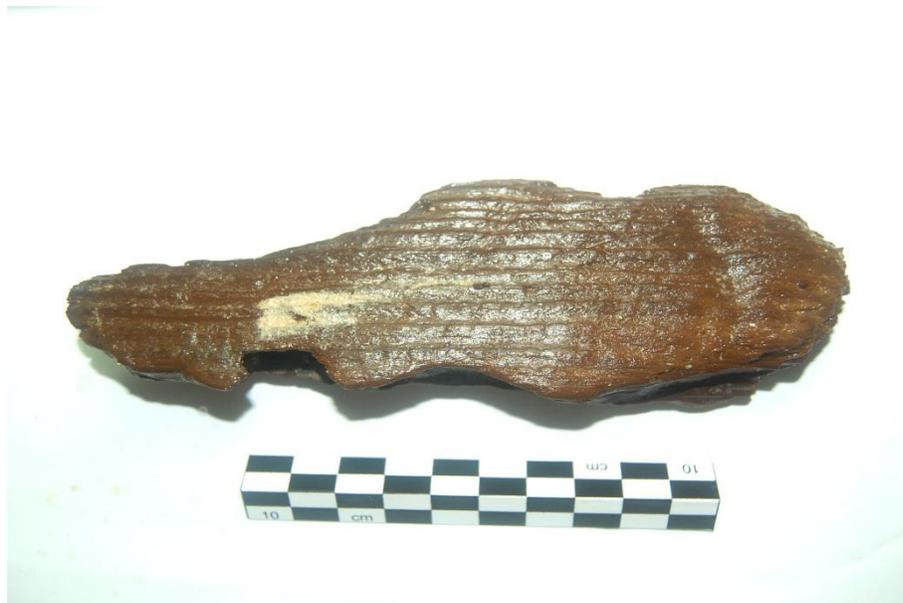
Lot Number 1210.01

Lot Number: 1210.01 Wood Number: 5006.02 Ceiling planking *Pinus nigra*
Featureless ceiling planking fragment demonstrating thickness of timber.

Pres. l. 9.5; w. 3.0; th. 4.1.

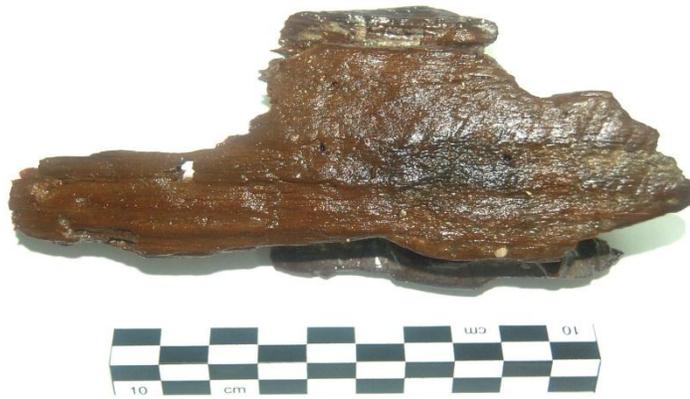
Lot Number 1210.02

Lot Number: 1210.02 Wood Number: 5006.03 Ceiling planking *Pinus nigra*
Original inner face surface with saw marks. One nail hole. See Lot Number 1210.01 for
thickness.

Pres. l. 13.4; w. 5.6; th. 2.9. Nail hole: diam. 0.4.

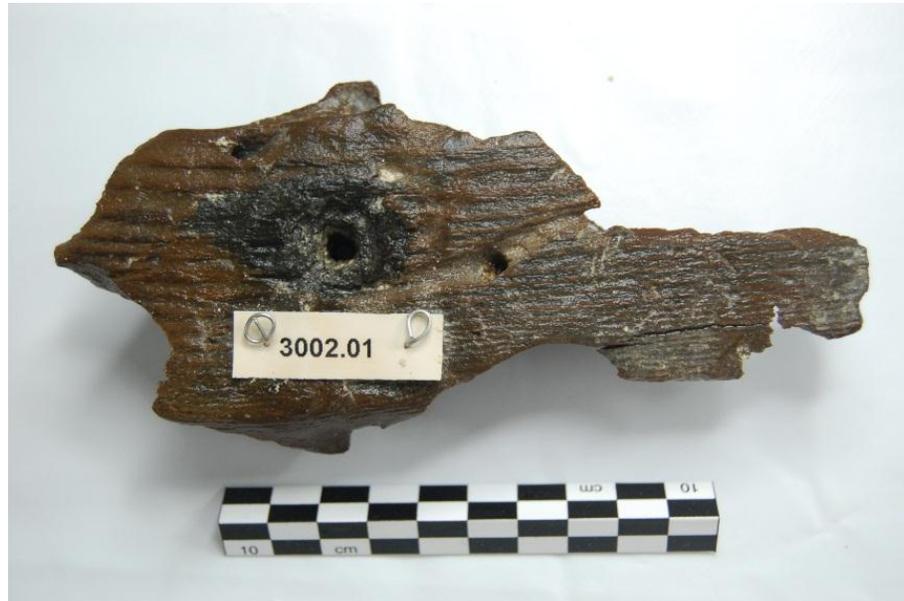
Lot Number 1339

Lot Number: 1339 Wood Number: 3002.01 Ceiling planking *Pinus brutia*
Heavily deteriorated ceiling planking fragment with one nail hole. Original surface on inner
and outer face.

Pres. l. 15.5; w. 7.4; th. 3.5. One nail hole: w. 0.5.

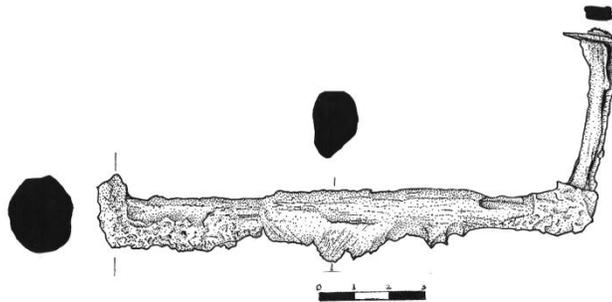
L. 21.3; max. w. 1.3; diam. head. 2.0; 1 clenched 7.4 cm. Complete in length degraded width. Square section shank. Retains some of the treenail and 3.3 cm of planking wood below the head. Shank length to first clenched 12.7 cm preserving the width (molded dimension) of the frame it secured. First clenched is formed by an angle of 98° with length 5.8 cm. Second clenched 1.6 cm in length.

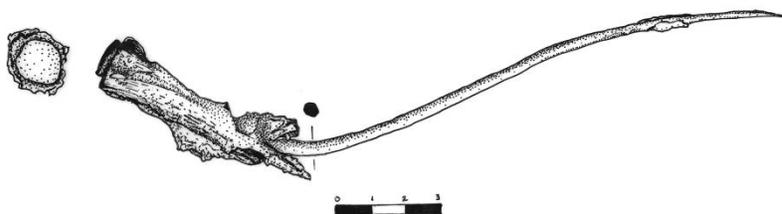
Pres. l 20.2; max w n/a; diam head 1.5; clenched length n/a. Flattened pyramidal head. Indeterminate shank shape and width. Remnants of treenail to 5.1 cm below head. Central portion is ferro-magnetic, but not the extremities.

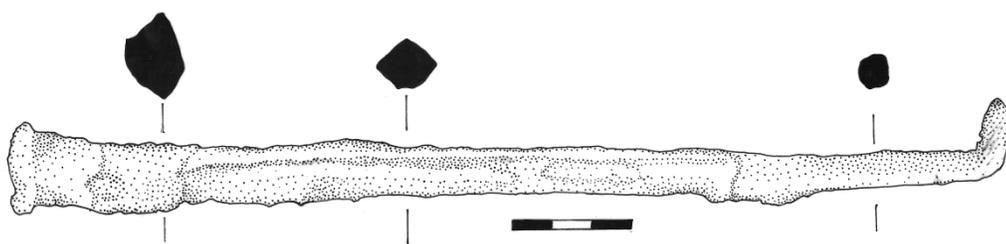
Pres. l. 26.9 cm; max. w. 1.5; diam. head 2.4; clenched length n/a. Restored from four fragments with clearly defined breaks. Indeterminate head shape. Square shank. Shank length to partial first clenched 24.1 cm preserving the molded dimension of the floor it secured. First clenched is formed by an angle of 104° . Second clenched is missing.

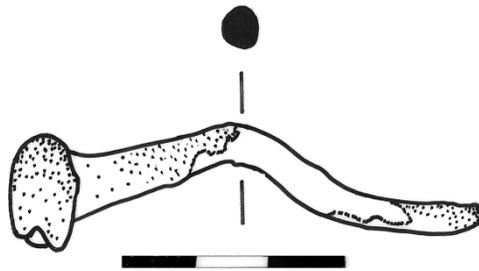
L. 7.0; max. w. 0.7; diam. head 1.6. Flattened pyramidal head. Square shank..

Compound curve starting at 2.8 cm below the bottom of head which is canted 104 degrees to the shank.

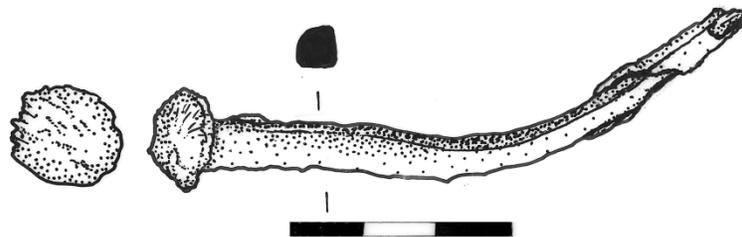
L. 8.4; max. w. 0.7; diam. head 1.5. Flattened pyramidal head. Square shank with a compound curve starting at 4.4 cm.

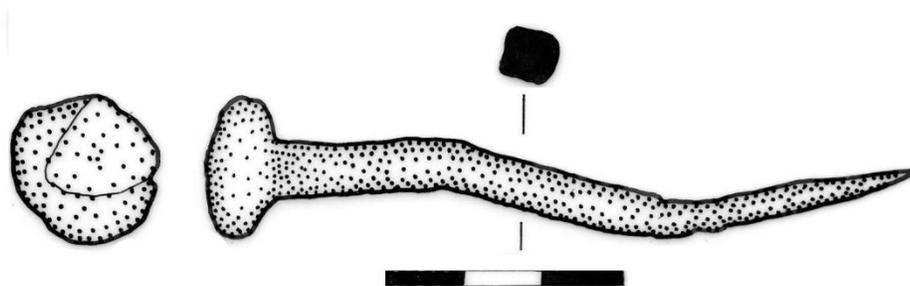
L. 9.2; max. w. 0.7; diam. head 1.9. Flattened pyramidal head. Square shank.
with bend starting at 4.5 cm below head.

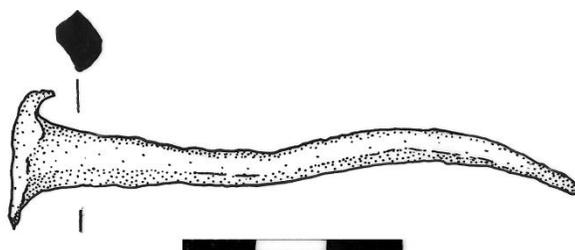
L. 8.0; max. w. 0.6; diam. head 2.0. Flat head. Square shank.

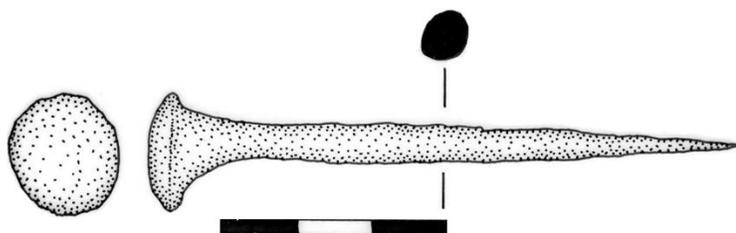
L. 7.6; max. w. 0.7; diam. head 1.7. Flattened pyramidal head. Square shank.

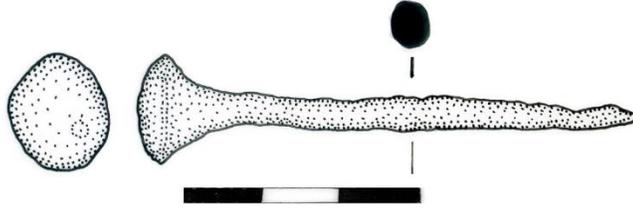
L. 6.5; max. w. 0.6; diam. head 1.5. Flattened pyramidal head. Square shank with degraded edges.

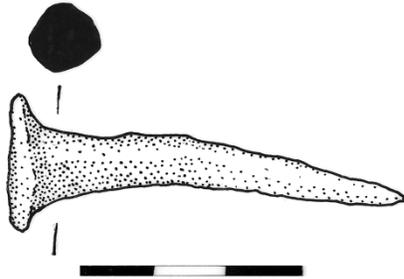
L. 5.4; max. w. 0.9; diam. head 1.9. Flat head. Square shank rapidly tapers toward distal end with slight curvature.

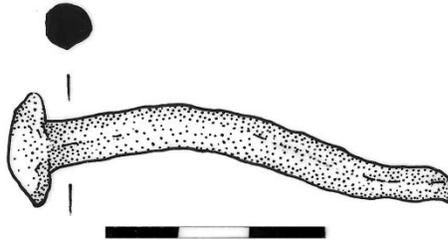
Pres. l. 6.0; max. w. 0.6; diam. head 1.5. Flattened pyramidal head. Square shank, with compound curved shape. Distal end is broken.

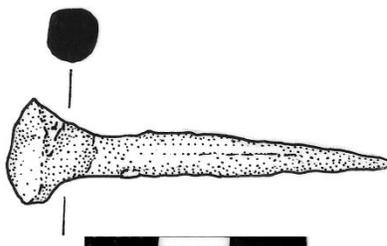
L. 5.2; max. w. 0.6; diam. head 1.5. Flattened pyramidal head. Square shank.

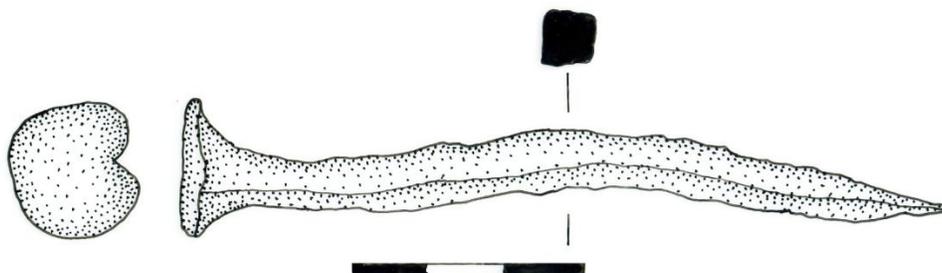
L. 9.8; max. w. 0.6; diam. head 1.7. Flat head split on one side, likely due to impact of heavy hammering. Square shank with broken distal end.

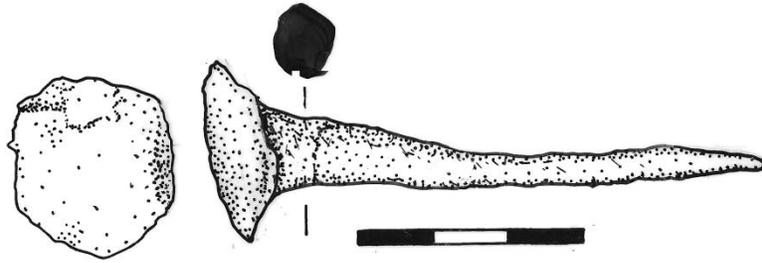
L. 7.4; max. w. 1.0; diam. head 2.5. Flat head canted at an angle of 104 degrees to the shank. Square shank tapers rapidly toward distal point.

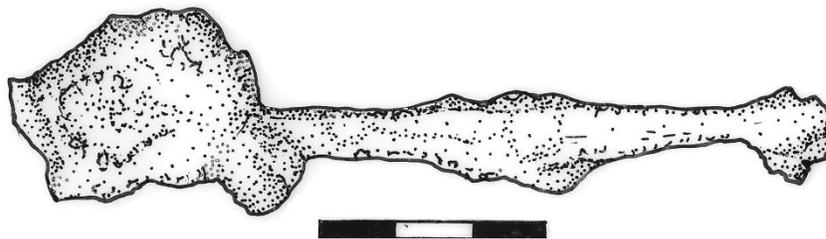
Pres. l. 8.8; max. w. 0.65; diam. head n/a. Incomplete. No head. Square-sectioned shank tapering to 0.45 cm at distal end.

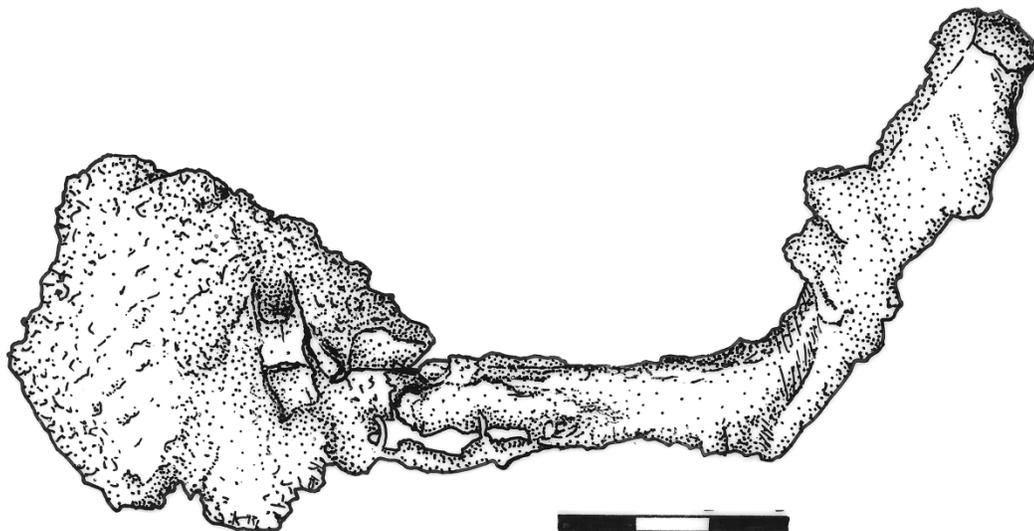
Pres. l. 12.1; max. w. 0.91; diam. head n/a. Incomplete. Head survives under iron bleed but is indeterminate. Iron impregnated wood encases approximately 6.5 cm of the shank. Square-sectioned shank tapers toward missing distal tip (0.91 cm to 0.76 cm).

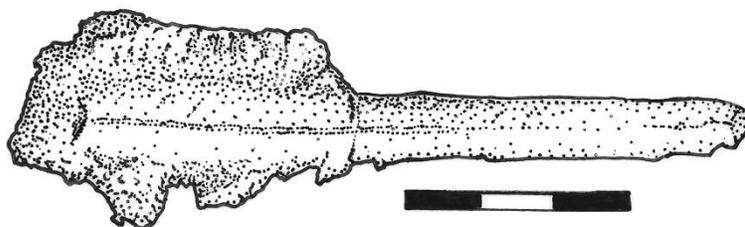
L. 8.4; max. w. 0.64; diam. head n/a. Incomplete. No head, may be broken off. Square shank tapering toward broken distal tip (0.64 cm tapering to 0.44 cm).
